**AN APPLICATION FOR A  
CERTIFICATE OF PUBLIC CONVENIENCE and NECESSITY**

**COPPER CONDUCTOR REPLACEMENT (CCR) PROJECT**

**June 27, 2008**

**Appendix A: FAILURE INVESTIGATION OF COPPER CONDUCTOR AND MATERIAL PROPERTIES ASSESSMENT**

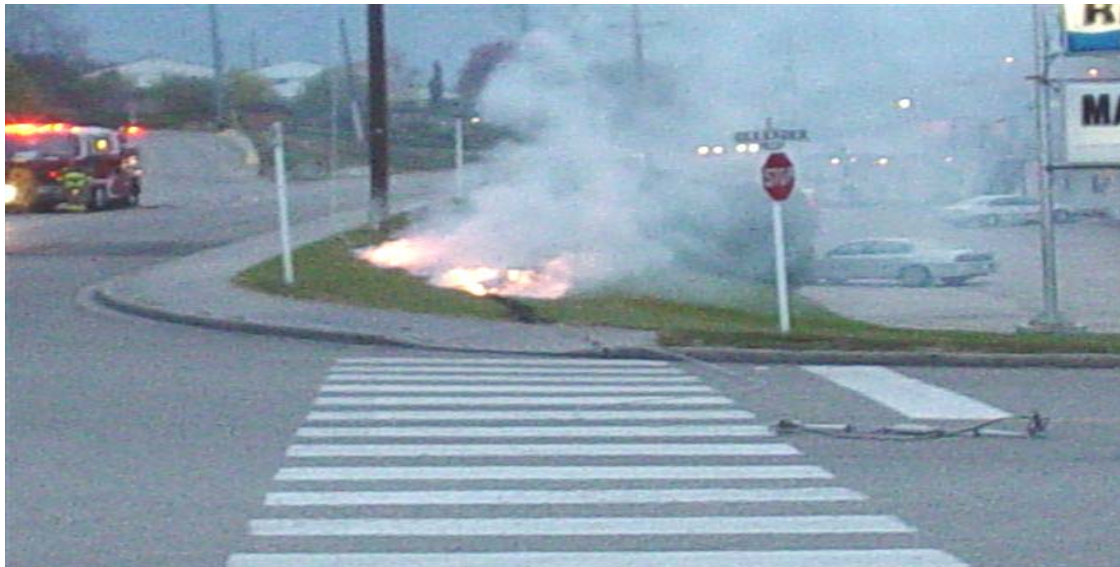
11   **Picture 1**  
12   **Energized Power Line on Ground**

8    The following Picture 1 provides an example of an incident in FortisBC's service area  
9    where a downed copper conductor remained energized on the ground resulting in a grass  
10   fire.

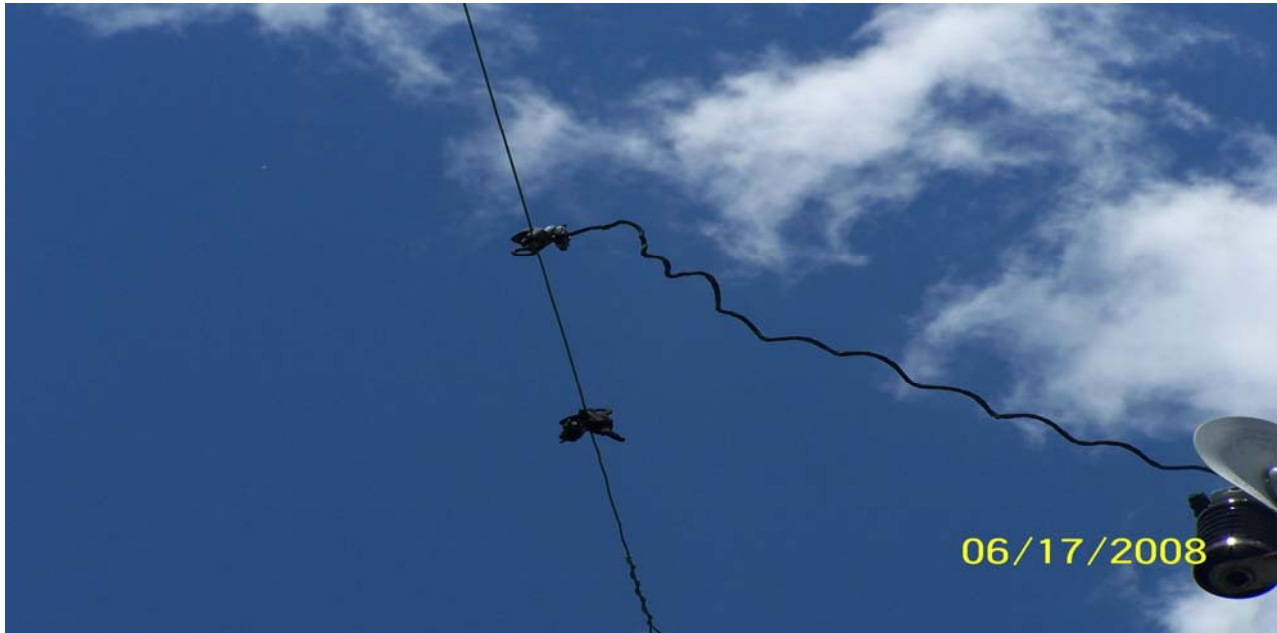
3 **Picture 2**  
4 **Hot Tap Connector Left on Conductor**

1 connectors on the conductor rather than risk the possibility of conductor failure by trying  
2 to remove it.

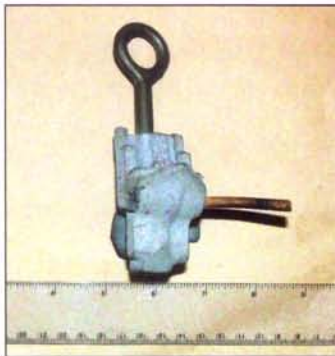
Figure 1: Hot tap and failed #4 AWG conductor received for examination

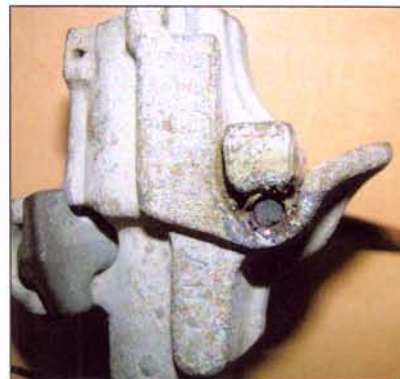
Figure 2: View of fractured conductor in hot tap saddle

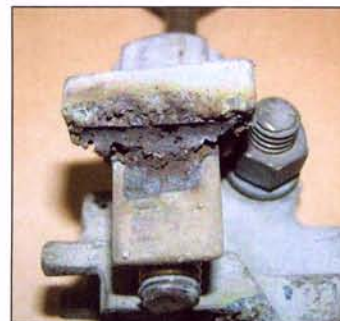
Figure 4: Buildup of contamination on clamping surface of hot tap in contact with copper conductor

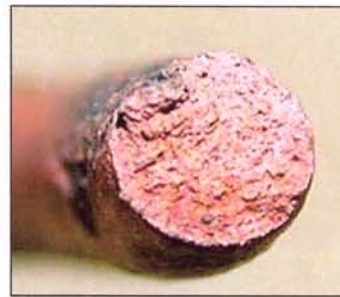
- The fracture surface of the conductor was fibrous and dimpled in topography, consistent with macro scale features of a ductile overload failure (Figure 6).

Figure 6:  
Macro image of  
fracture surface  
of copper  
conductor

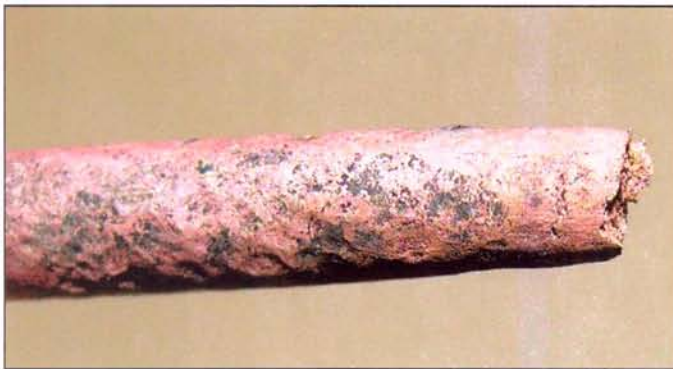
- The outer surface of the failed conductor in the portion within the hot tap clamp was pitted heavily from corrosion attack (Figure 7).
- The diameter of the wire just below the fracture surface was measured with a micrometer to be 3.96 mm. The diameter of the wire at the opposite end of the sample was 5.15 mm (#4 AWG size). The measurements show a 41% reduction in the cross sectional area of the conductor at fracture. The large scale elongation and necking down of the diameter is typical of ductile overload in annealed copper.

Figure 7: Macro image of surface  
condition of failed copper conductor

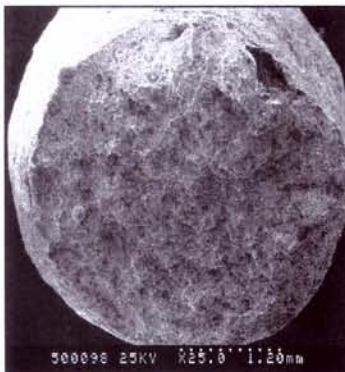
The cleaned fracture surface of the failed conductor was sectioned approximately half an inch below the fracture and examined in a Hitachi S-2500 Scanning Electron Microscope. Microscale features of the fracture consisted of rupture dimples formed by microvoid coalescence, characteristic of a ductile overload fracture (Figures 8 and 9).

Figure 8: Low magnification scanning electron  
micrograph of fracture surface of copper  
conductor.

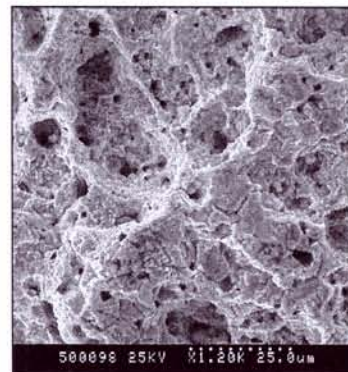
Figure 9: High magnification scanning electron  
micrograph of fracture surface of copper  
conductor.

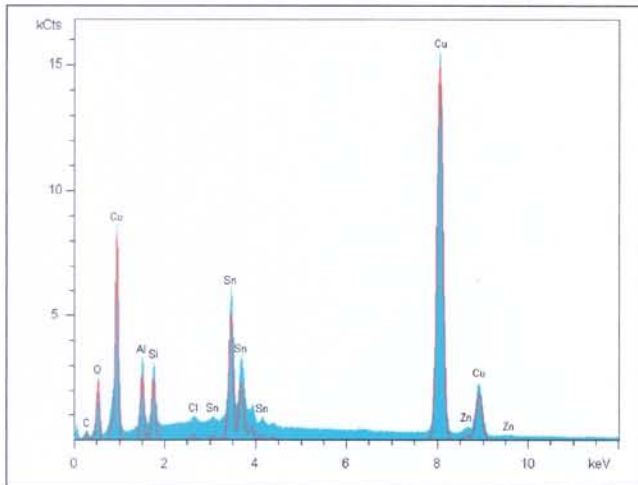
A portion of the adherent contaminant layer was removed from the clamp surface and analyzed by Energy Dispersive X-Ray Spectroscopy (EDS) using Quartz X-One Microanalysis Software. The spectrum obtained from the analysis (Figure 10) showed an elemental composition high in aluminum (Al), copper (Cu), tin (Sn), zinc (Zn) and oxygen (O), indicating the majority of the

contaminant is corrosion (oxide) product from the tin coating, the aluminum alloy body of the clamp, and the copper conductor itself. Minor traces of silicon (Si) and chlorine (Cl) are attributable to general environmental contamination.

Figure 10: EDS spectrum obtained from the analysis of corrosion product within hot tap connection.

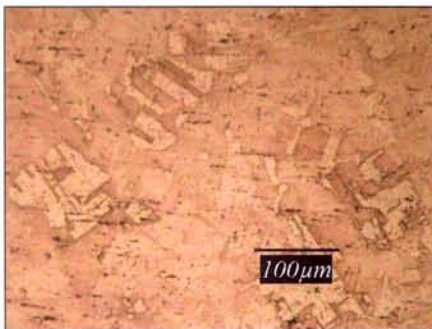
Figure 11:  
Microstructure  
0.025 inches  
below fracture  
surface  
Hardness  
57 HV  
Mag: 200X

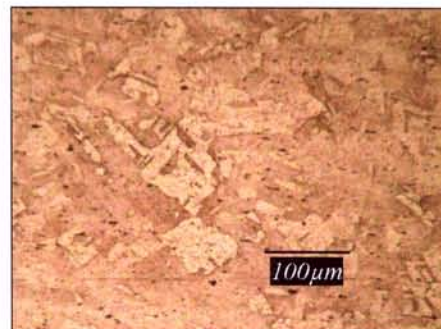
Figure 12:  
Microstructure  
0.500 inches  
away from  
fracture  
surface  
Hardness  
60 HV  
Mag: 200X

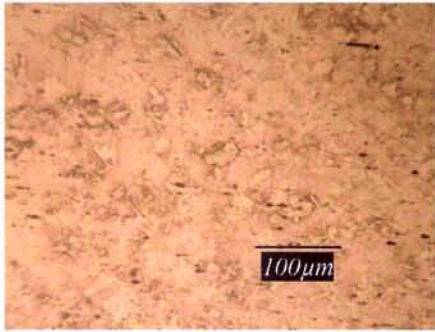
Figure 13:  
Microstructure  
1.00 inches  
away from  
fracture  
surface  
Hardness  
63 HV  
Mag: 200X

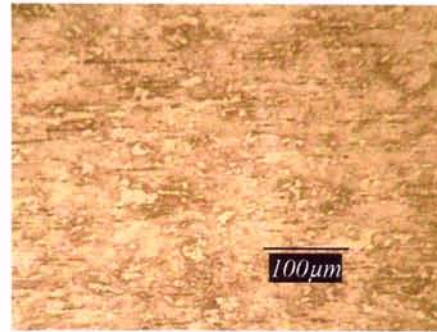
Figure 14:  
Microstructure  
2.00 inches  
away from  
fracture  
surface  
Hardness  
80 HV  
Mag: 200X

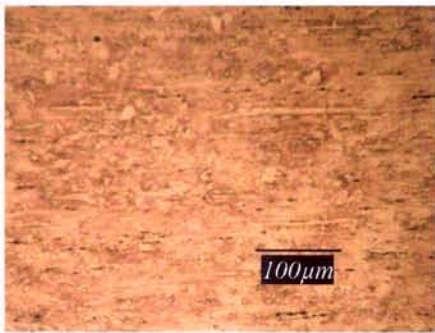
Figure 15:  
Microstructure  
2.50 inches  
away from  
fracture  
surface  
Hardness  
91 HV  
Mag: 200X

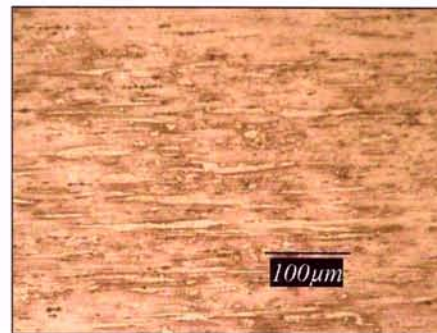
Figure 16:  
Microstructure  
3.00 inches  
away from  
fracture  
surface  
Hardness  
104 HV  
Mag: 200X

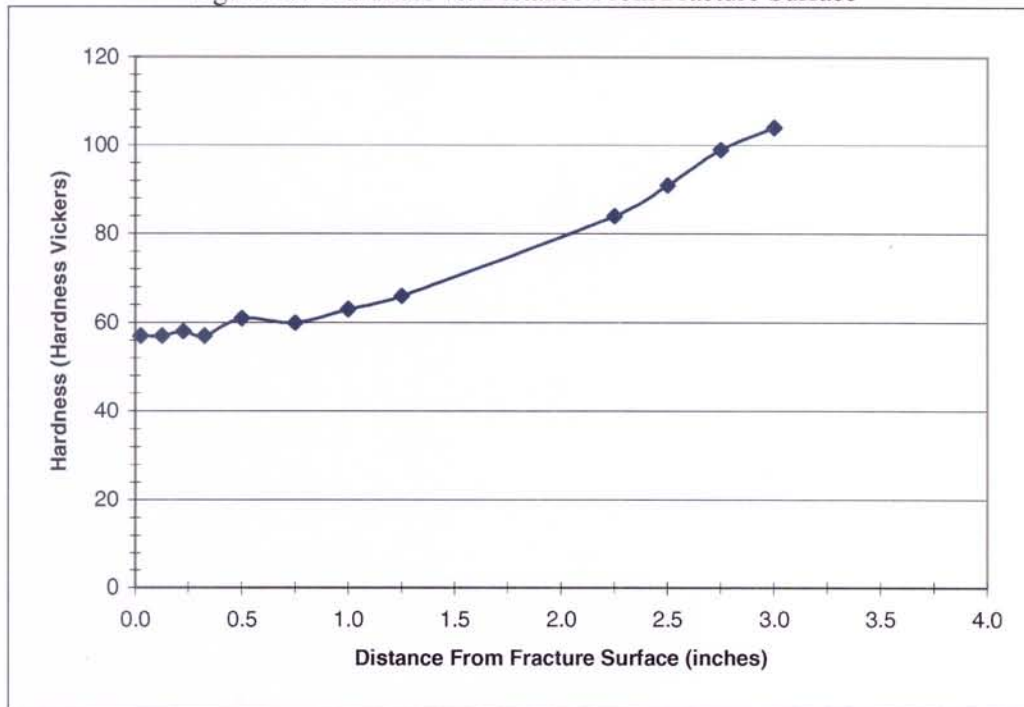
Figure 17: Hardness vs. Distance From Fracture Surface

The hardness values obtained from the survey show that the conductor within the clamping area of the connection had softened considerably, consistent with copper in the annealed condition. Outside of the connection area, the hardness returns to values closer to that expected for the hard drawn condition.

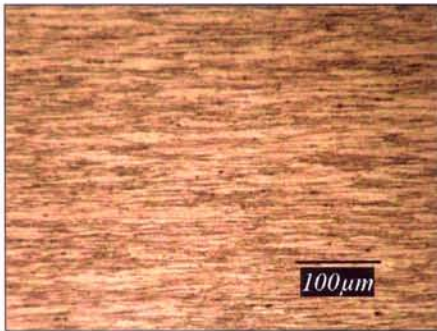
Figure 25:  
Microstructure  
seen in sample  
6a  
Magnification:  
200X

Metallographic specimens were prepared from samples 6a, 8a, 90, and 2s. Specimens were also prepared from sections of conductor within the splices of samples 3a and 4b, as well as approximately 2" outside the splice area. Sections of the conductor were prepared in the transverse and longitudinal cross section. Micrographs taken of the microstructure of samples 6a, 8a, 2s show elongated grains consistent with hard drawn copper (Figures 25-27). In sample 8a some fine equiaxed grains are seen, indicating some recrystallization and grain growth may be occurring. The microstructure of sample 90 shows elongated grains are not as compacted as the other samples, indicating the conductor may have been in the medium drawn condition, or some grain growth has occurred (Figure 28). Both the microstructures seen in sample 8a and 90 are consistent with the lower tensile strengths seen.

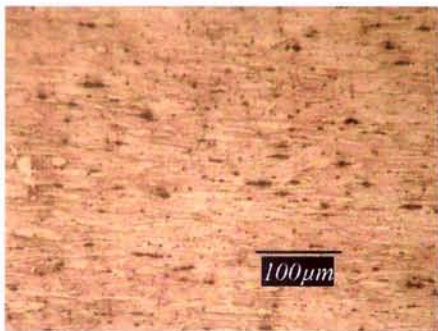
Figure 29:  
Microstructure  
seen in sample  
3a, outside of  
splice area  
Magnification:  
200X

In samples 3a and 4b, the microstructure of the conductor outside the splice area consisted of elongated grains typical of hard drawn copper, with some recrystallization seen in 3a (Figures 29 and 31). In both samples the area within the splice showed markedly larger grain sizing, indicating some annealing has occurred within the splice connections (Figures 30 and 32).
