July 9, 2015

#### Re: FortisBC Inc. (FBC or the Company)

## Application for a Certificate of Public Convenience and Necessity (CPCN) for the Kootenay Operations Centre (the Application)

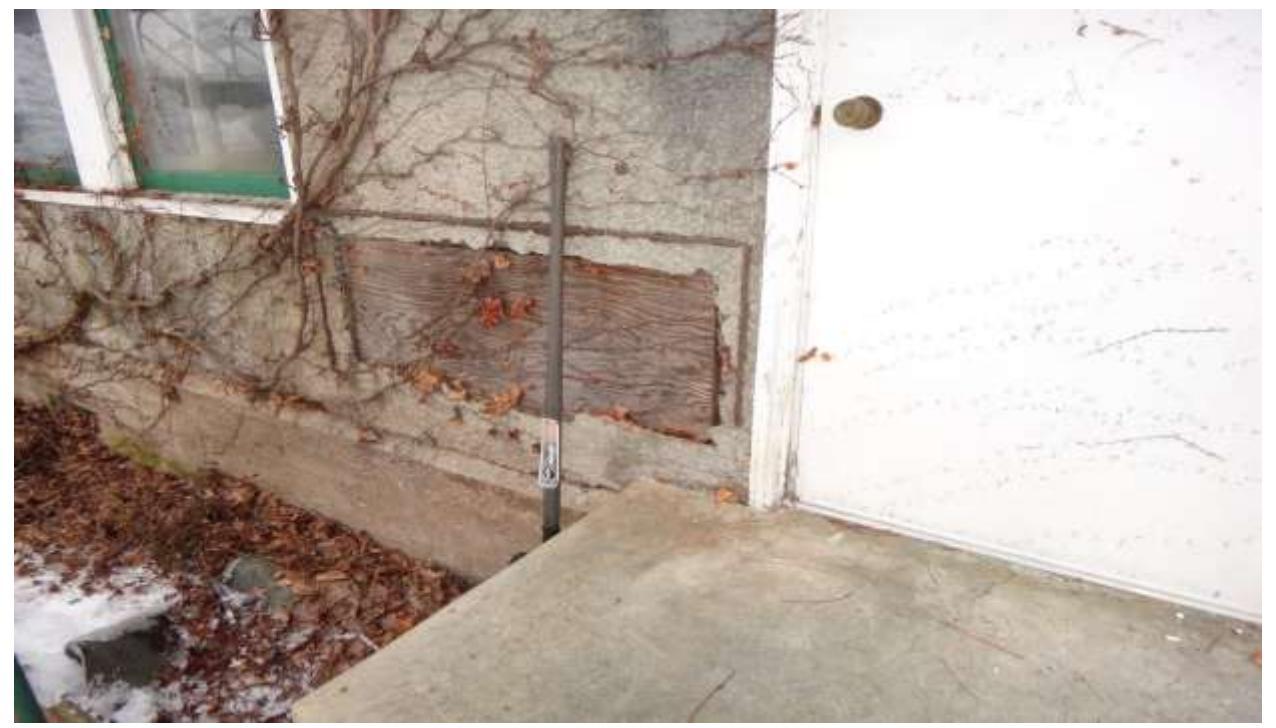
- Figure 4-2: Generation Administration Office and Warehouse
- 6 Generation Administration Building Envelope Failure

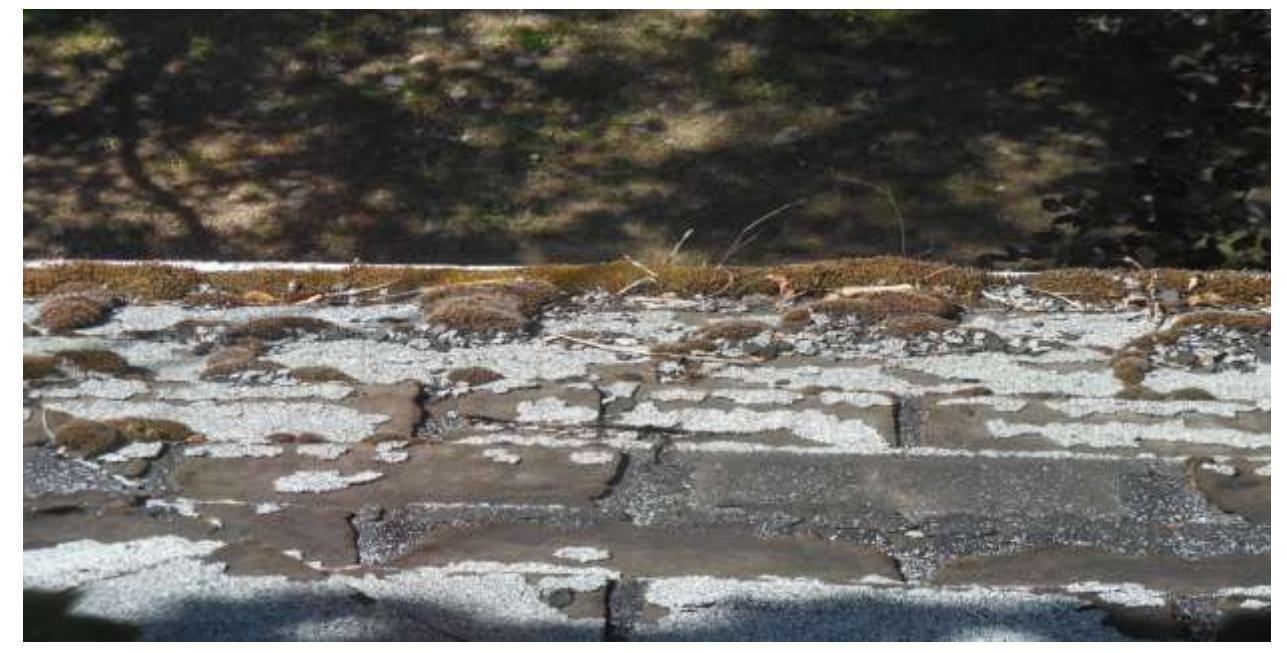
- 7
- 8 Generation Administration Office Building Roof Condition

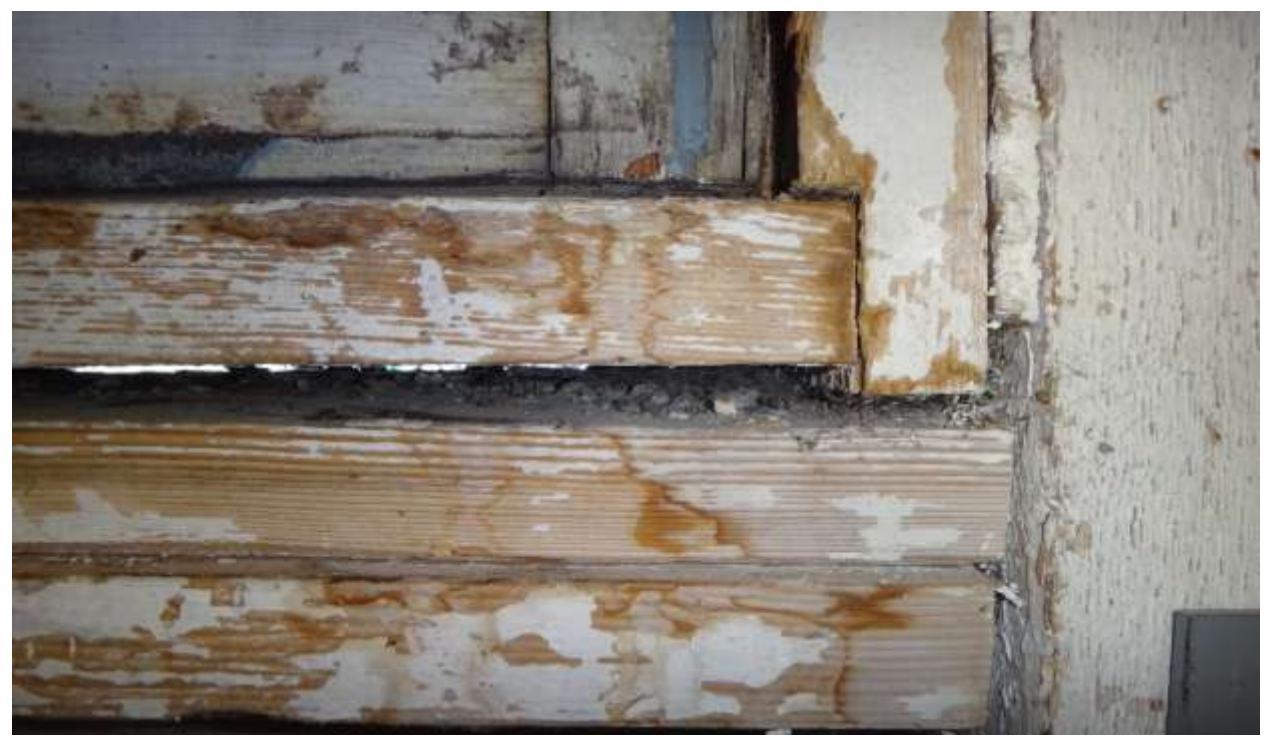
## 1 Generation Warehouse Water Penetration through the Building Envelope

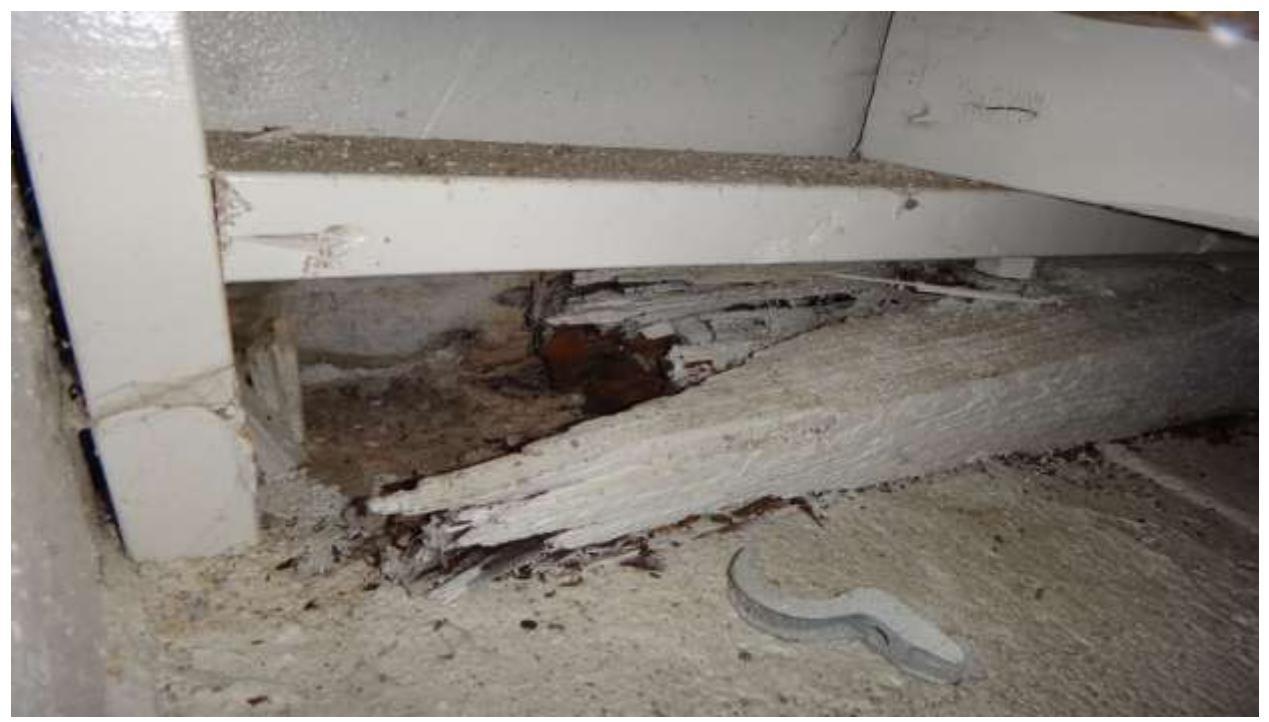
3 Generation Warehouse Sill Plate Rot

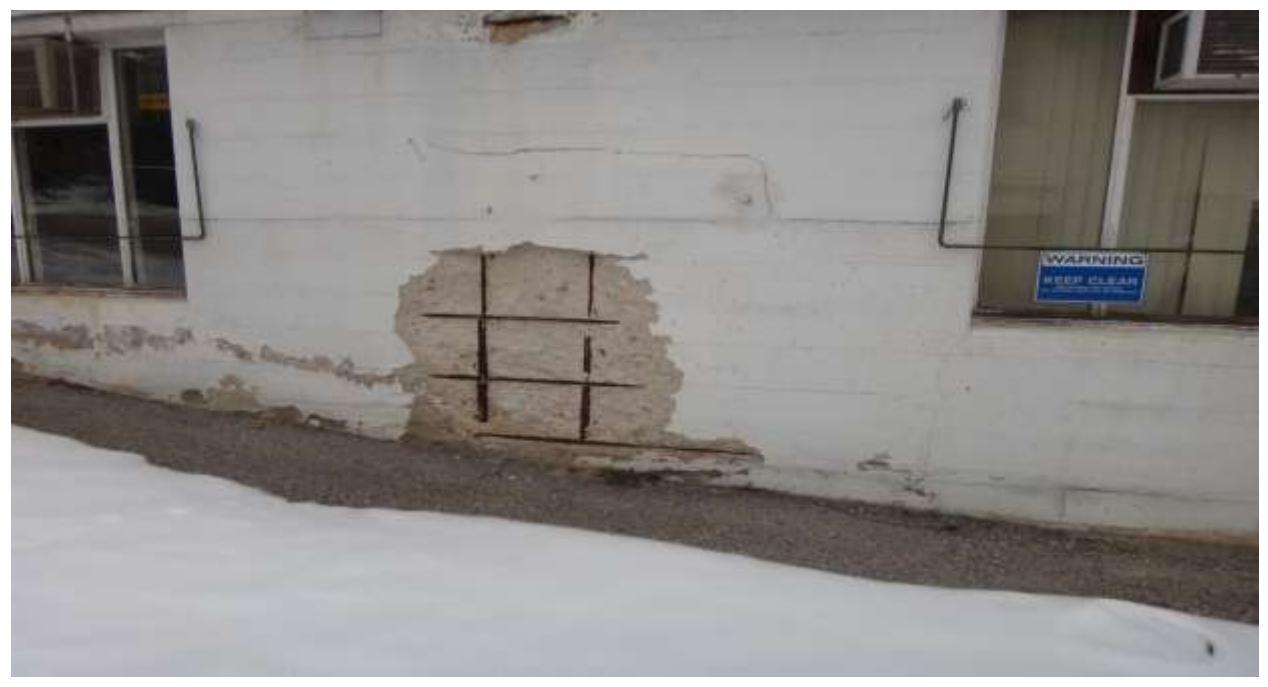
1 Generation Warehouse Building Envelope Failure

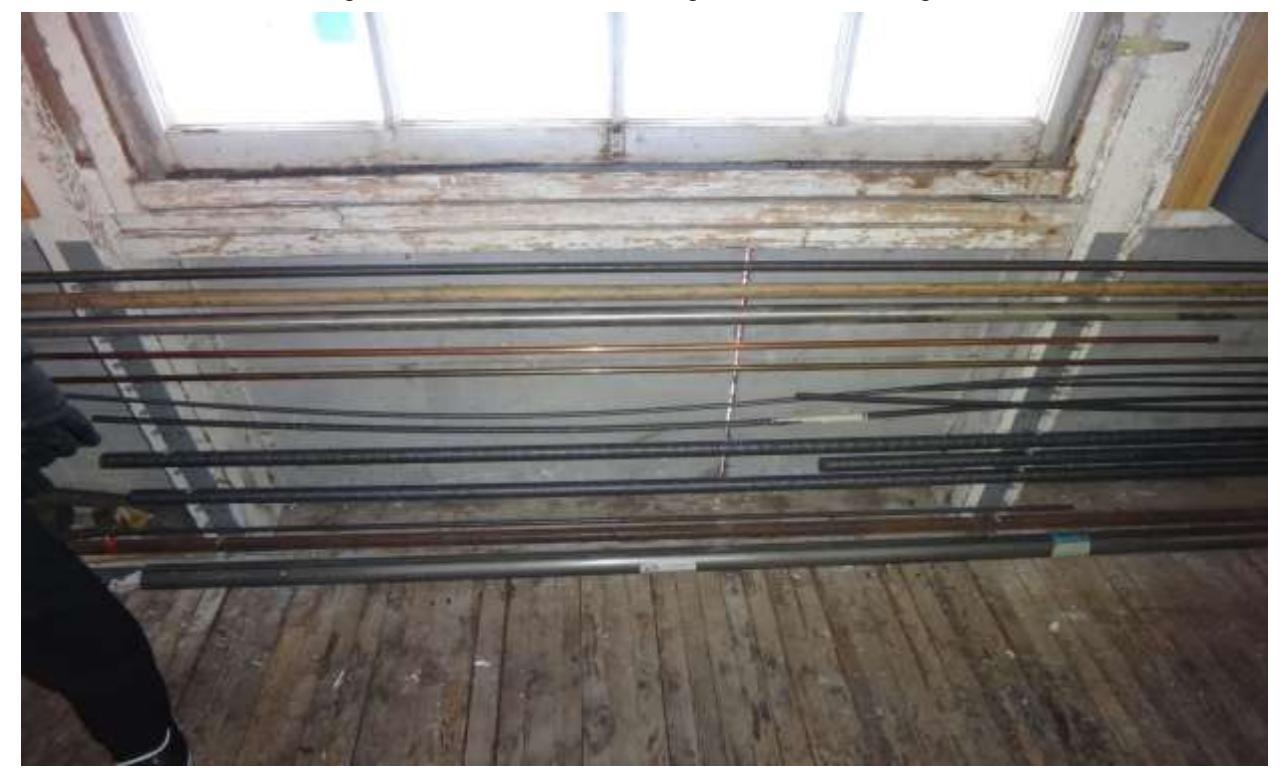
3 Generation Warehouse Single Pane Window, No Building Insulation, Flooring Condition

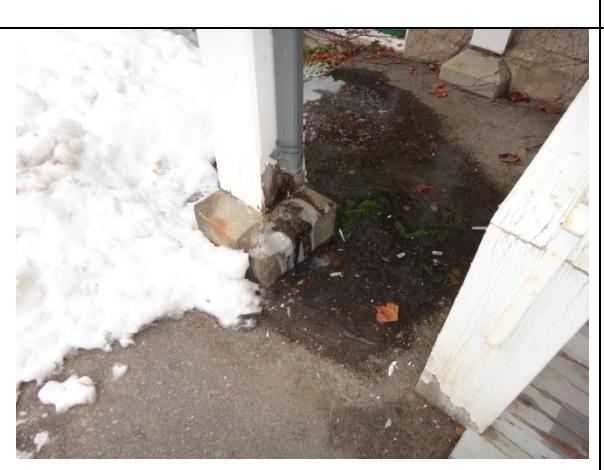
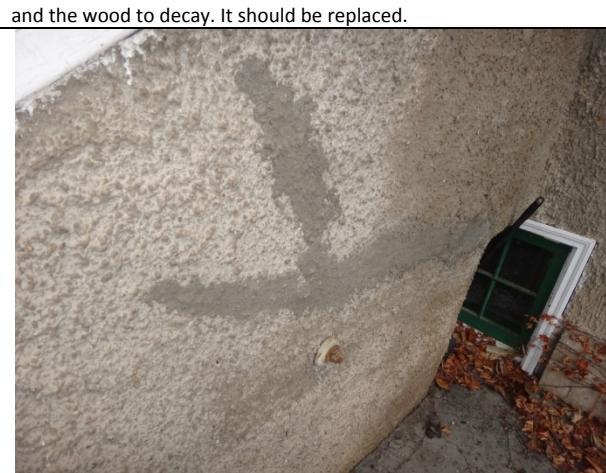
**#7** - A small section of gutter has been installed above the Main Entrance. Because it does not have heat tracing, and is not connected to a storm water system, the melt water simply refreezes in the drain pipes and on the ground.

$\ensuremath{\texttt{\#8}}$  - The stucco sides of the Main Entrance Stairs are cracked and have been repaired.

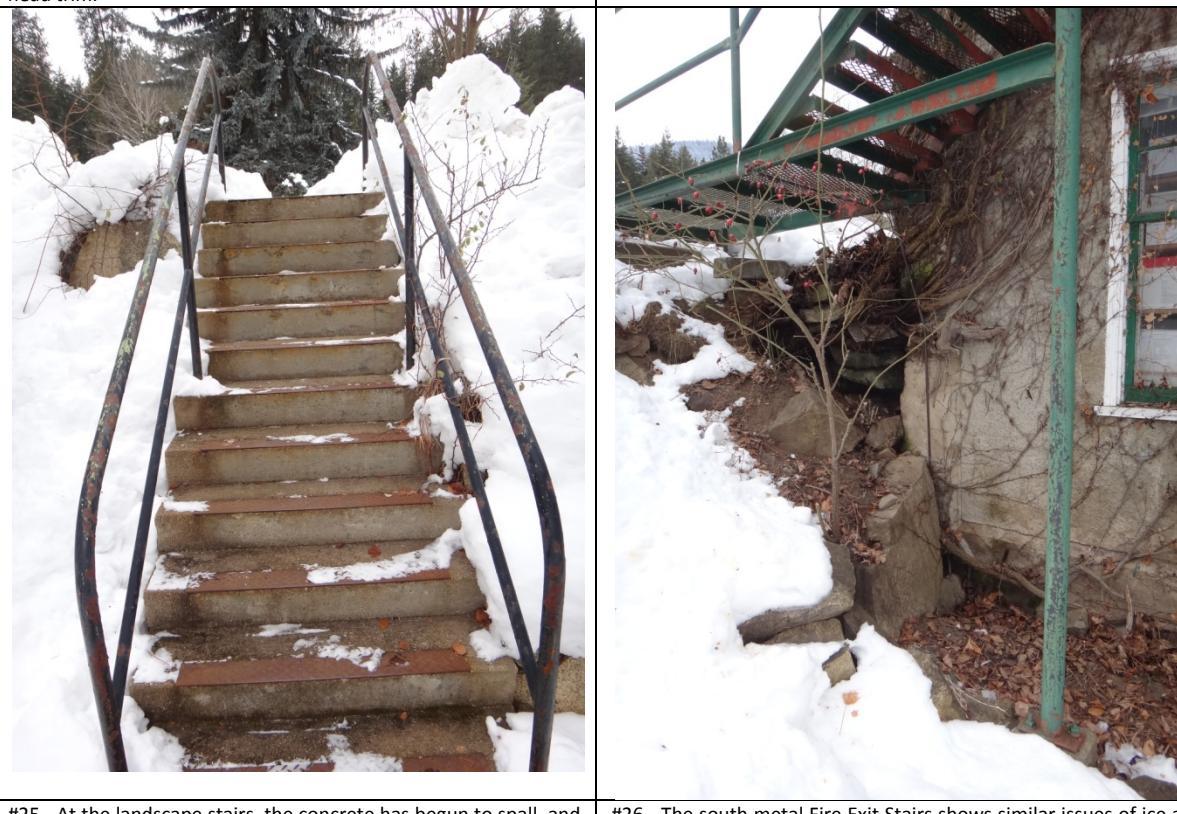
#25 - At the landscape stairs, the concrete has begun to spall, and the railings rust.

#26 - The south metal Fire Exit Stairs shows similar issues of ice and rust. The stone retainign wall should be replaced with concrete.

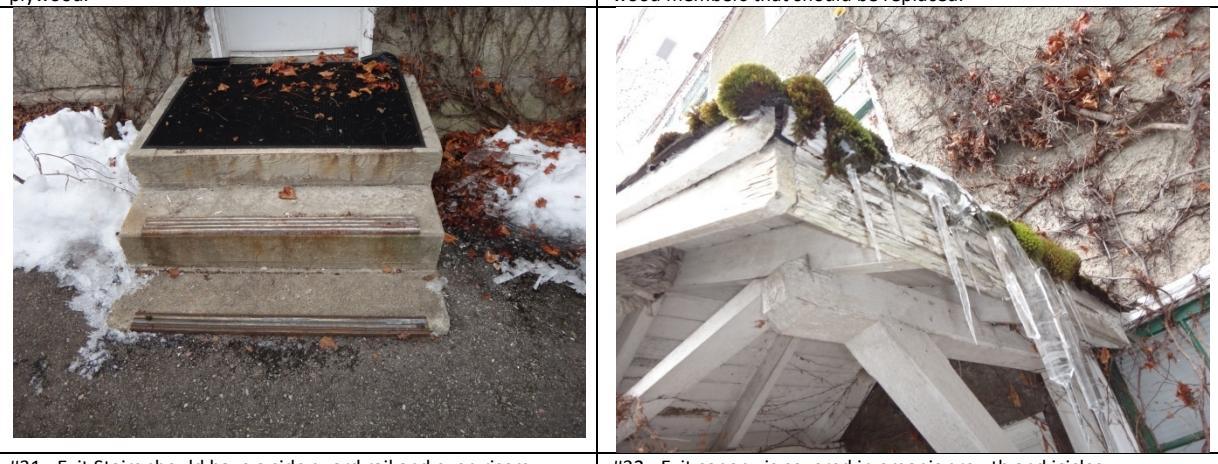
#31 - Exit Stairs should have a side guard rail and even risers. #32 - Exit canopy is covered in organic growth and icicles.

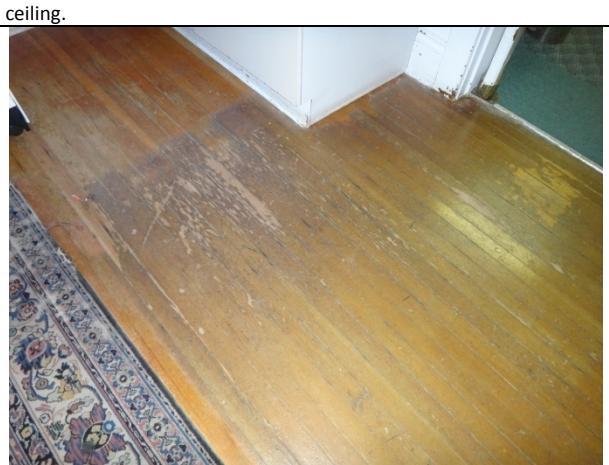
#47 - The basement salon has been converted to a lunch room. While the view is lovely, the millwork should be replaced to meet current office and FBC standards.

#48 - The historic fir flooring is showing its age, and requires repair and refinishing.

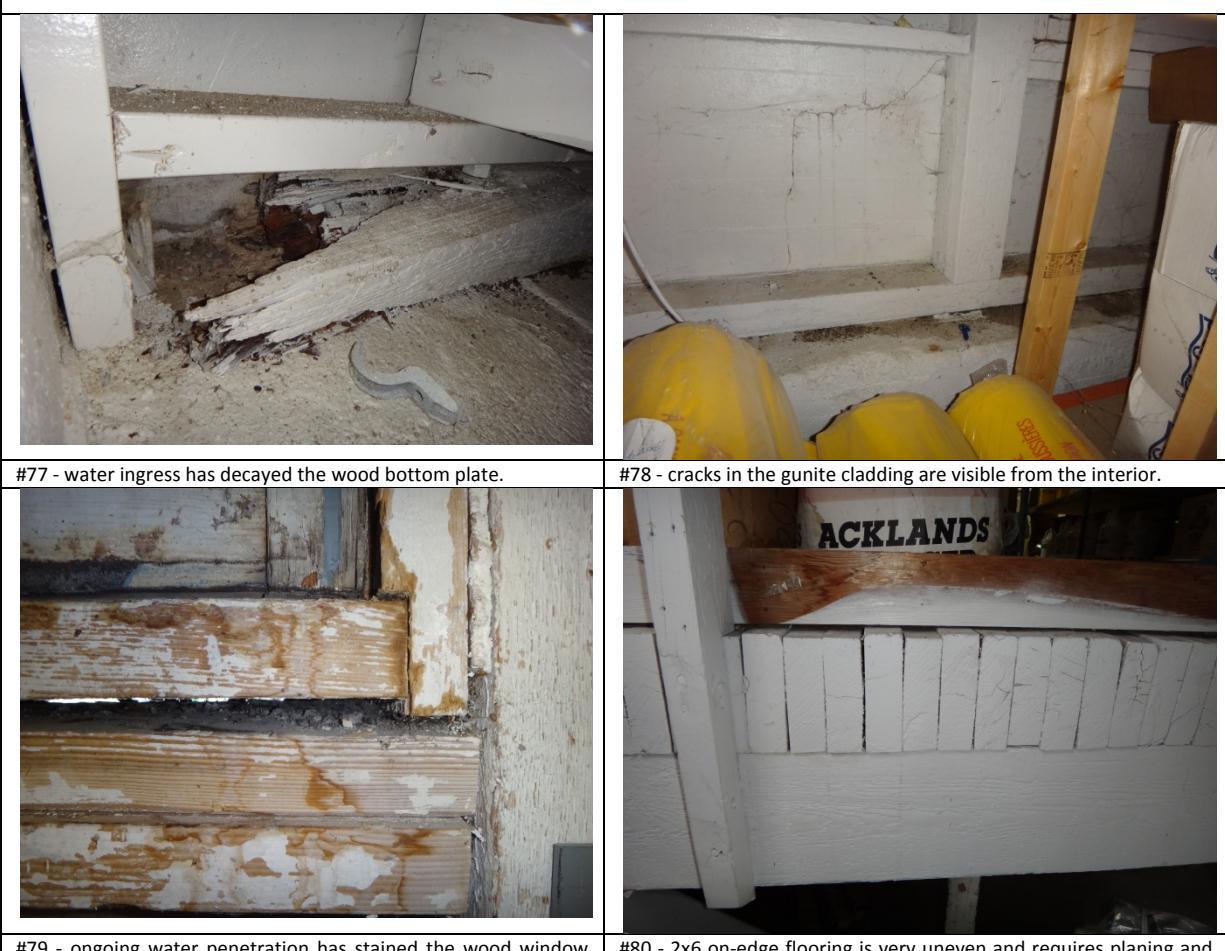
$\ensuremath{\texttt{\#79}}$  - ongoing water penetration has stained the wood window framing.

#80 - 2x6 on-edge flooring is very uneven and requires planing and refinishing.

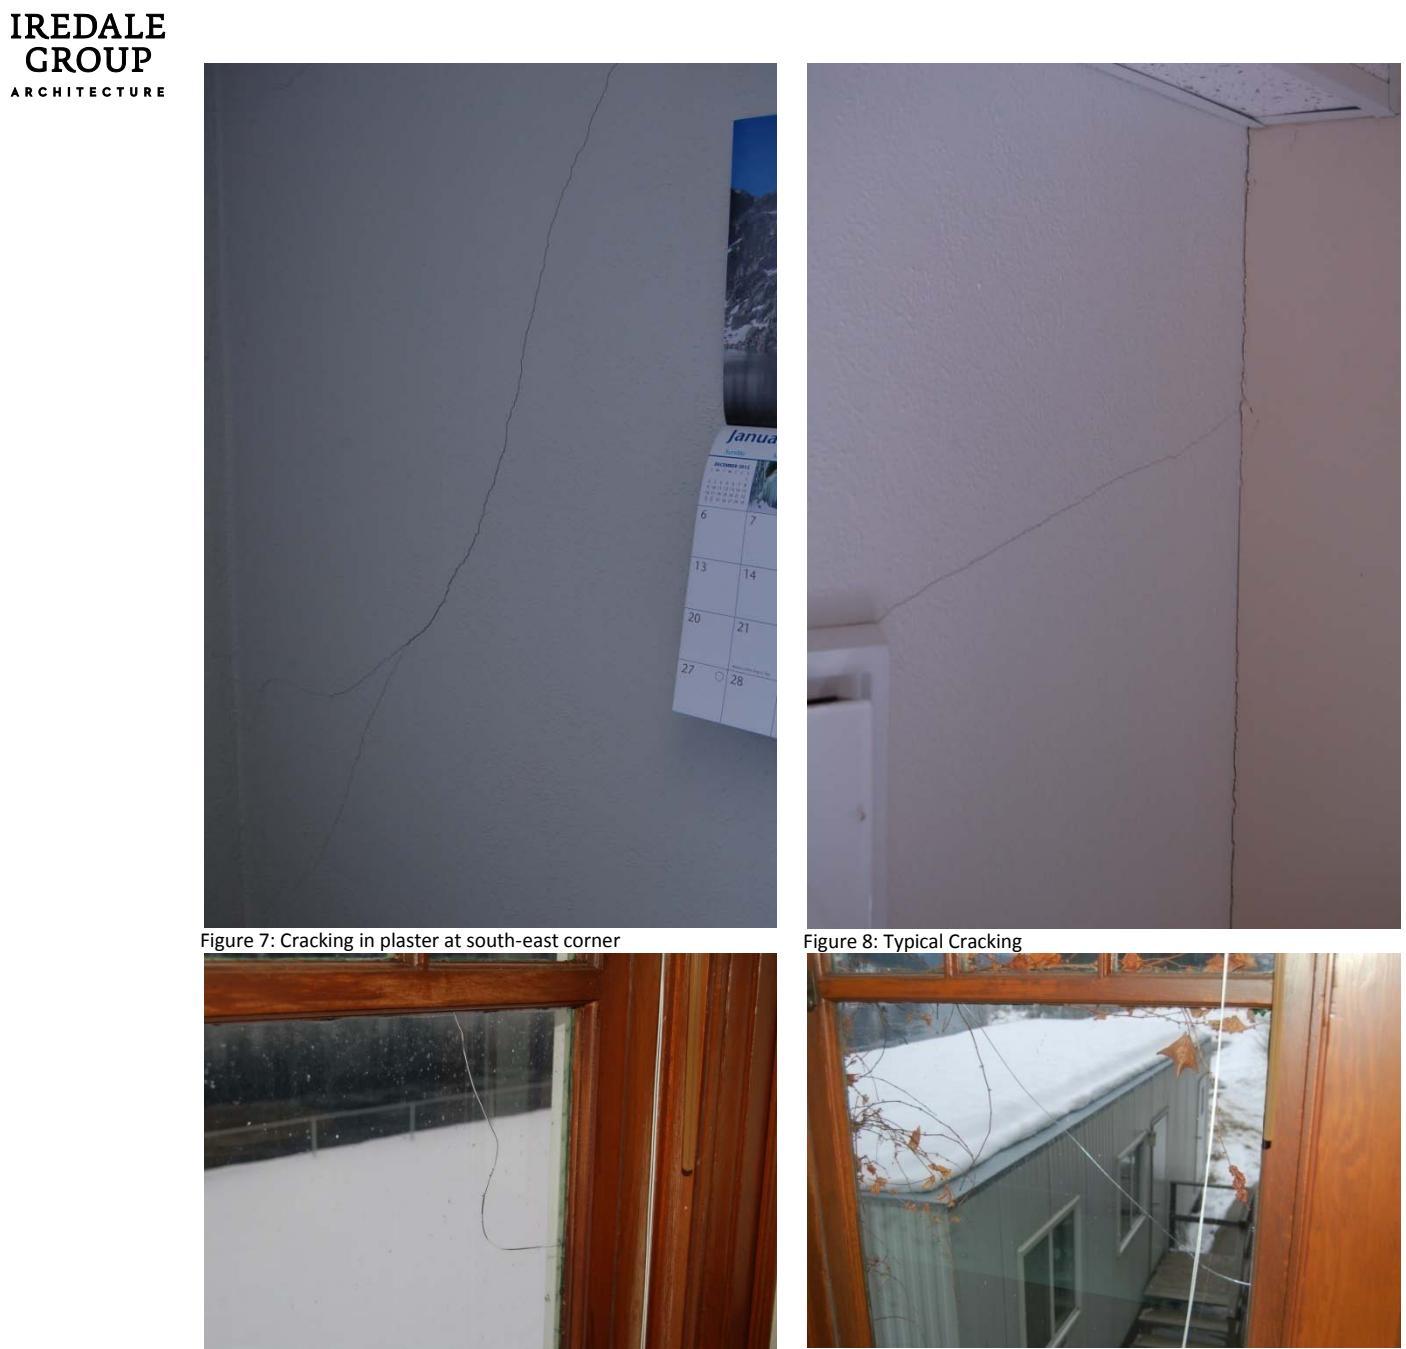
Figure 9: Glazing pressure crack

Figure 10: Glazing pressure crack

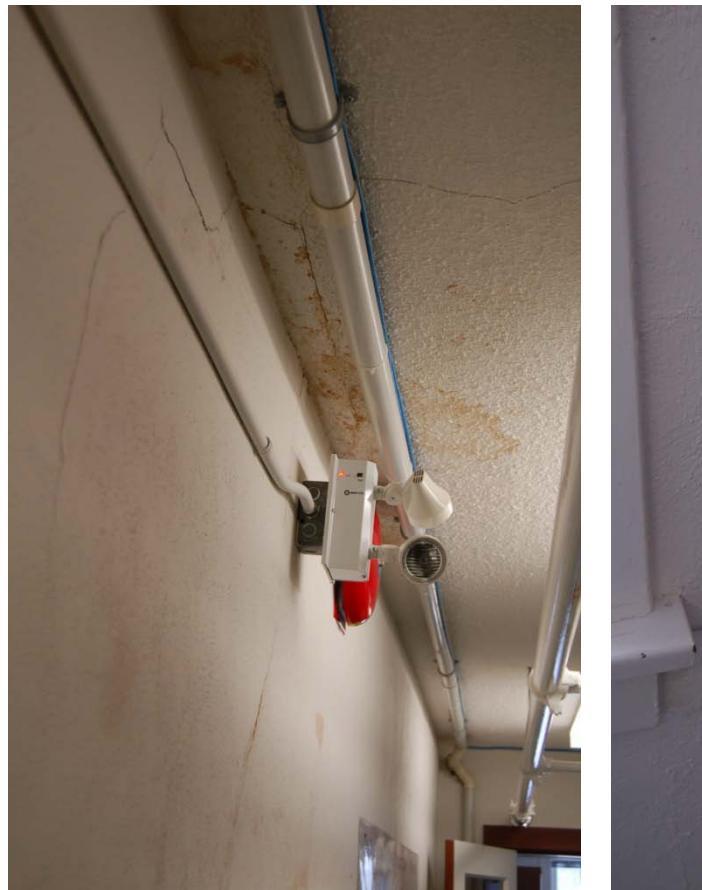
Figure 11: Typical cracking basement level

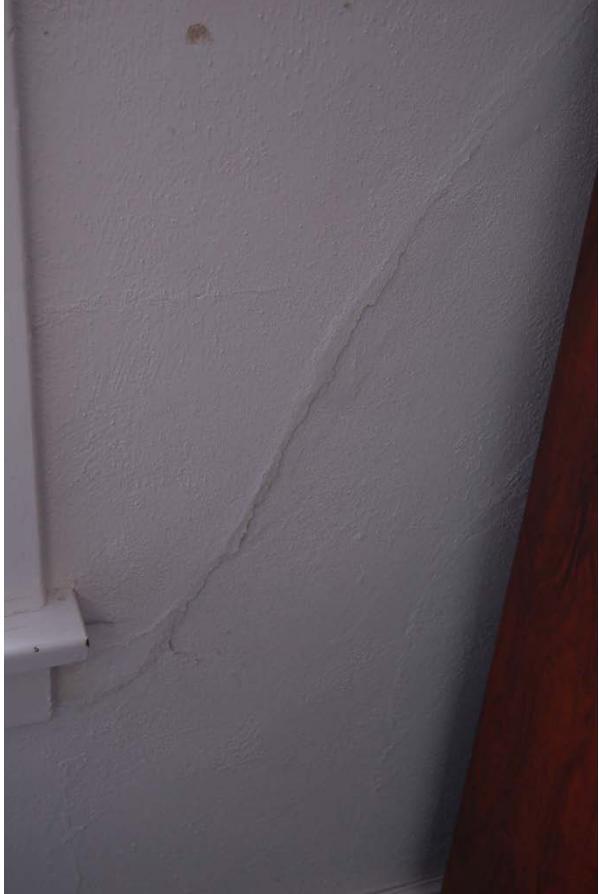
Figure 12: Typical cracking at opening corners

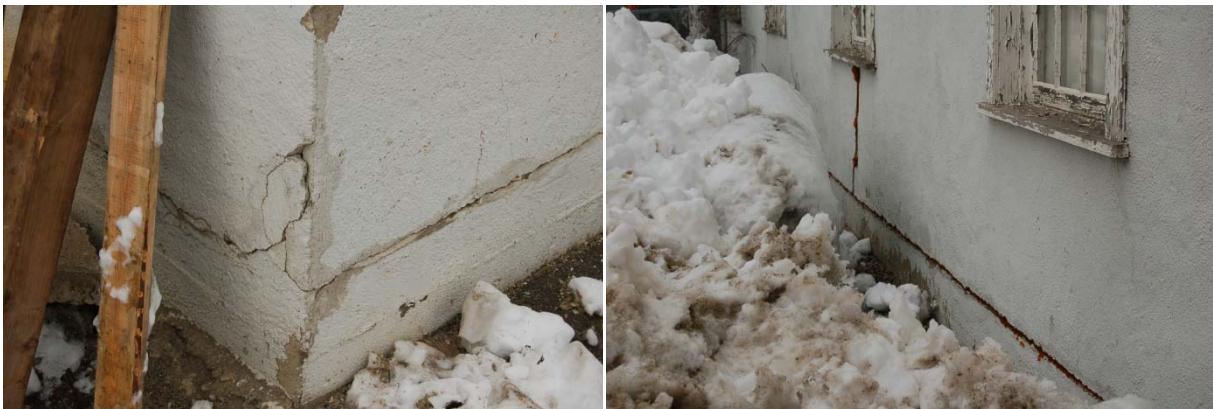
Figure 23: Cracking of Gunite at north east corner

Figure 24: Repair where foundation has settled with respect to wall framing

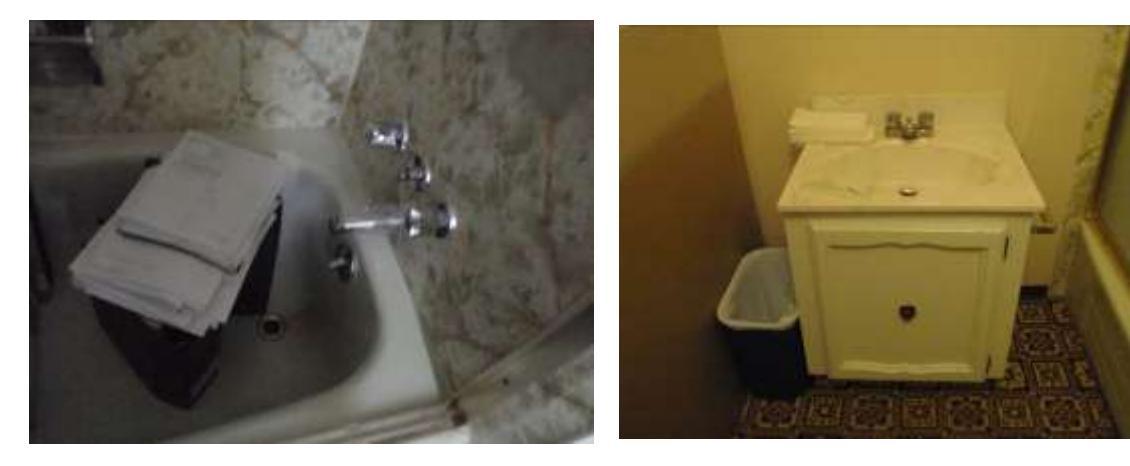
Shower not in use

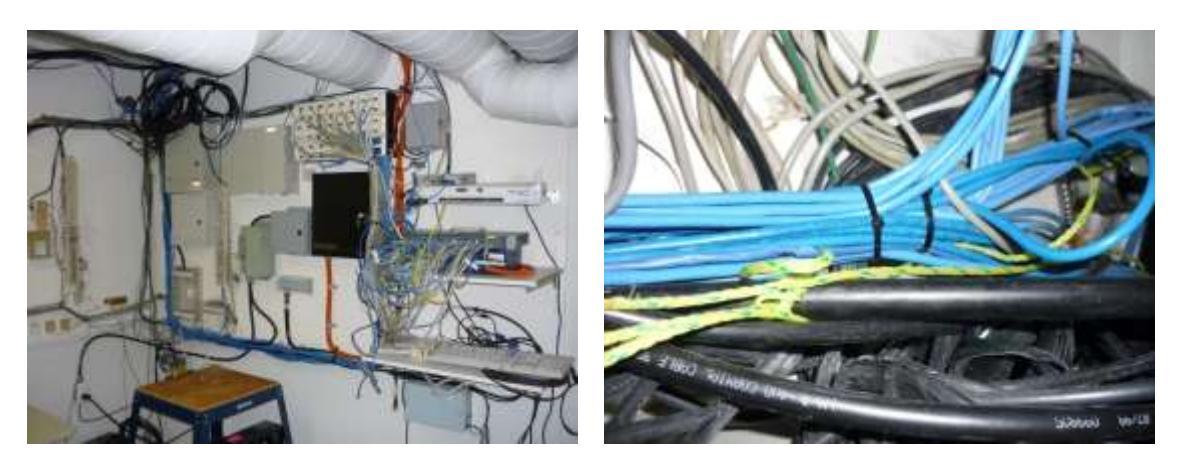
Data/comm cables (CAT5 + 5e) on Main and Upper Floors concealed within walls. In Lower FIr, wiring exposed suspended and strapped to wall and ceiling surfaces – subject to damage. Installation does not conform to accepted practice per TIA/EIA-568-C, Commercial Building Telecommunication Standards. Passage of cables at wall partitions without benefit of conduits for mechanical protection. Cables in Comm Rm subject to damage due to placement and wide open accessibility (non-locked room and passage to a Storage Rm). Cabling currently serves occupants adequately but with newer technology, CAT5 cabling has bandwidth limitations. Server Rm has no cooling or ventilation. Placement of equipment (UPS, backup batteries) susceptible to damage. Bonding to ground of communication cabinet is not evident.

Exposed unprotected data cables

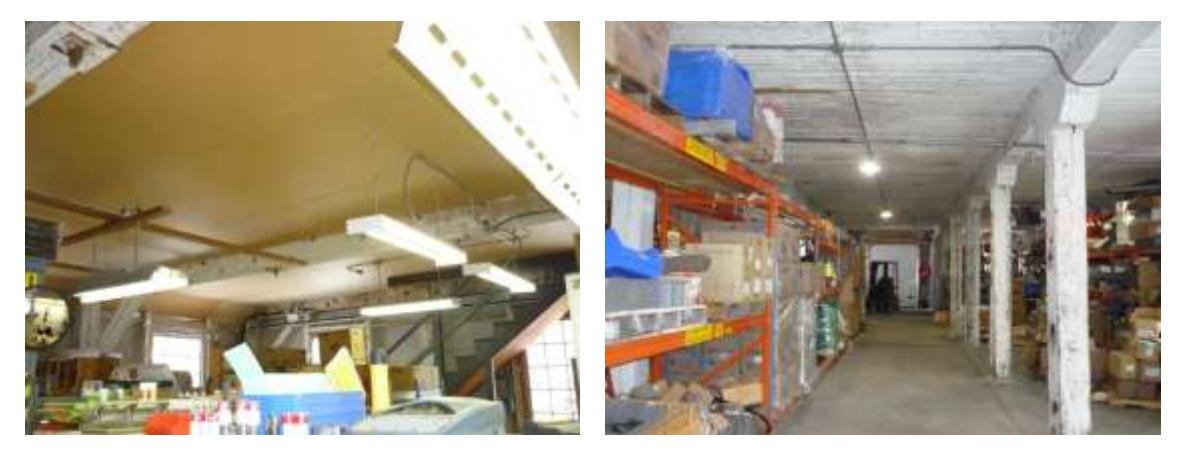
Majority of luminaires utilize inefficient T12 4-foot fluorescent lamps/ballast. T12 lamps are no longer manufactured, banned from manufacturing due to energy inefficiency. T12 lamps on store shelves are last stock available.

Lower Floor with poor illumination levels

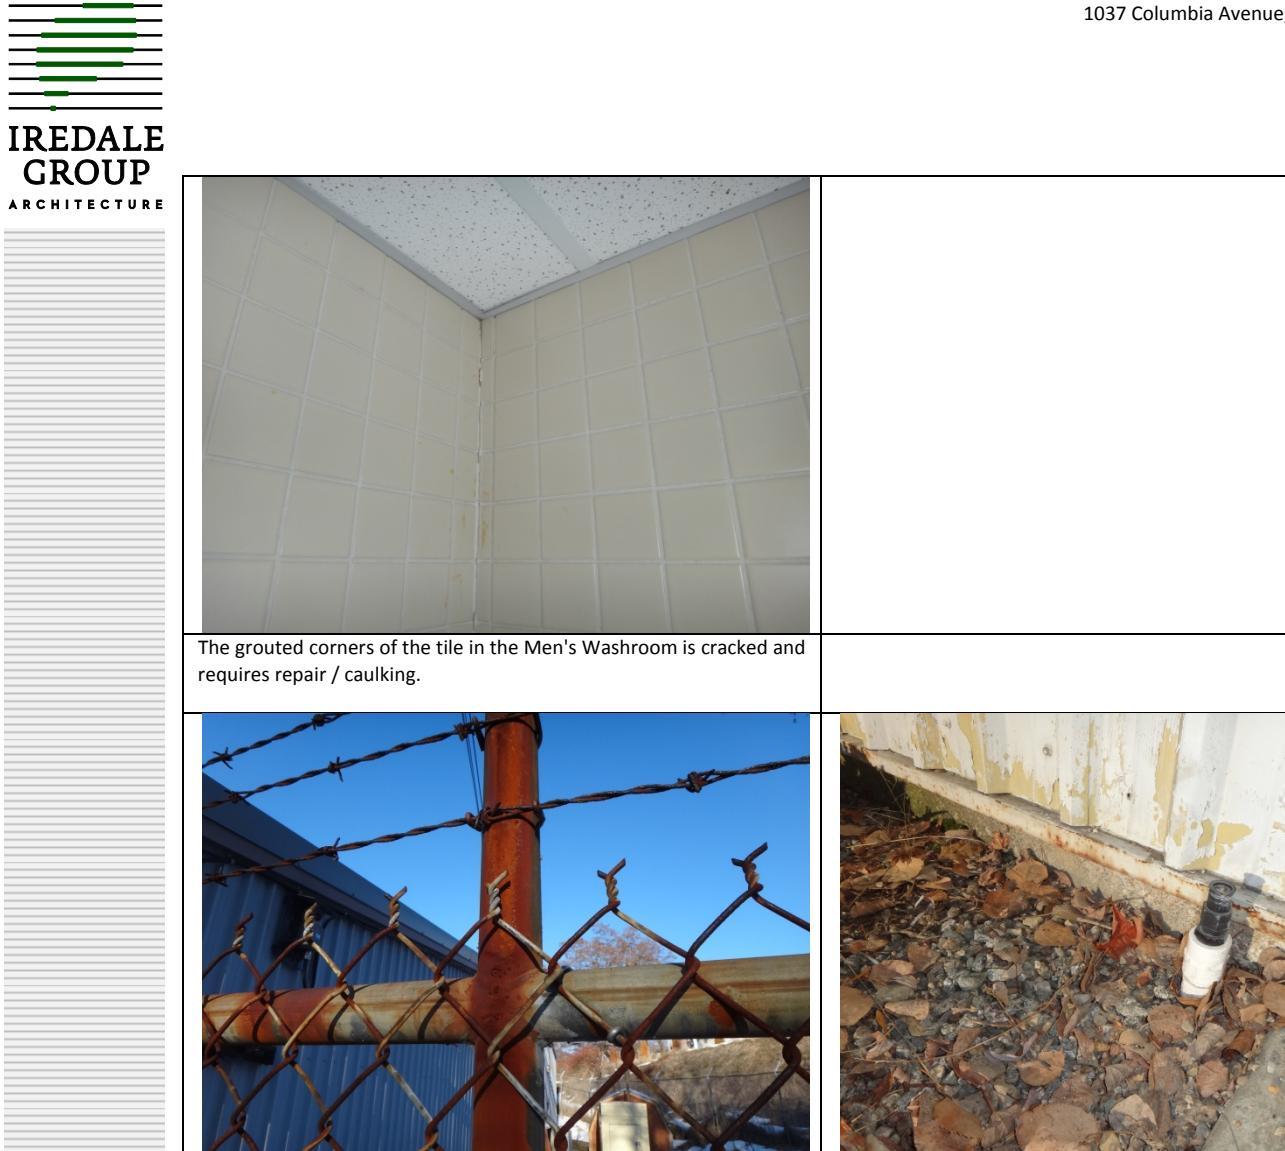
The older portions of the existing fence are quite rusted.

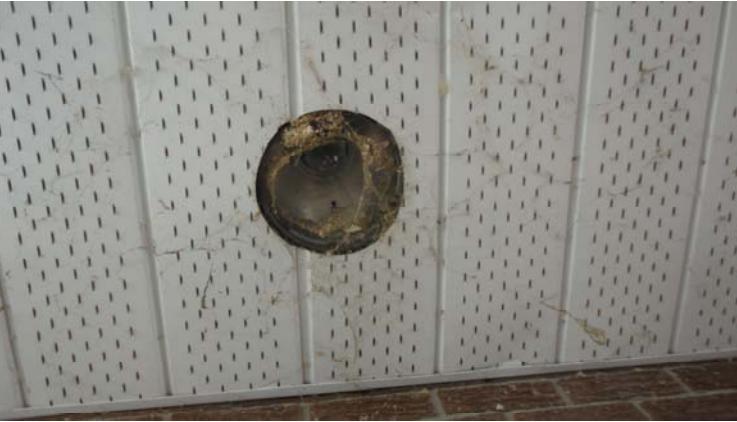
4. Exterior Downlight with Missing Lens and Infestation.JPG

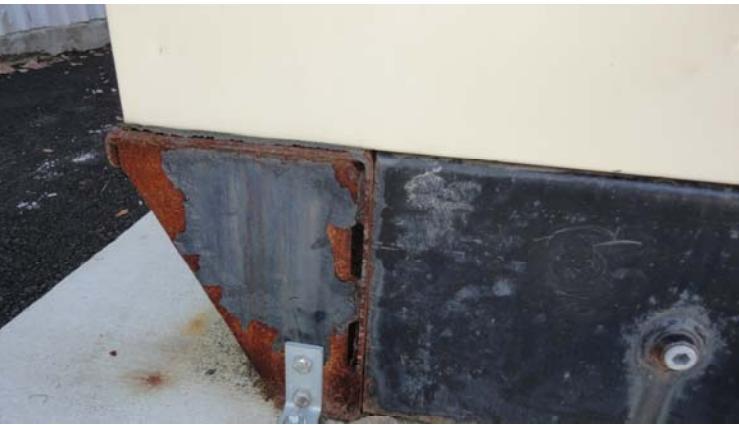
9. Exterior Generator Mount with Corrosion.JPG

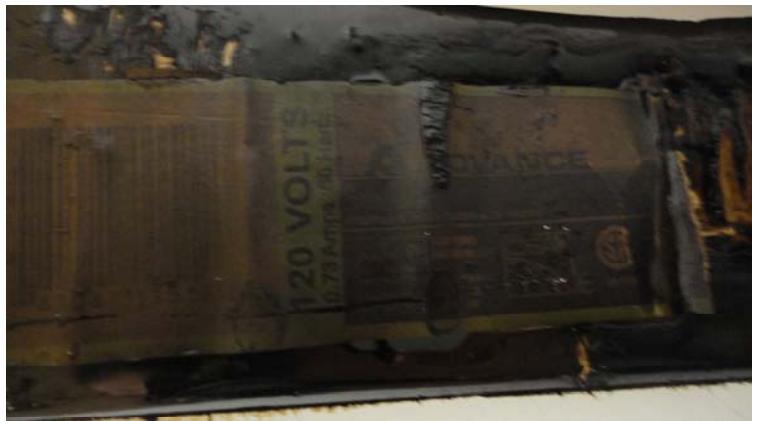
5. Old T12 Electromagnetic Ballast.JPG
