Re: FortisBC Energy Inc. (FEI)

Application for Use of Lands under Sections 32 and 33 of the *Utilities Commission Act* (UCA) in the City of Coquitlam for the Lower Mainland Intermediate Pressure (IP) System Upgrade (LMIPSU) Projects – Coquitlam Gate IP Project (Project) (the Application)

FEI Evidence on Phase Two Issues

Supplemental Evidence for Phase Two

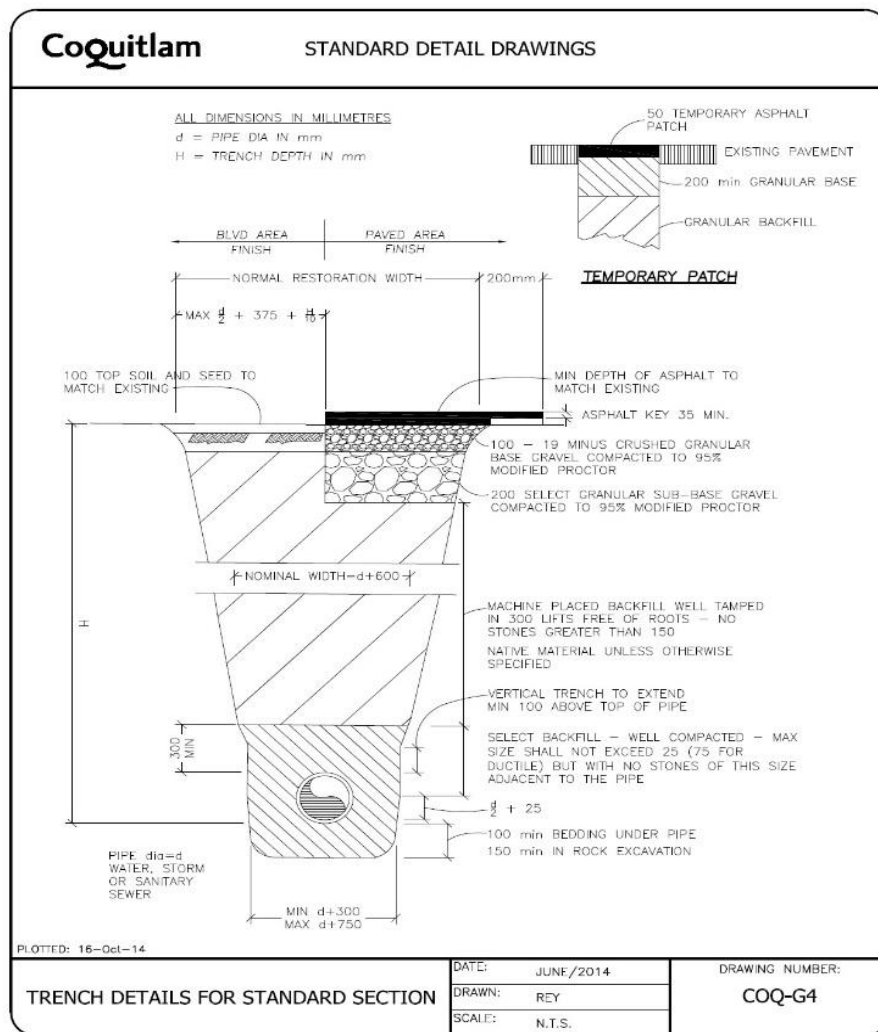
Figure 2-1: City Paving Specification for Trenches, COQ-G4 Specification to MMCD

1 The City's Paving Specifications describe requirements for paving restoration in City streets and
2 require that pavement restoration depth matches the existing asphalt depth for the width of the
3 trench, and a 35 millimetre depth for a width of 200 millimetres on either side of the trench (this
4 is referred to as the Asphalt Key) as detailed in Figure 2-1.

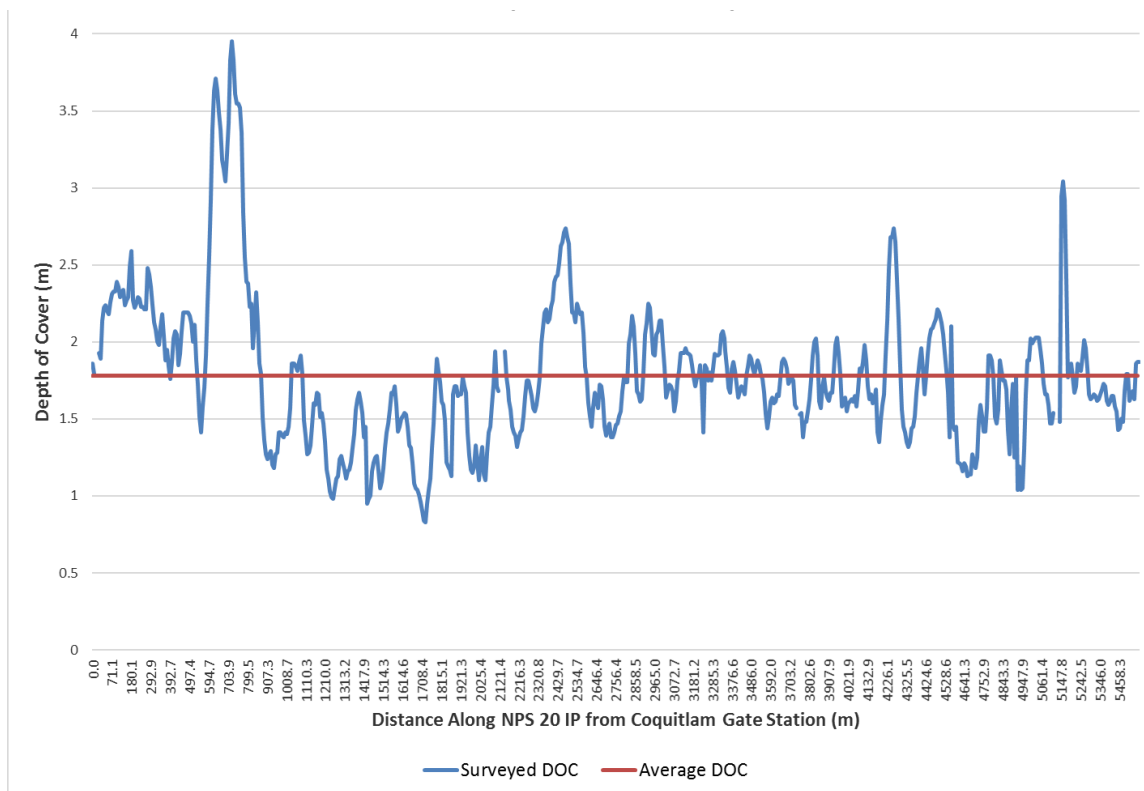
Figure 3-1: NPS 20 IP Depth of Cover

The NPS 20 IP gas line exits from Coquitlam Gate Station below ground onto Spuraway Avenue. An elbow fitting then turns the gas line through ninety degrees from where it travels west for approximately 5.5 kilometres along Como Lake Avenue until it enters the City of Burnaby at North Road. Between Coquitlam Gate Station and North Road the NPS 20 IP gas line is routed along the eastbound lanes of Como Lake Avenue.

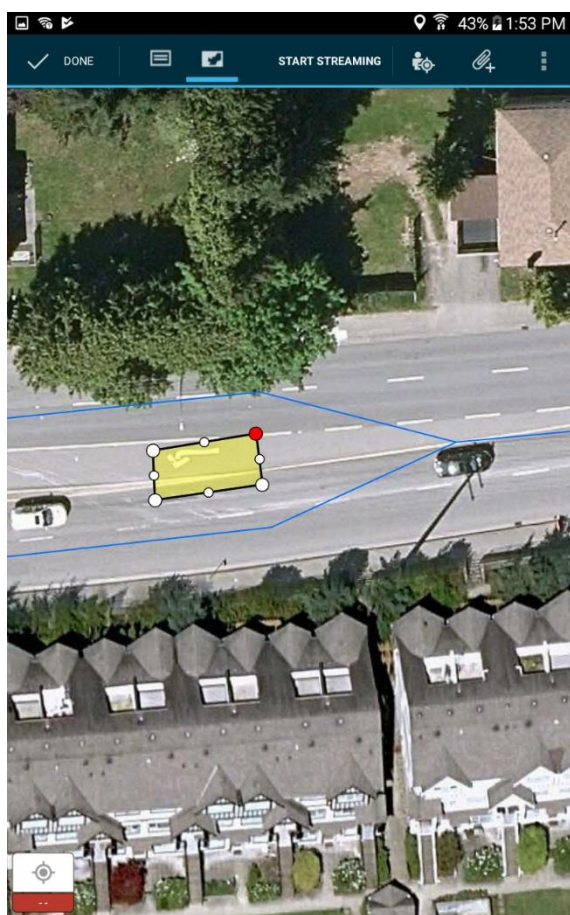
Staff recorded their observations in a mobile ArcGIS Collector application and digitized the approximate location and extent of the distresses on their mobile data collection device. The locations of the distresses were located using the underlying orthophotos of the roadway as location references and digitized on the screen of the device. The location and extent of the observed distresses were located based on the available resolution of the orthophotos, the ability to digitize the desired location on the mobile device, and observed field references. Therefore, the locations and measurements recorded in this survey are expected to be approximately located to within 1 meter of the noted distress area observed in the field by the condition assessment staff. A screen shot of the digitization feature is shown below.

Figure 2 - Collector for ArcGIS – Example of Digitizing a Field Observation Area

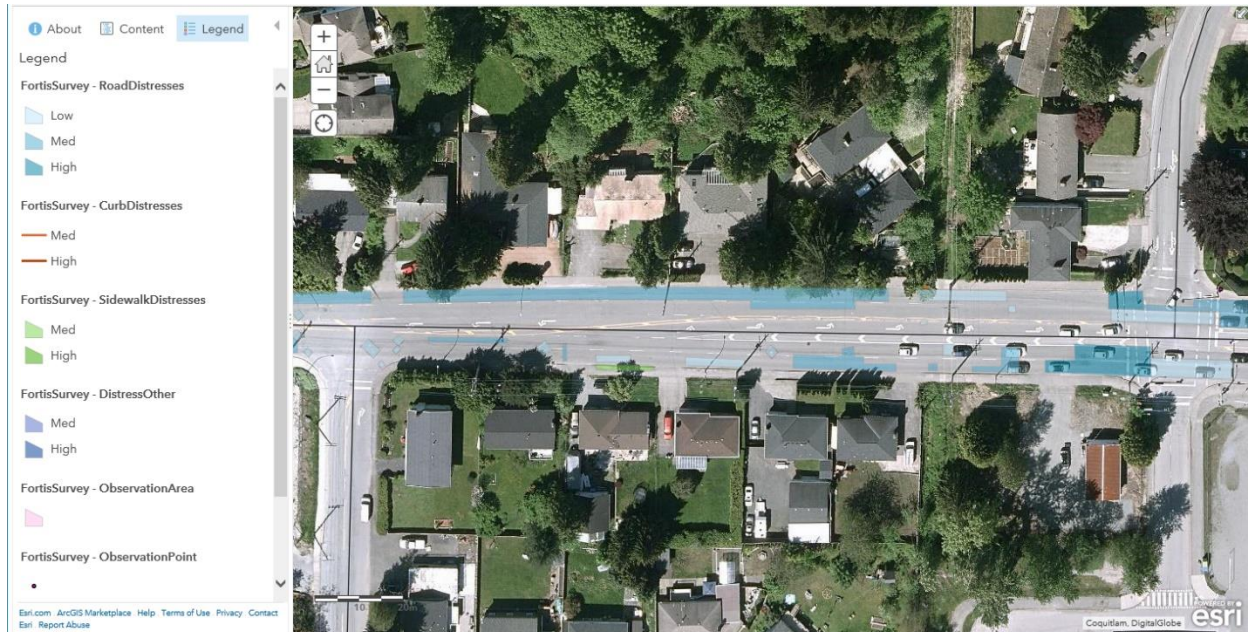
This collected information provides a comprehensive map of the location of existing distresses and will help to identify areas where proposed utility works may be adjacent to existing pavement distresses, as shown in the figure below.

Figure 3 - Example of Digitized Distress Observations – Como Lake Ave from Montrose St to Thermal Dr

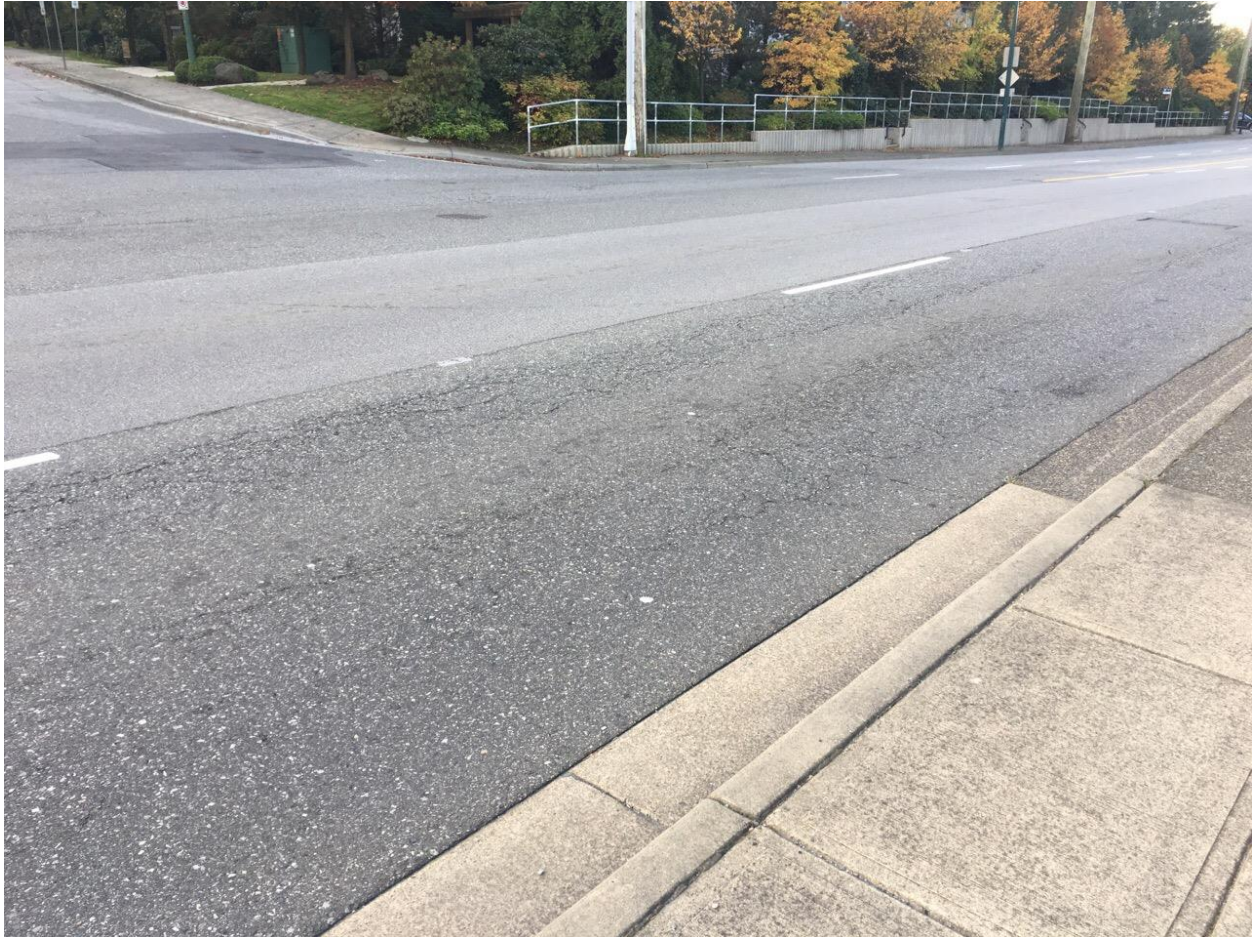
The Coquitlam mapping system indicates that this section was last paved in 1989. We note that sections of the road between Clairmont St and Emerson St appear to have been repaved as part of recent transit system works and these dates have not been noted on the City mapping system. The majority of distresses observed in this section are rutting, patching and distortions. There are some areas of linear cracking and alligator cracking.

Figure 5 - Example of Alligator Cracking – North to Robinson

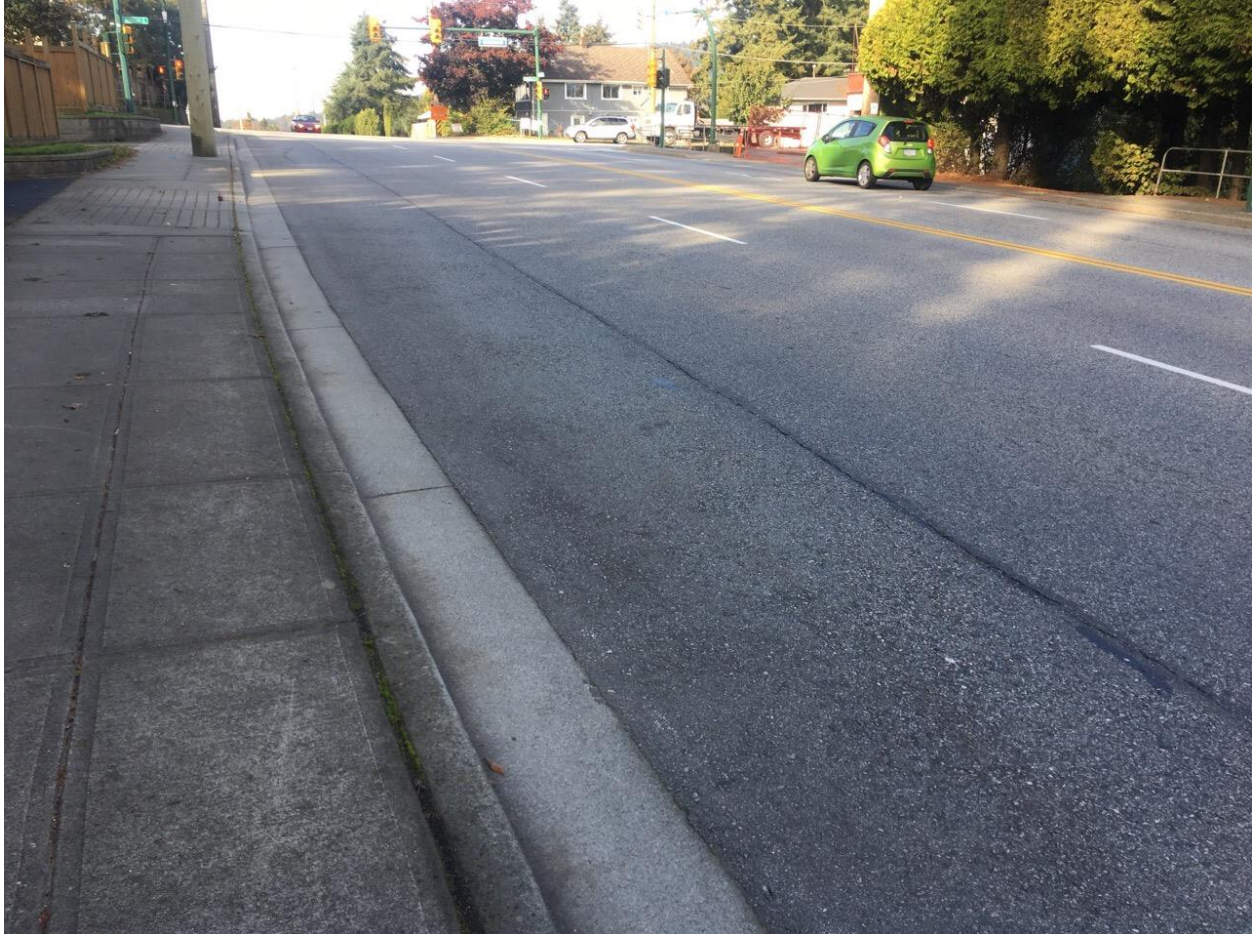
The Coquitlam mapping system indicates that this section was last paved in 2006. The majority of distresses observed in this section are patching, linear cracking, and rutting. There are some areas of alligator cracking and distortions.

Figure 6 - Example of Patching – Robson to Blue Mountain

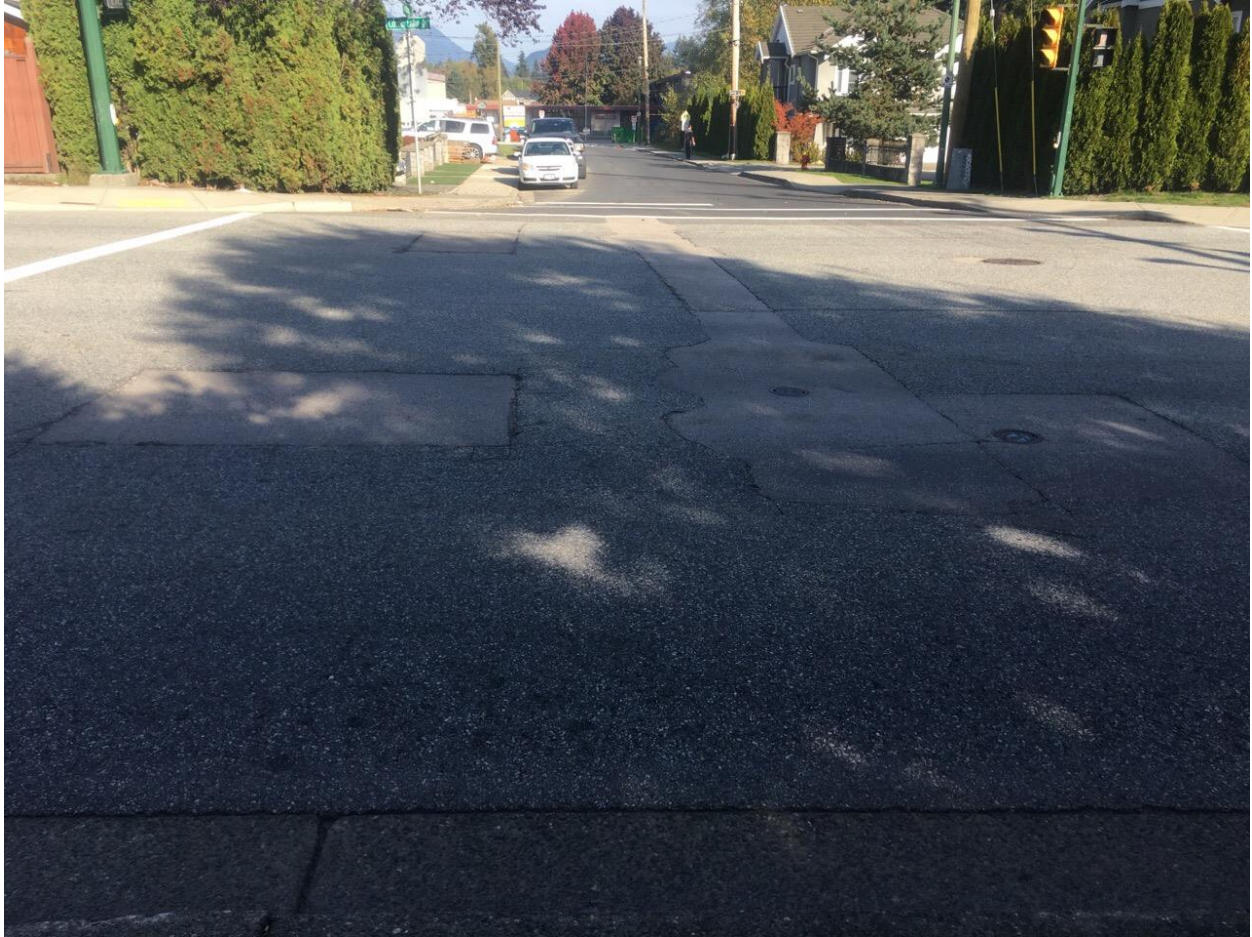
Figure 7 - Example of Patching at Banting St

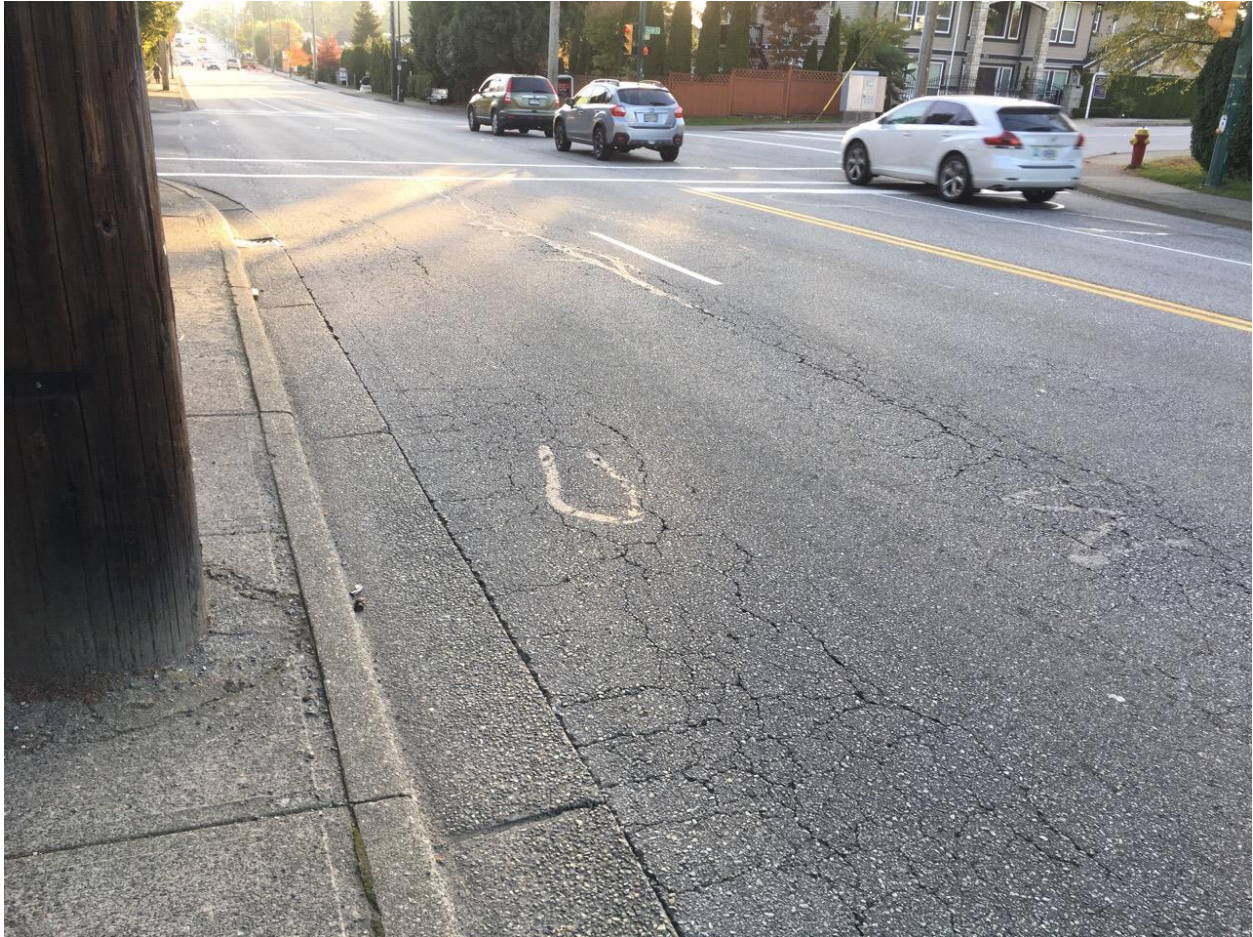
The Coquitlam mapping system indicates that this section was last paved in 2004. The majority of distresses observed in this section are alligator cracking, patching, and distortions. There are some areas of linear cracking and rutting. The type and location of distresses observed would indicate that this section could be a candidate for a potential full width rehabilitation treatment.

Figure 8 – Example of Alligator Cracking – Near Blue Mountain St

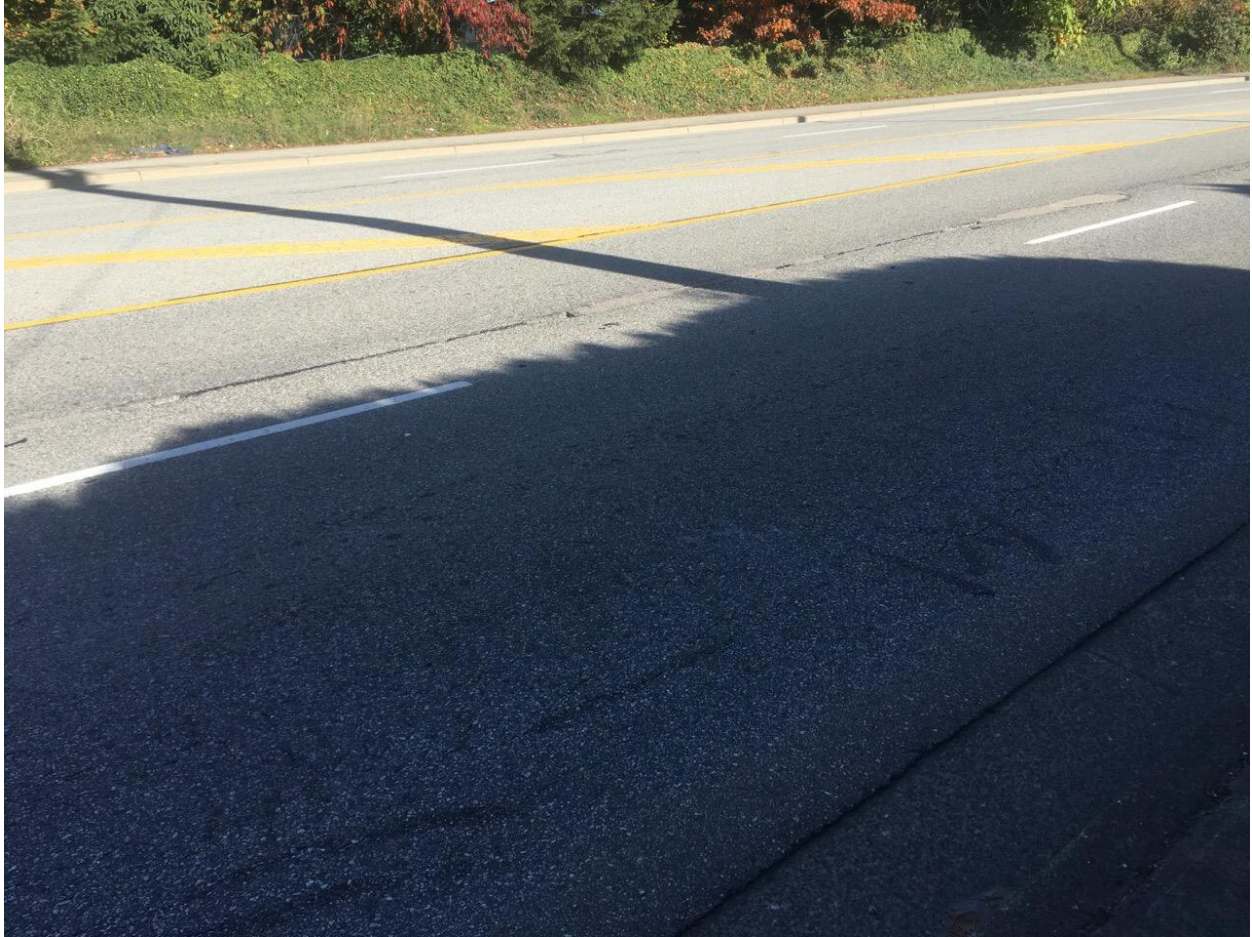
Figure 9 - Example of Linear Cracking and Alligator Cracking Near Blue Mountain St

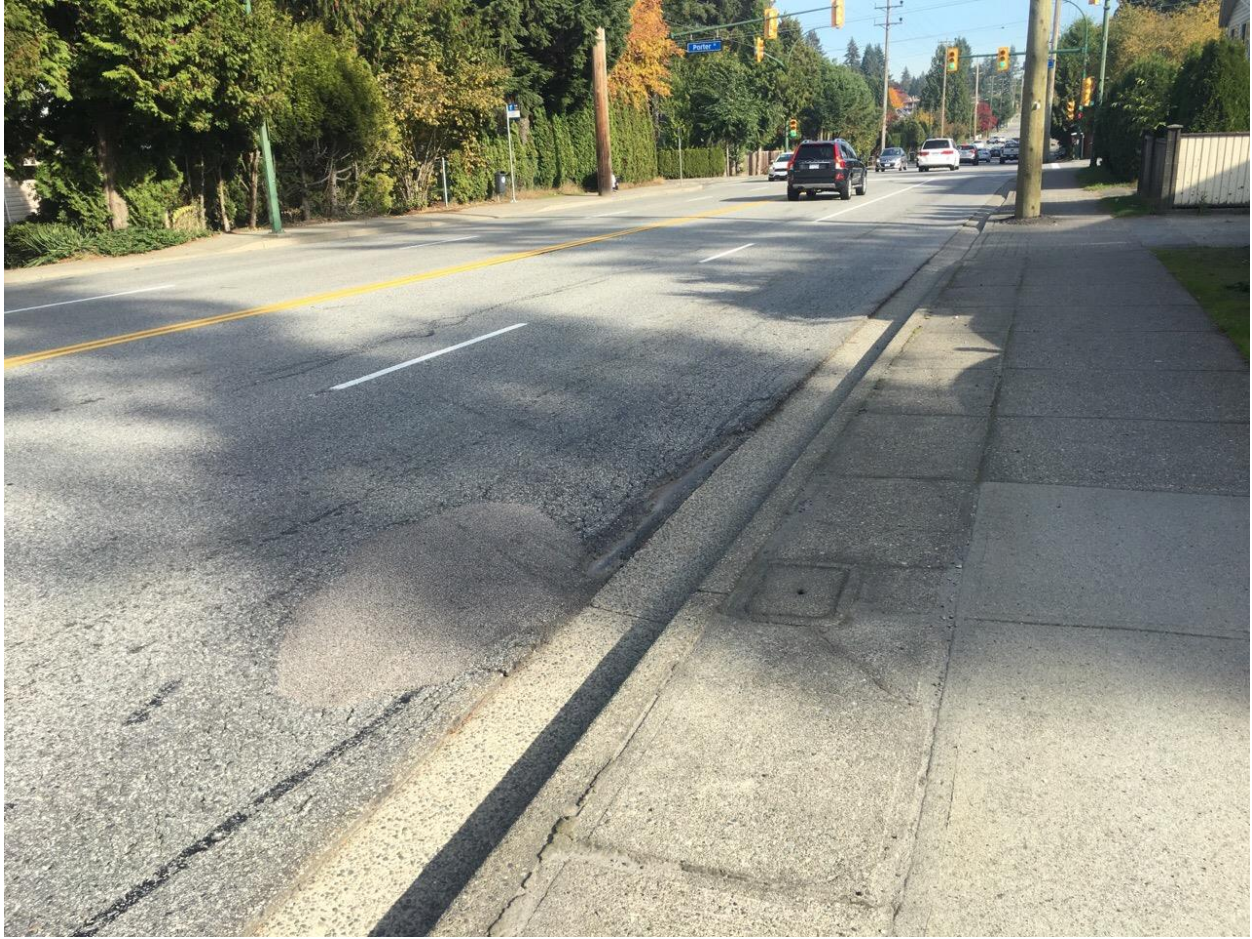
Figure 10 - Example of Alligator Cracking - Near Porter St

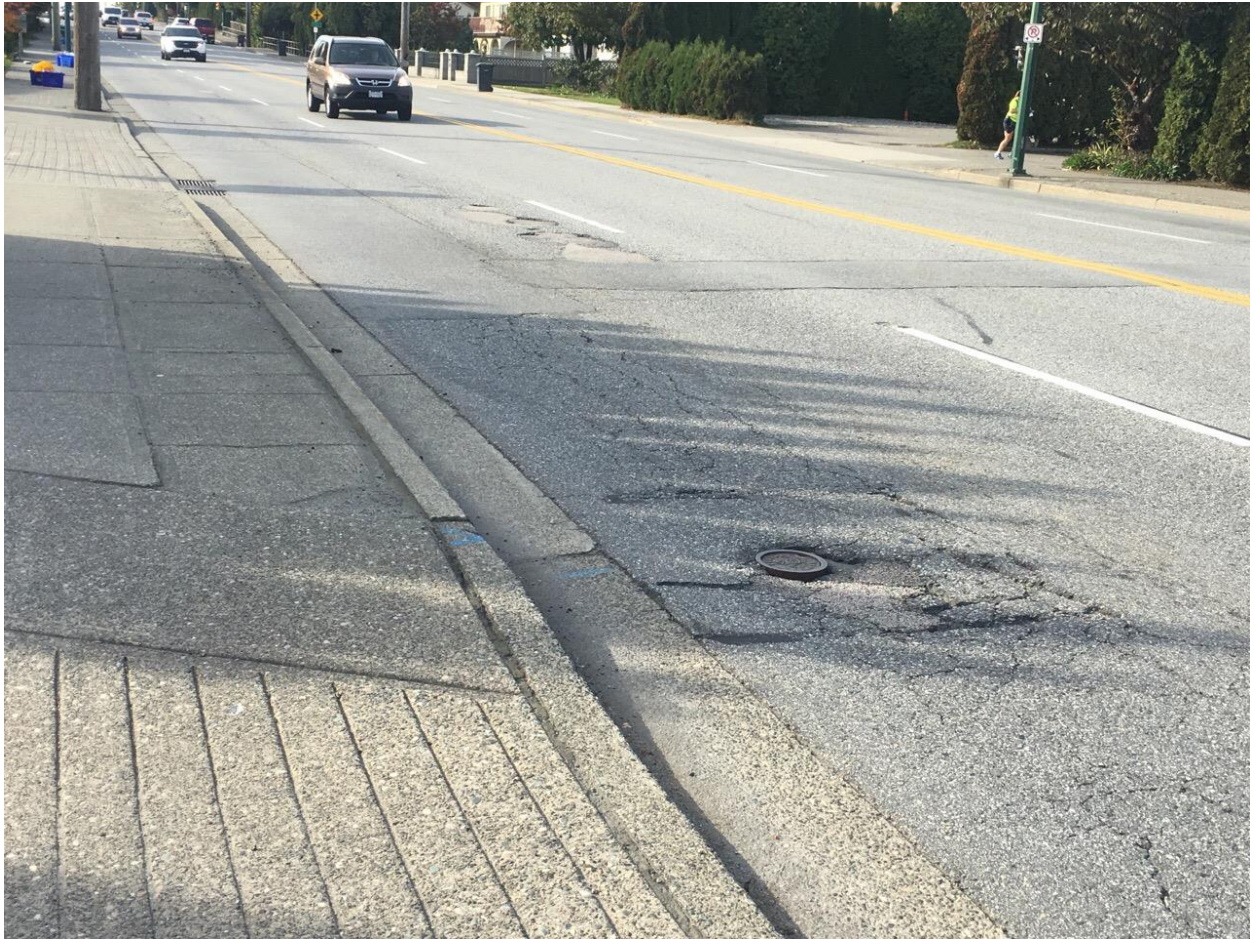
Figure 11 - Alligator Cracking and Patching Near Lillian St

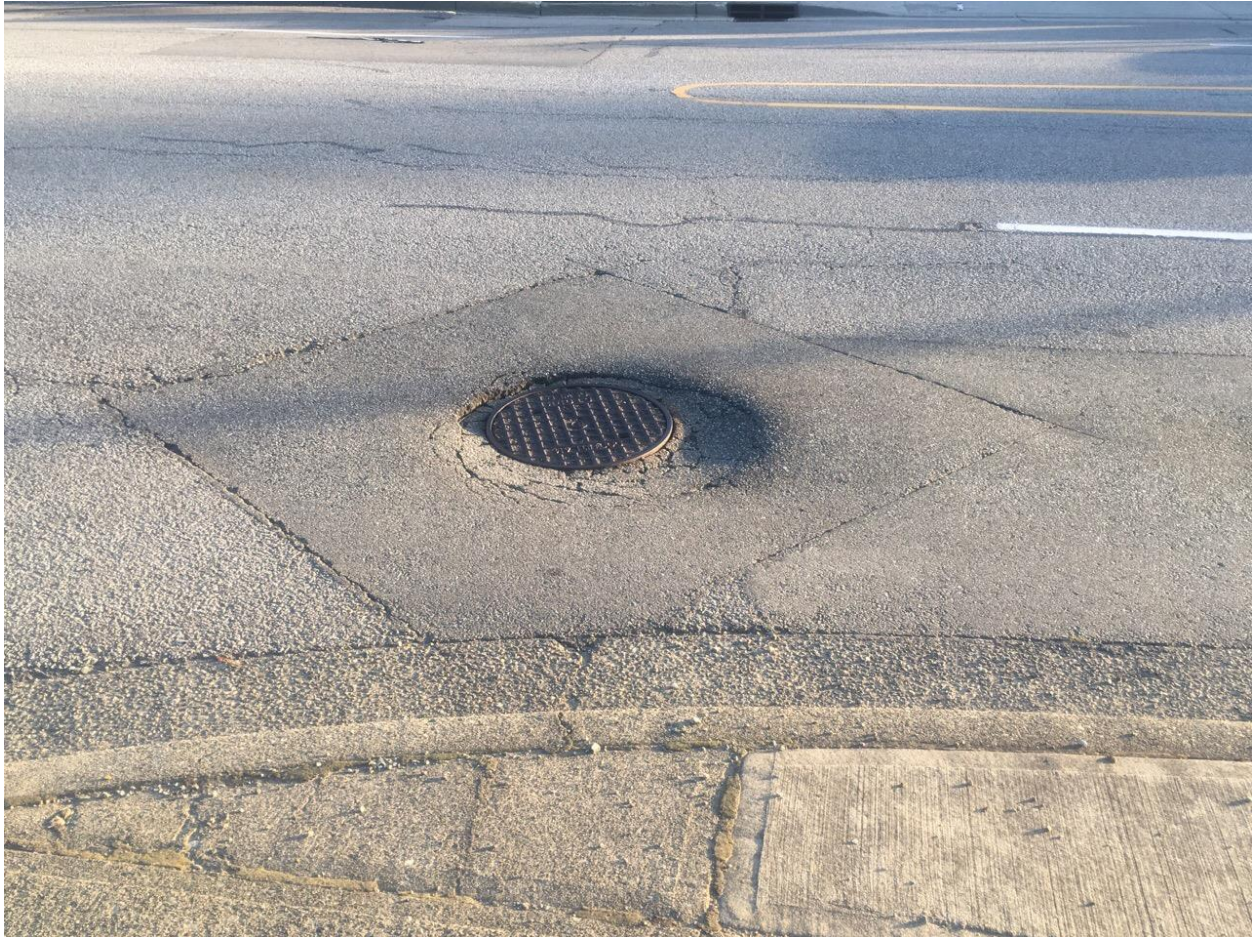
The Coquitlam mapping system indicates that this section was last paved in 2003. The majority of distresses observed in this section are patching, linear cracking, and alligator cracking. There are some areas of distortions and rutting. The type and location of distresses observed would indicate that this section could be a candidate for a potential full width rehabilitation treatment.

Figure 12 - Example of Patching at Regent St

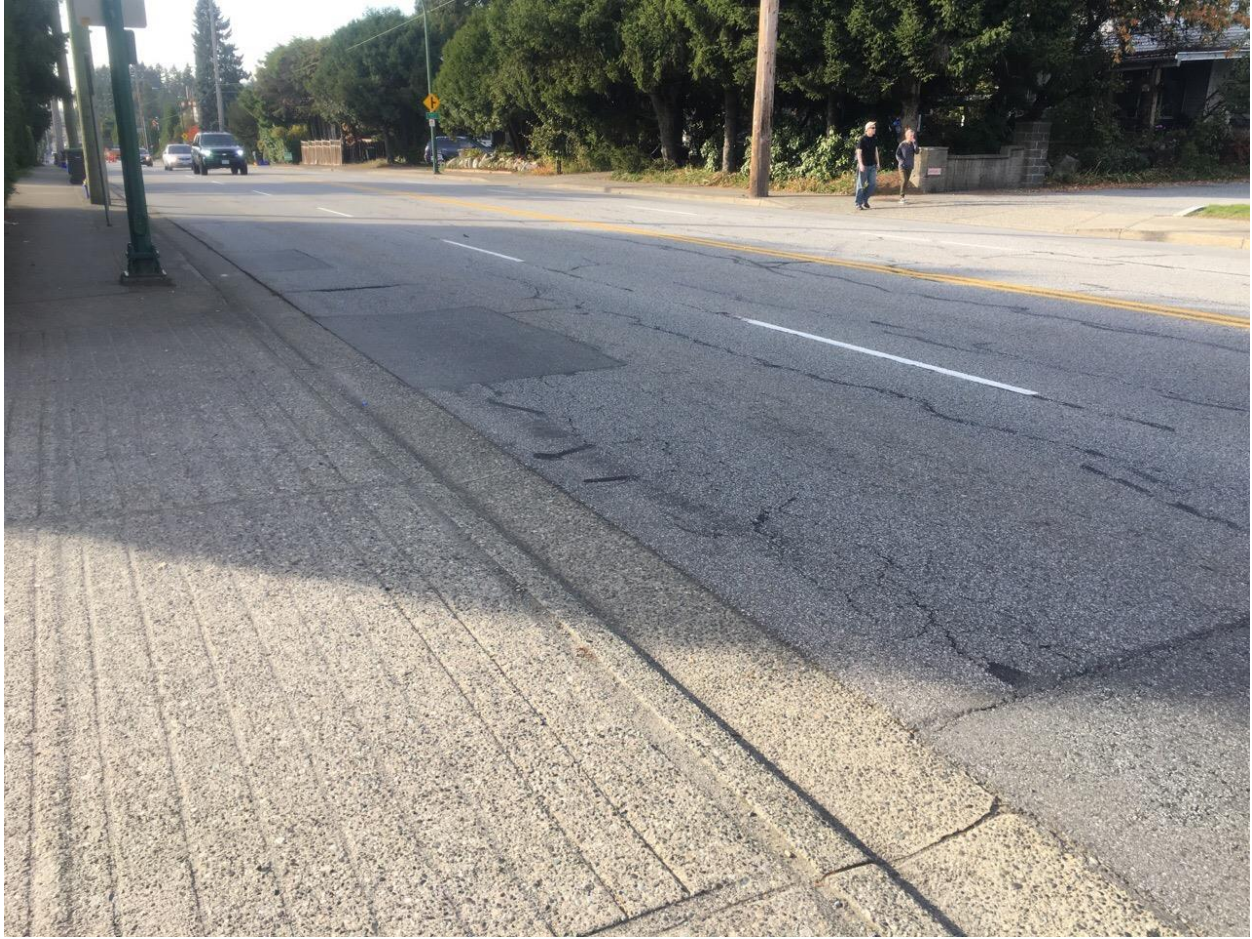
Figure 13 - Example of Alligator Cracking Near Crestwood Dr

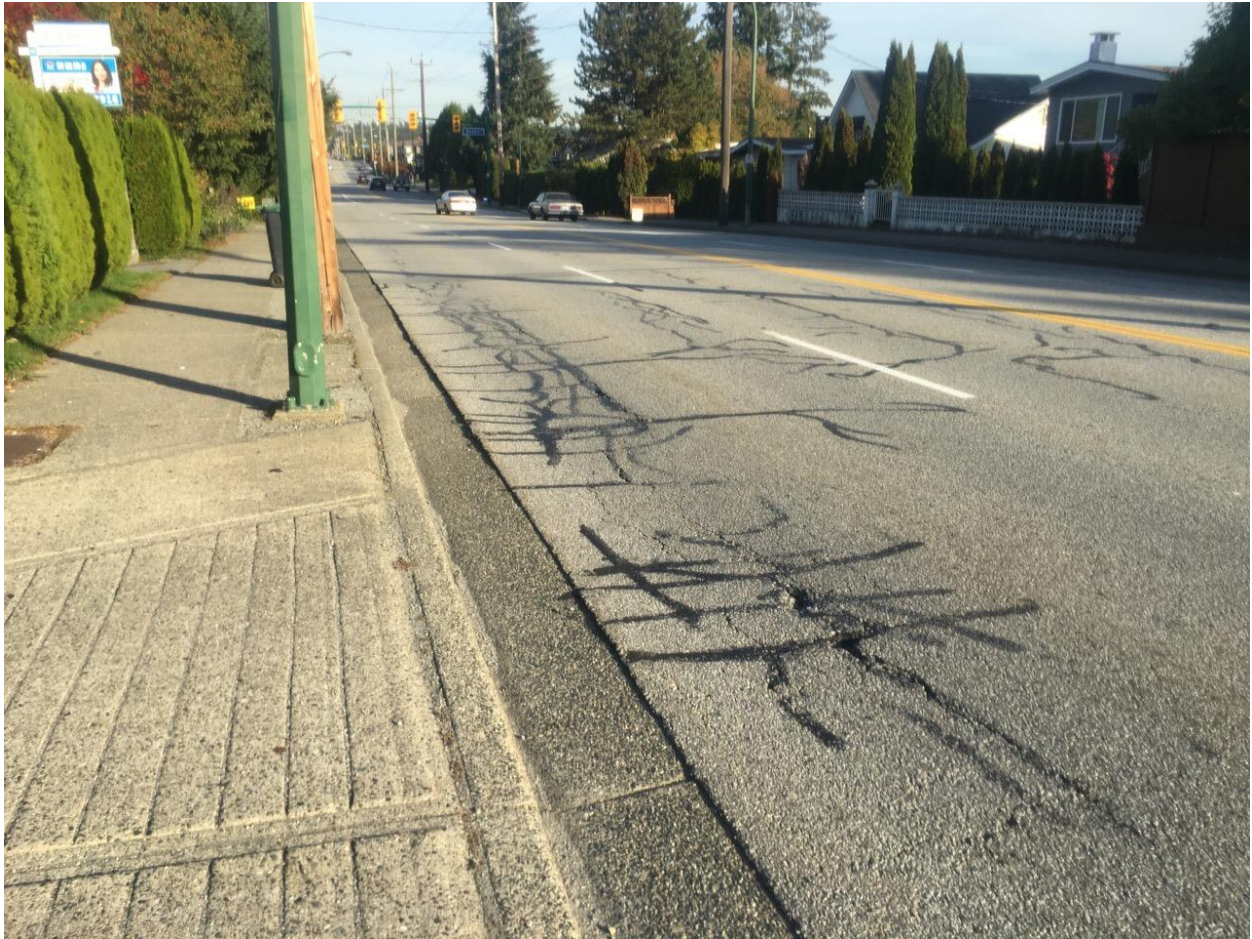
Figure 14 - Example of Alligator Cracking Near Wasco St

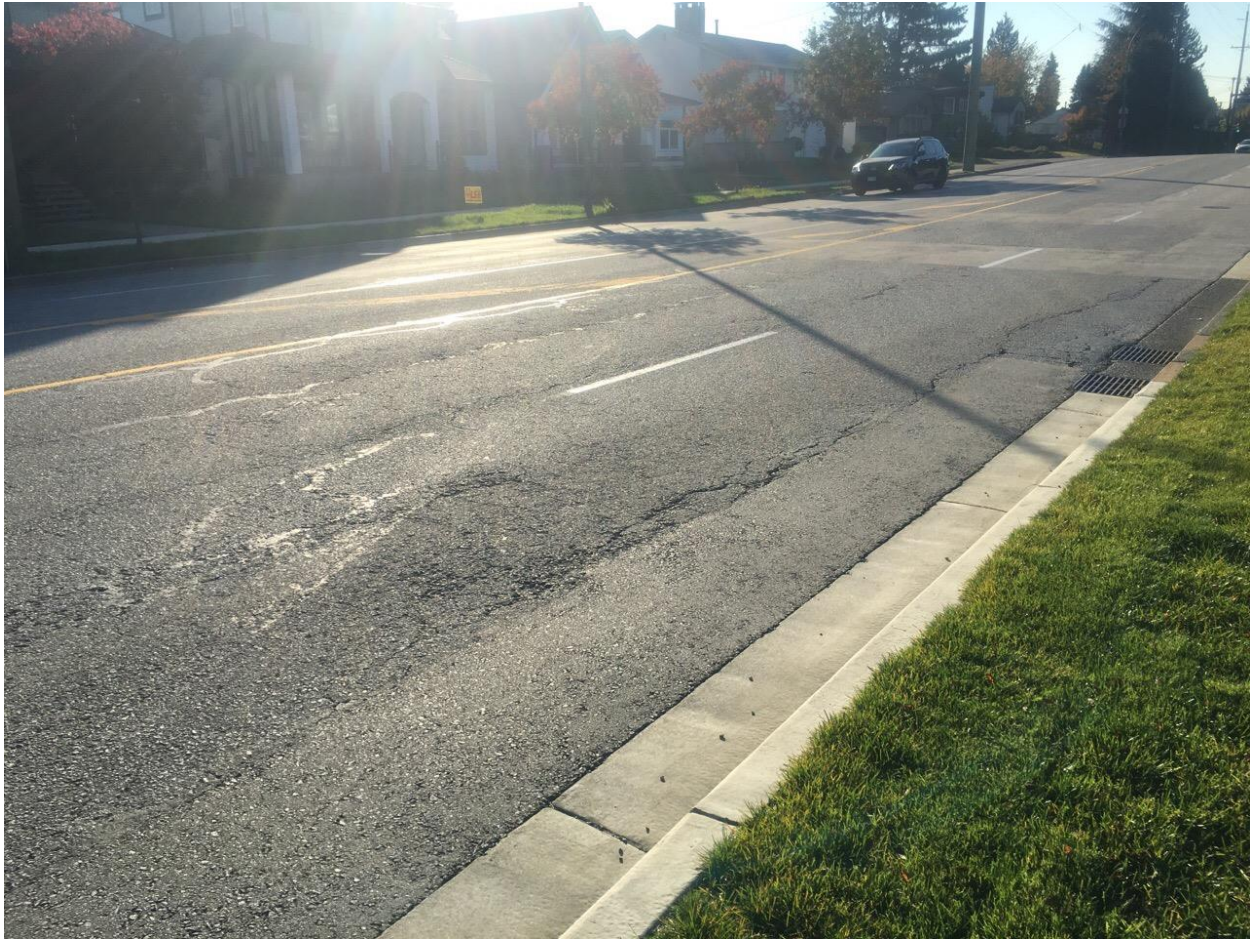
Figure 15 - Example of Distortion and Cracking Near Poirier St

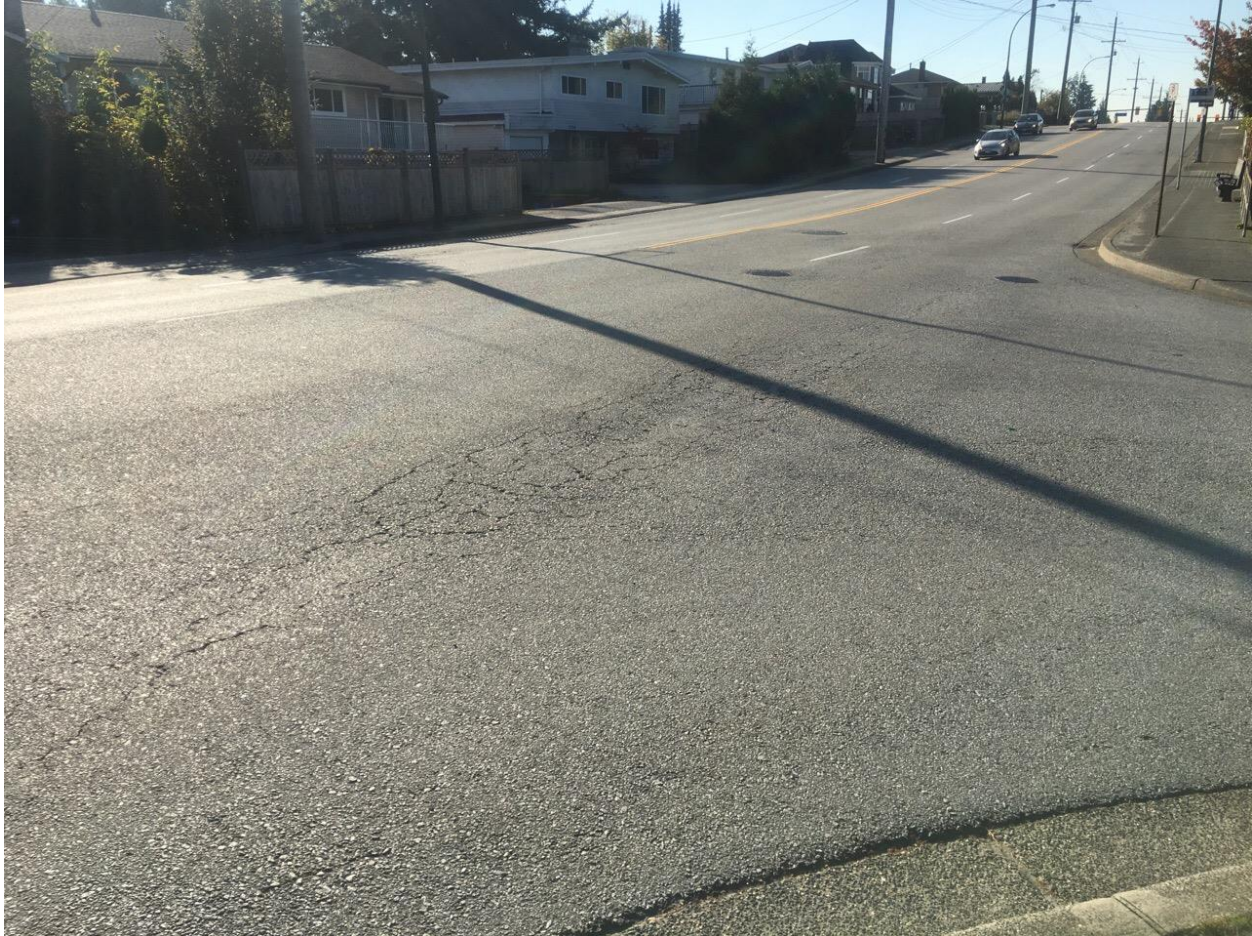
The Coquitlam mapping system indicates that this section was last paved in 1965, although it is possible that this area has been repaved since that time. The vast majority of distresses observed in this section are linear cracking, and alligator cracking. There are some areas of patching, rutting, and distortions, along with further extents of low severity sealed linear cracking that was not recorded during the survey. The type and location of distresses observed would indicate that this section could be a candidate for a potential full width rehabilitation treatment.

Figure 16 - Example of Alligator Cracking at Prospect St

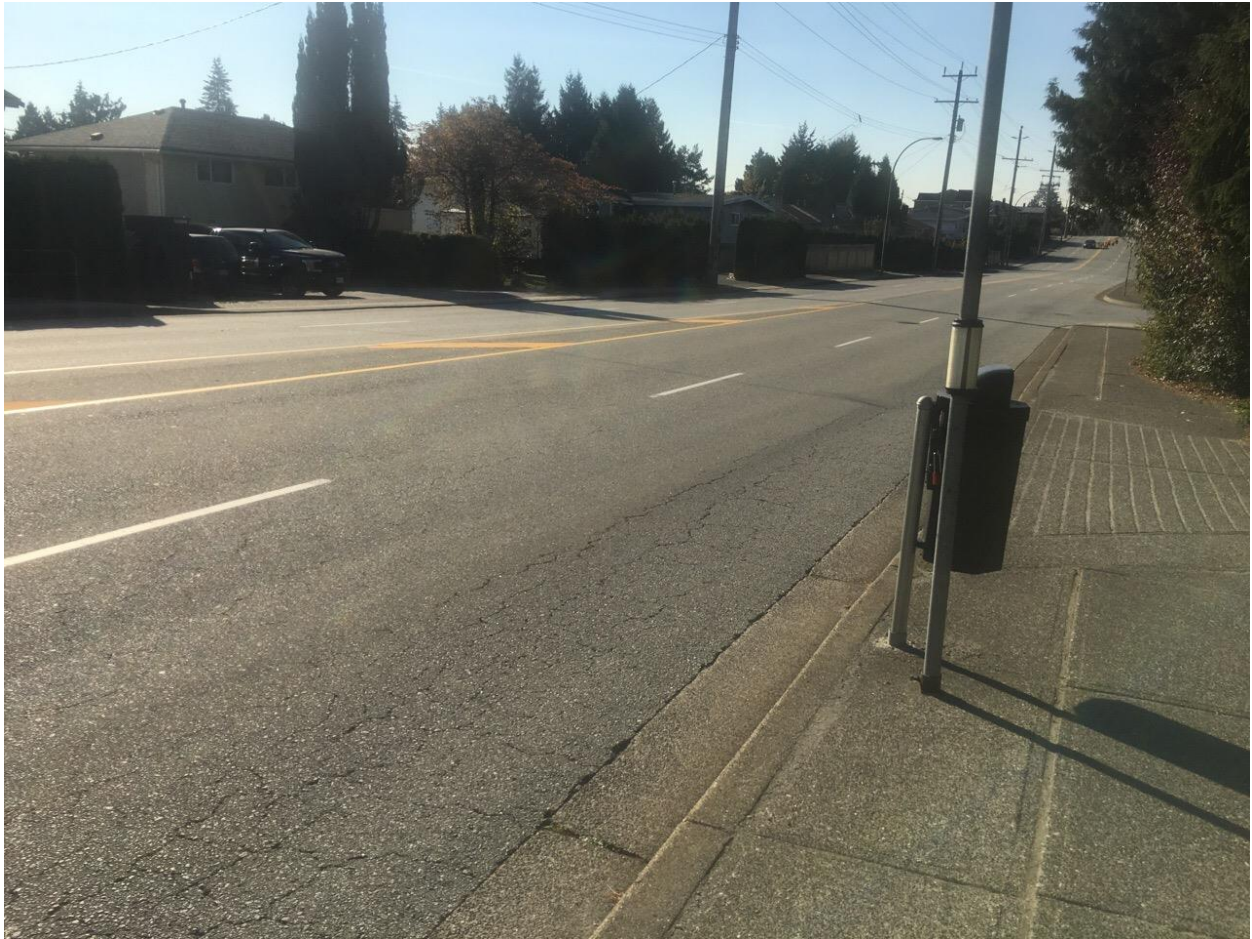
Figure 17 - Example of Alligator Cracking Near St Laurence St

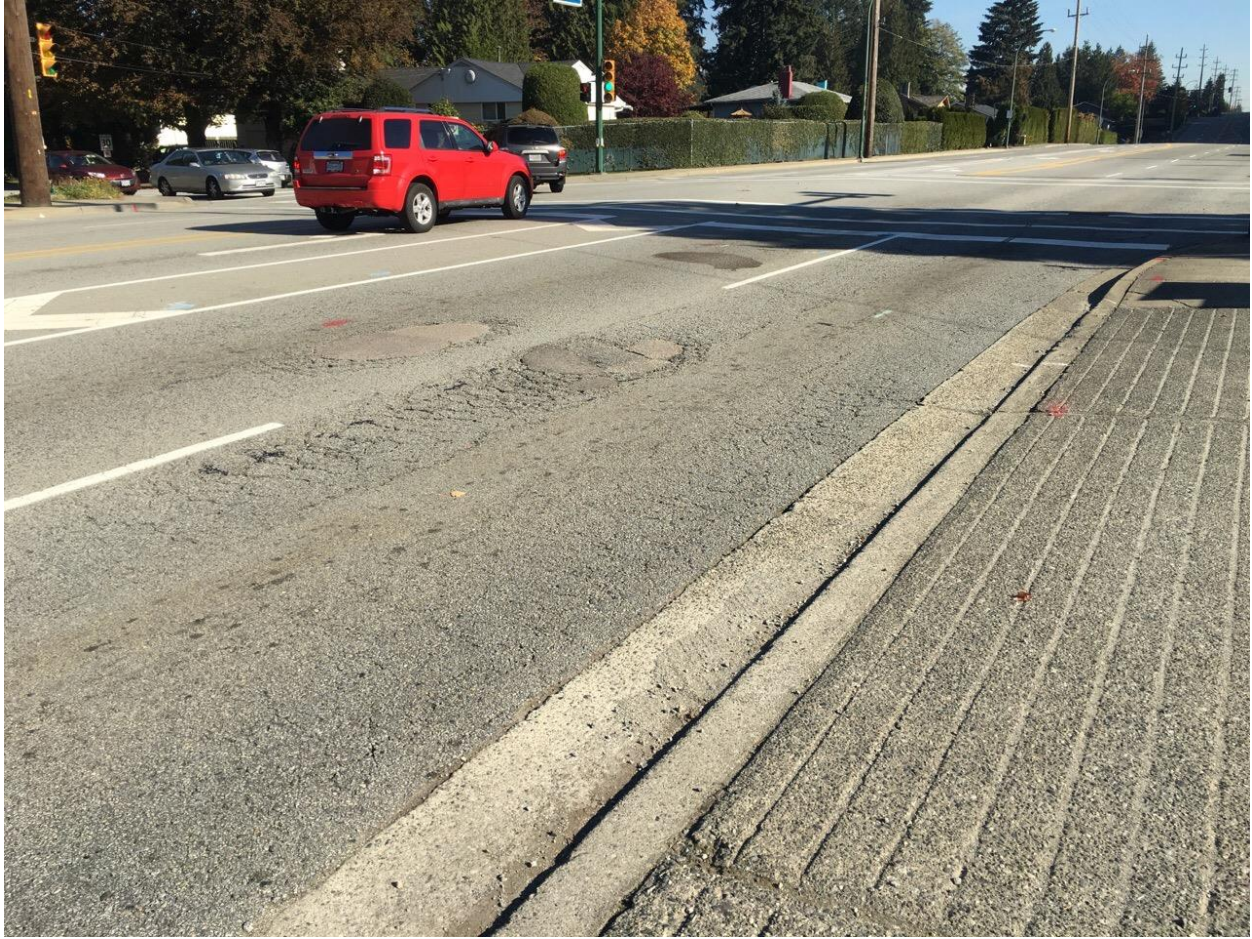
Figure 18 - Example of Alligator Cracking at Thermal St

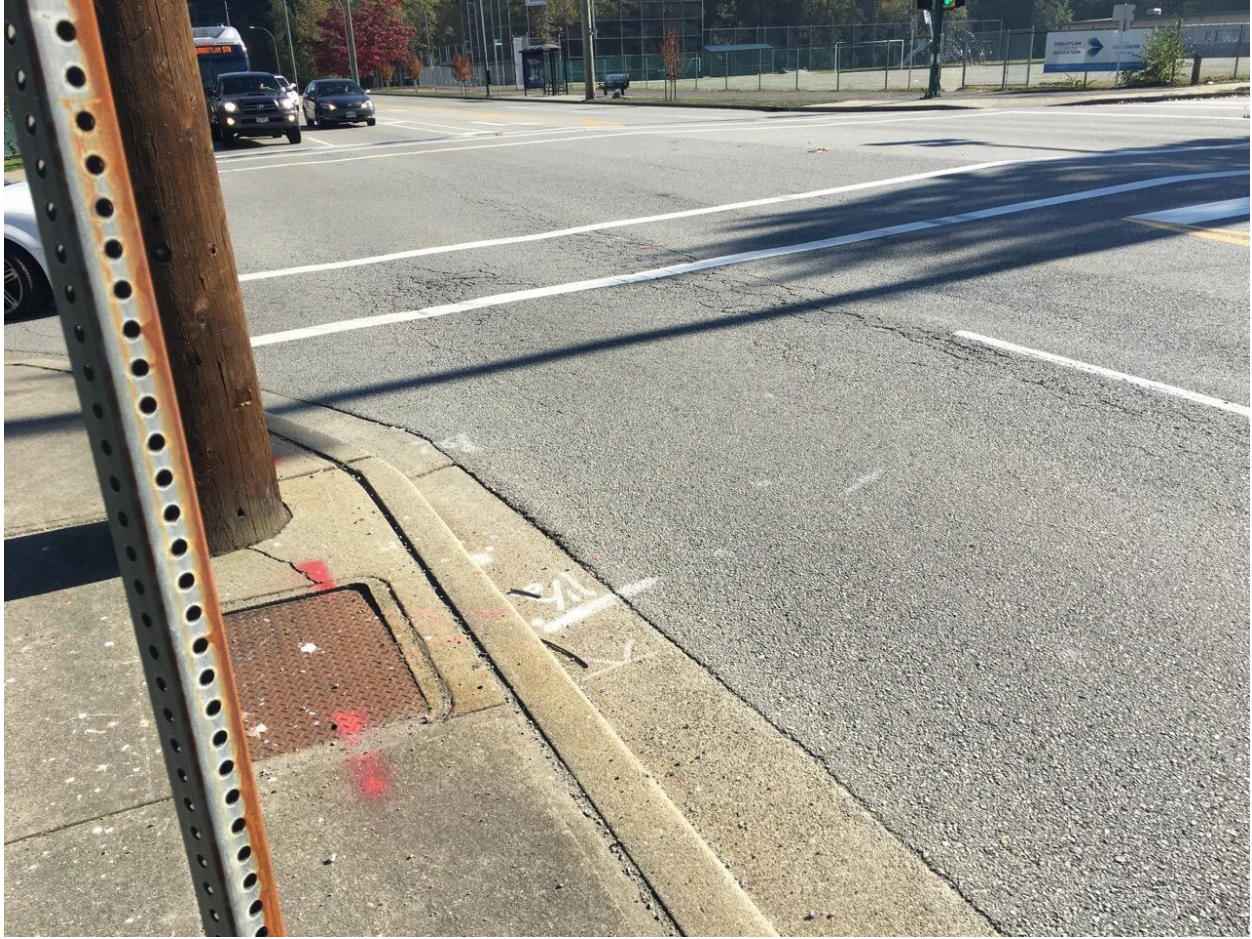
Figure 19 - Example of Alligator Cracking at Thermal St
