Re: FortisBC Energy Inc. (FEI)

Application for Use of Lands under Sections 32 and 33 of the *Utilities Commission Act* (UCA) in the City of Coquitlam for the Lower Mainland Intermediate Pressure (IP) System Upgrade (LMIPSU) Projects – Coquitlam Gate IP Project (Project) (the Application)

FEI Evidence on Phase Two Issues

Supplemental Evidence for Phase Two

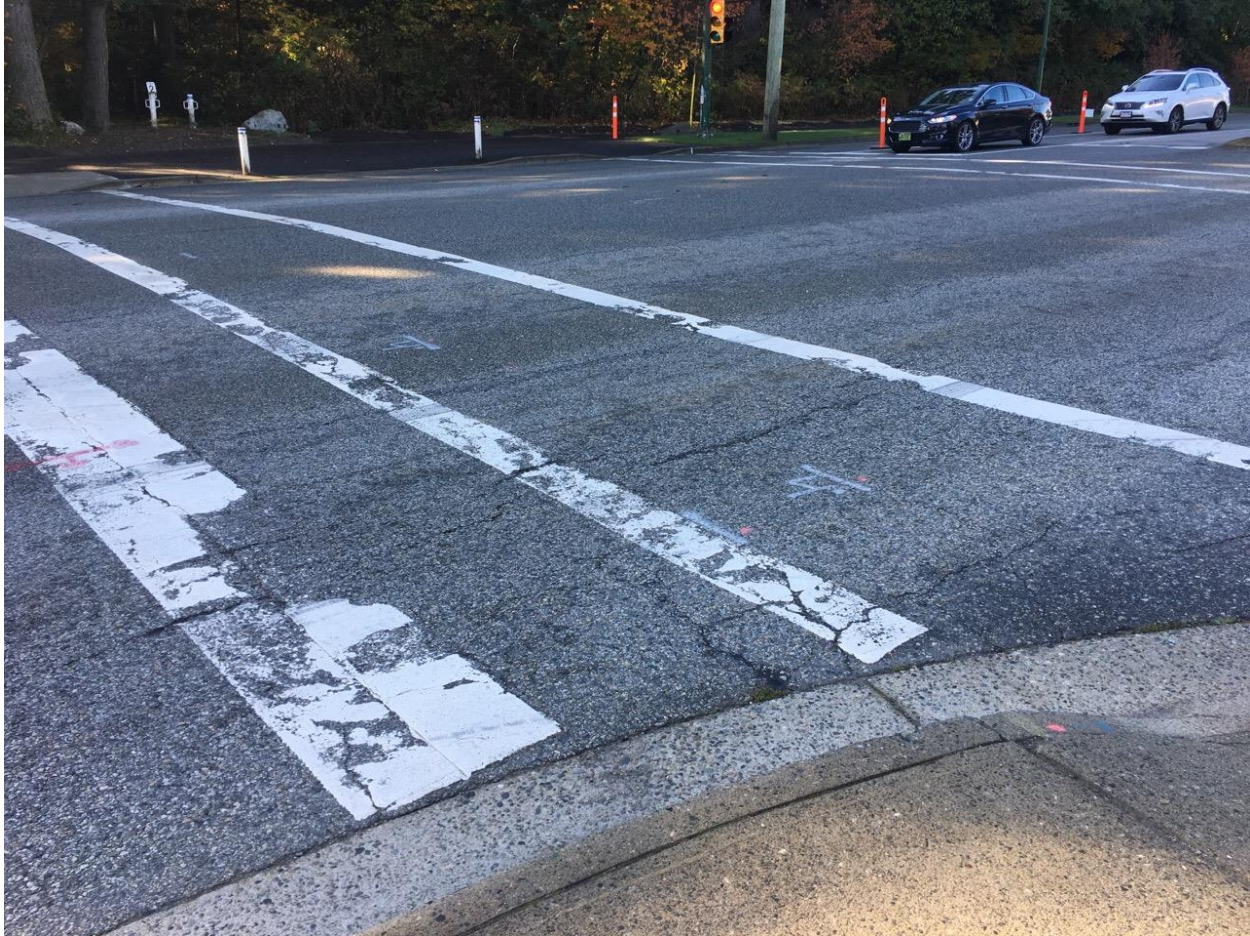
The Coquitlam mapping system indicates that this section was last paved in 1962, although it is possible that this area has been repaved since that time. The vast majority of distresses observed in this section are alligator cracking, linear cracking, and patching. There are some areas of distortions, along with further extents of low severity sealed linear cracking that was not recorded during the survey. The type and location of distresses observed would indicate that this section could be a candidate for a potential full width rehabilitation treatment.

Figure 20 - Example of Alligator Cracking at Baker St

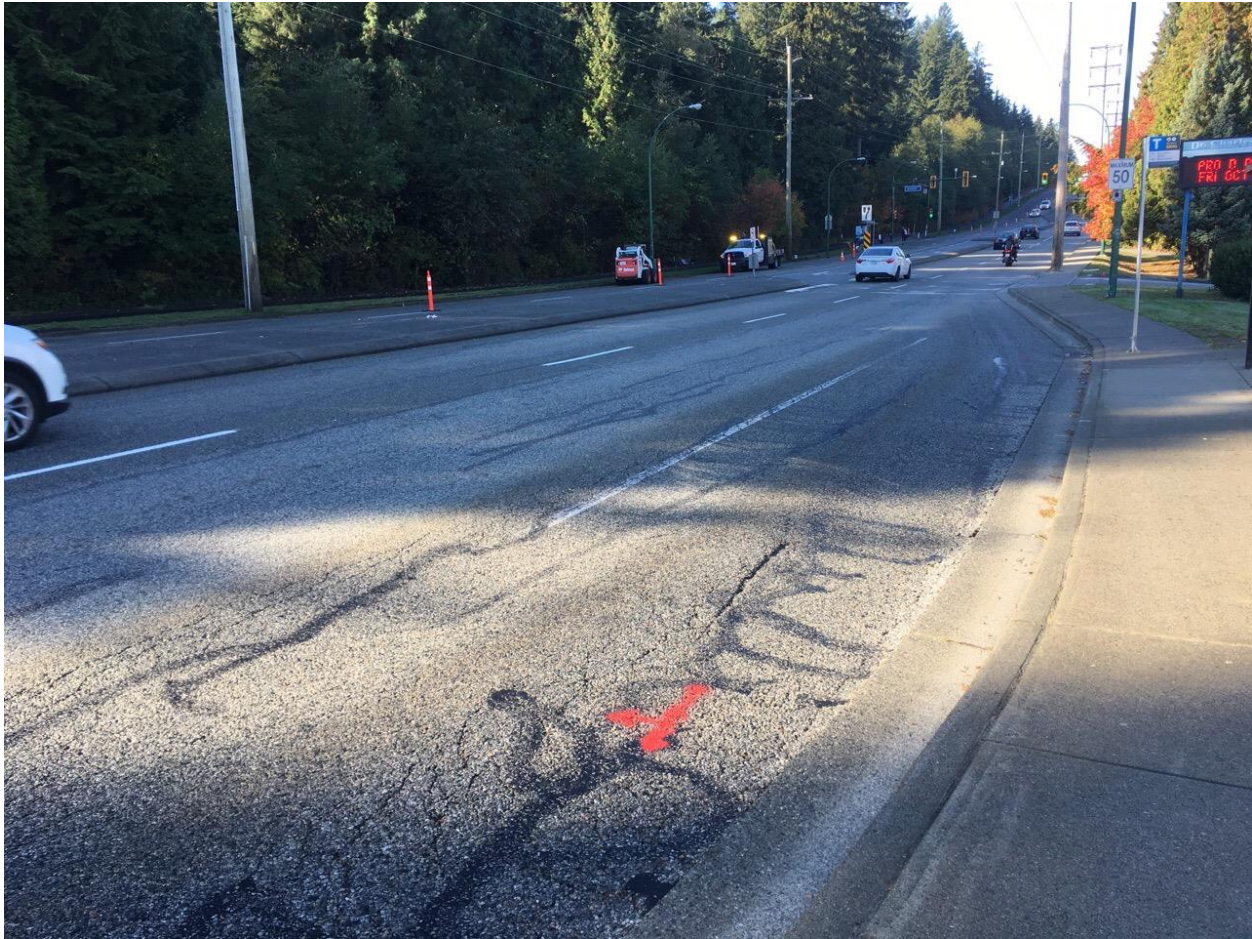
Figure 21 - Example of Alligator Cracking and Distortions East of Baker at Bus Stop

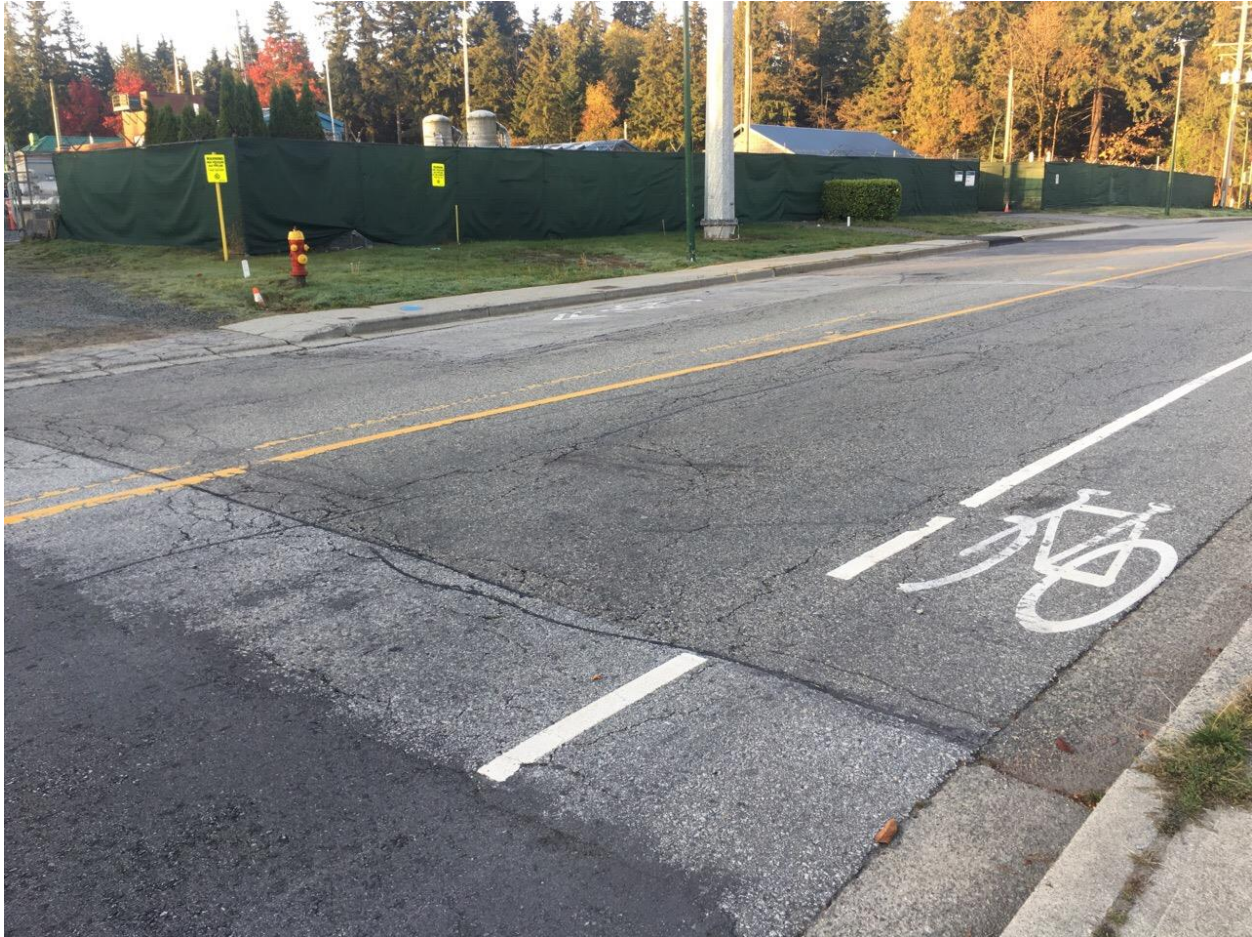
The Coquitlam mapping system indicates that this section was last paved in 1962, although it is possible that this area has been repaved or partially repaved since that time. There is a large area of high severity alligator cracking in this section and other areas of patching. The type and location of distresses observed would indicate that this section could be a candidate for a potential full width rehabilitation treatment.

Figure 22 - Example of Alligator Cracking West of Pinnacle St

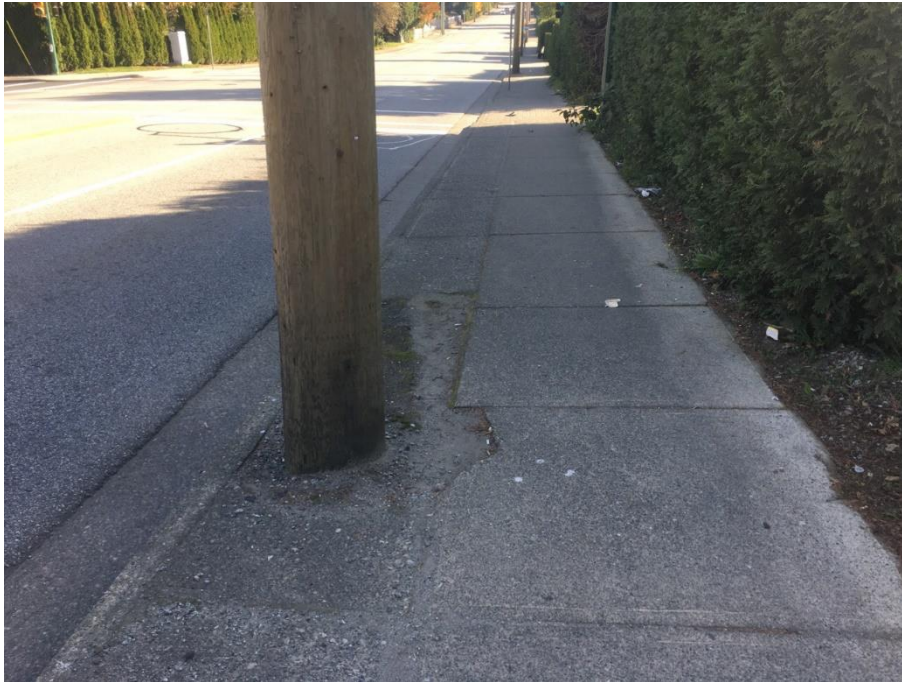
Figure 23 - Example of Sidewalk Out of Elevation (settled patch around pole)

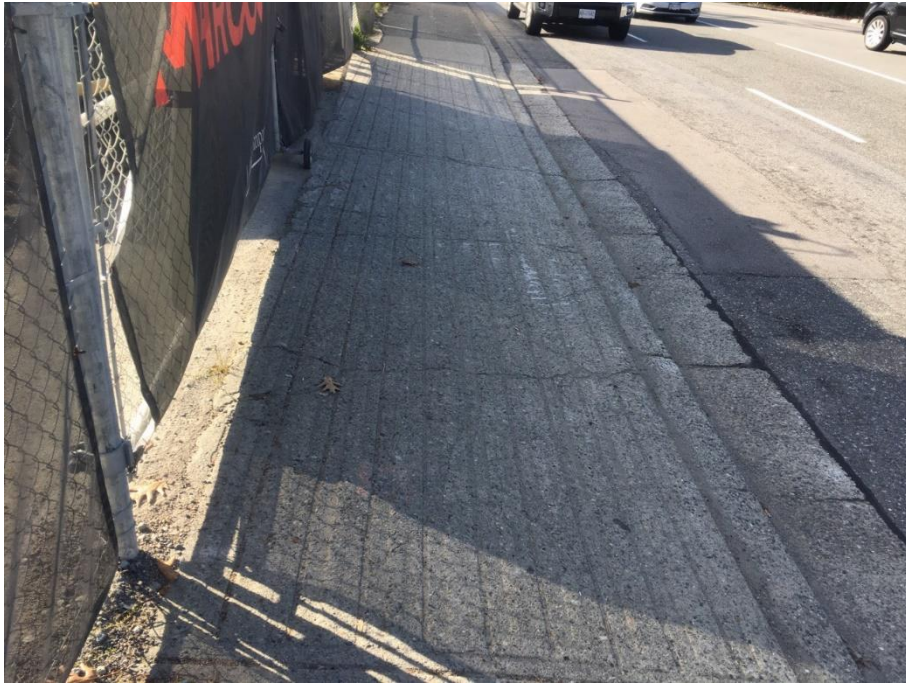
Figure 24 - Example of Sidewalk Cracking - High (driveway crossing next to construction site)

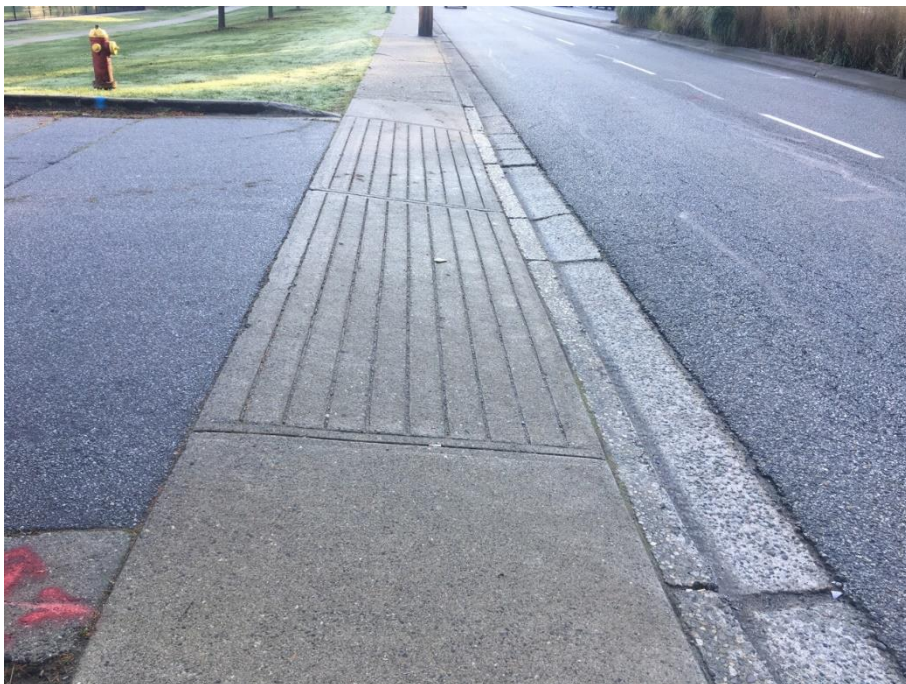
Figure 25 - Example of a Cracked Curb

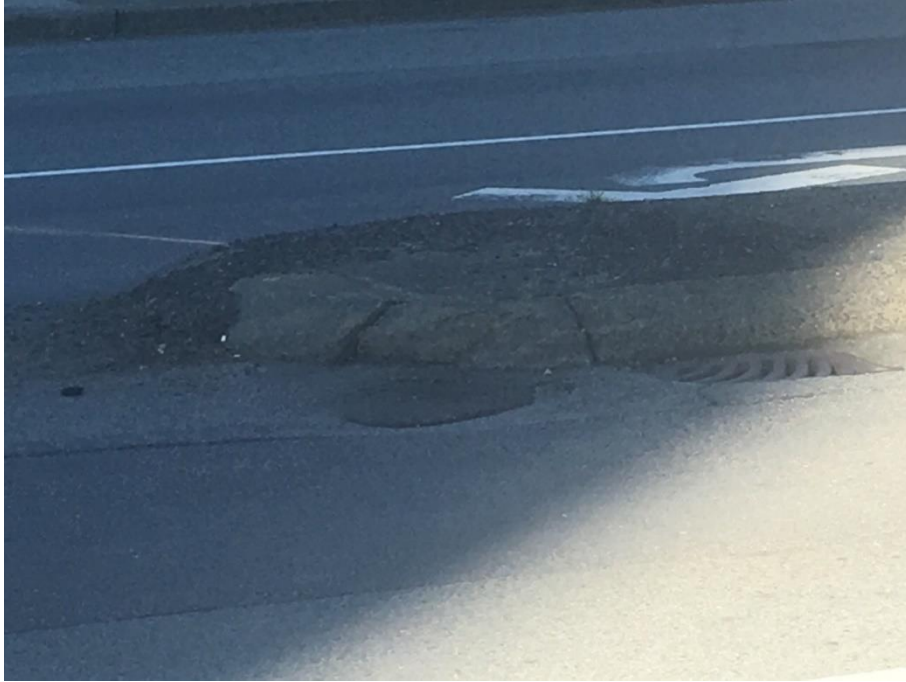
Figure 26 - Example of a Broken Median

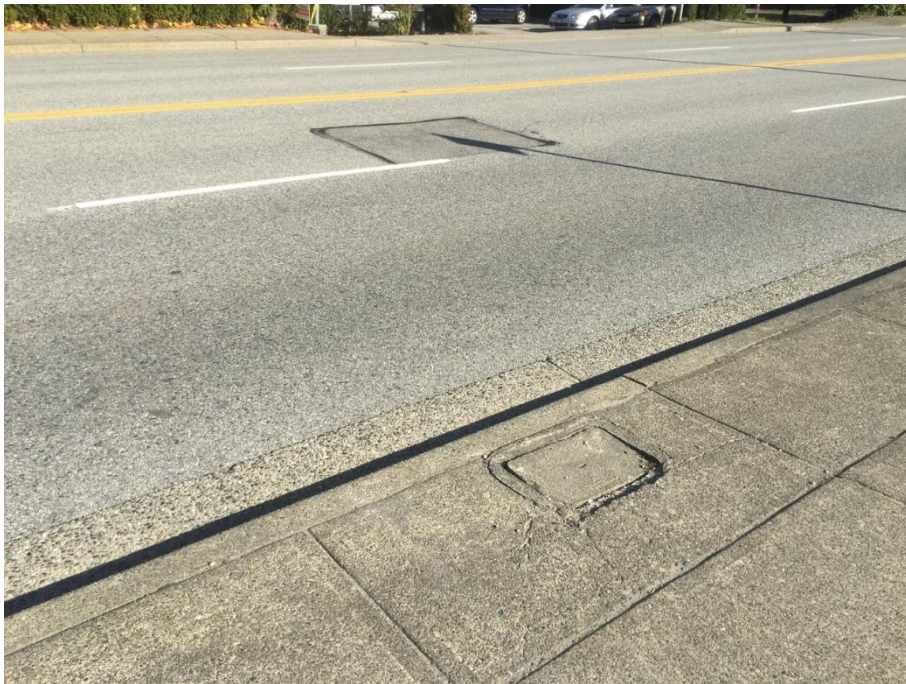
Figure 27 - Example of Observation – Junction / Utility Box Lid Damaged / Settled

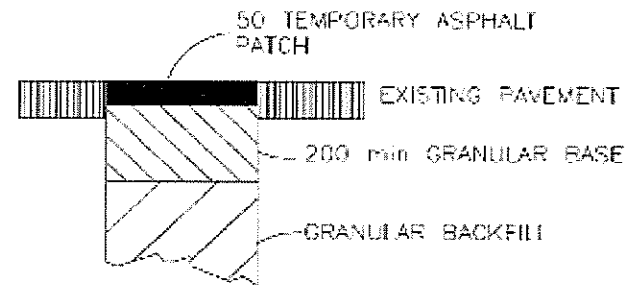
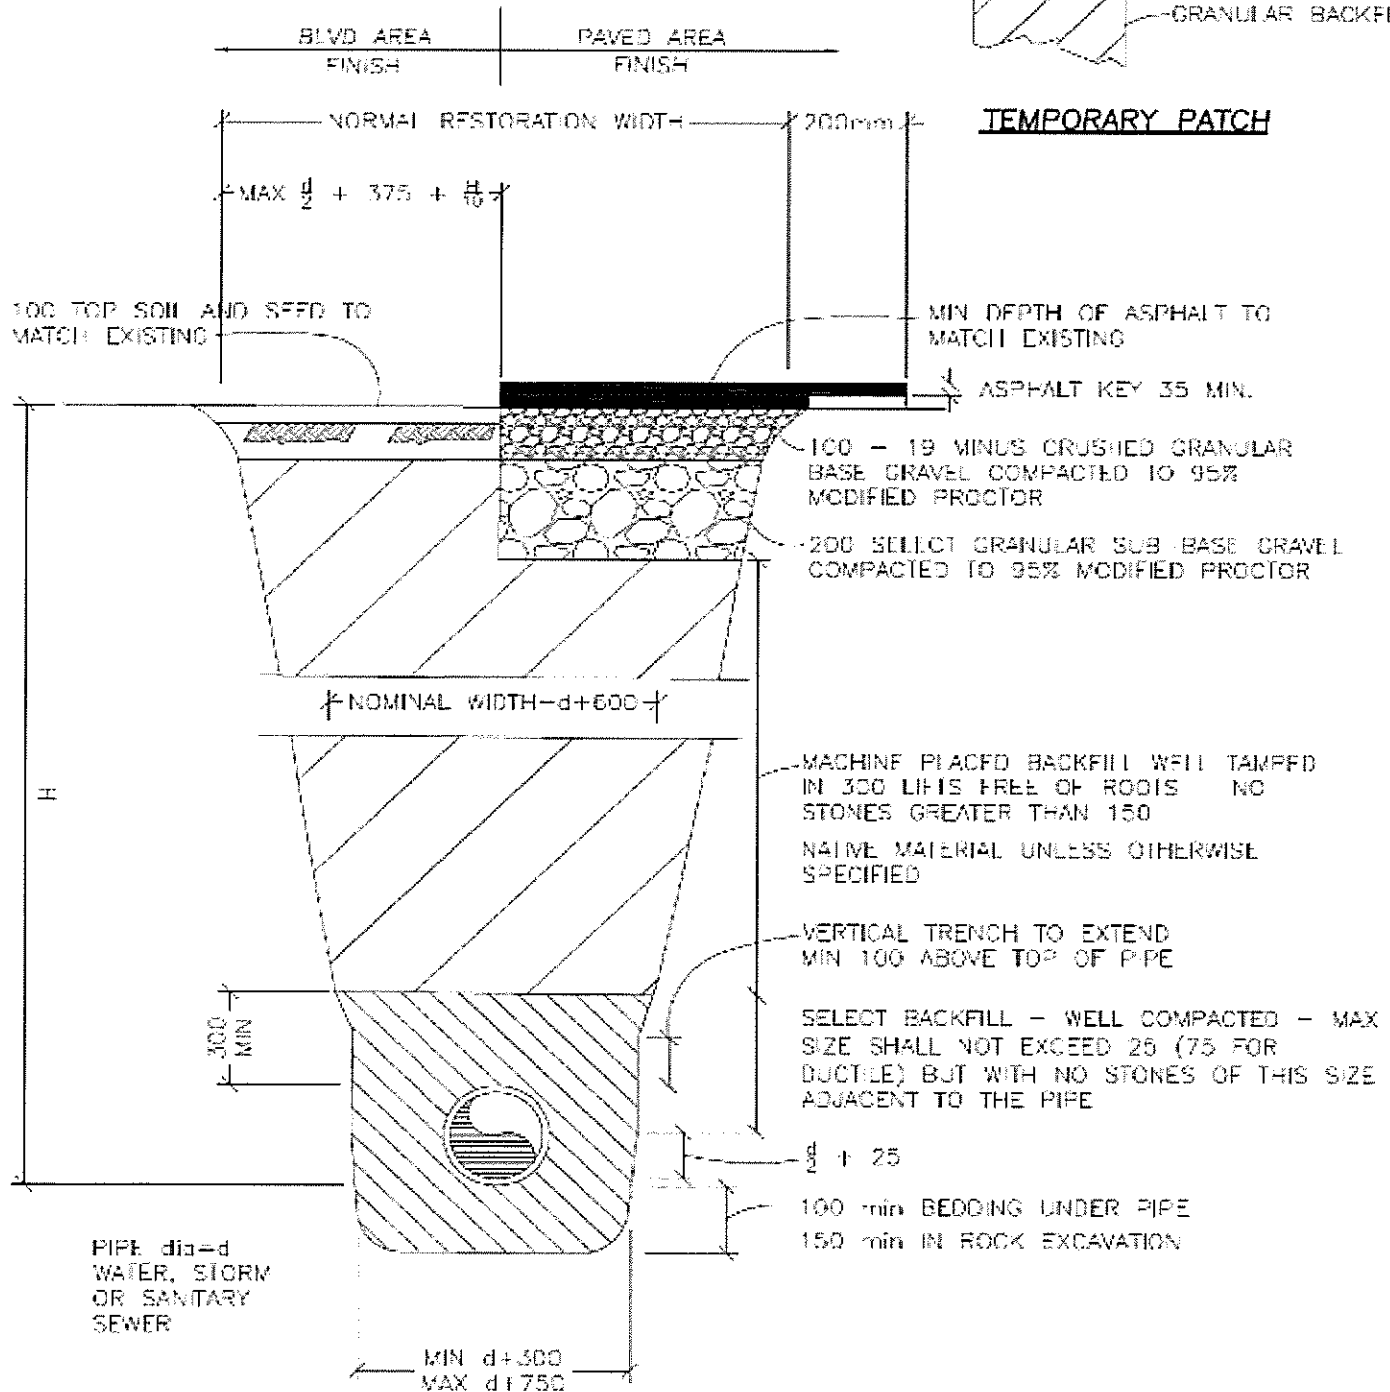
TRENCH DETAILS FOR STANDARD SECTION

H = TRENCH DEPTH IN mm
