July 9, 2015

#### Re: FortisBC Inc. (FBC or the Company)

## Application for a Certificate of Public Convenience and Necessity (CPCN) for the Kootenay Operations Centre (the Application)

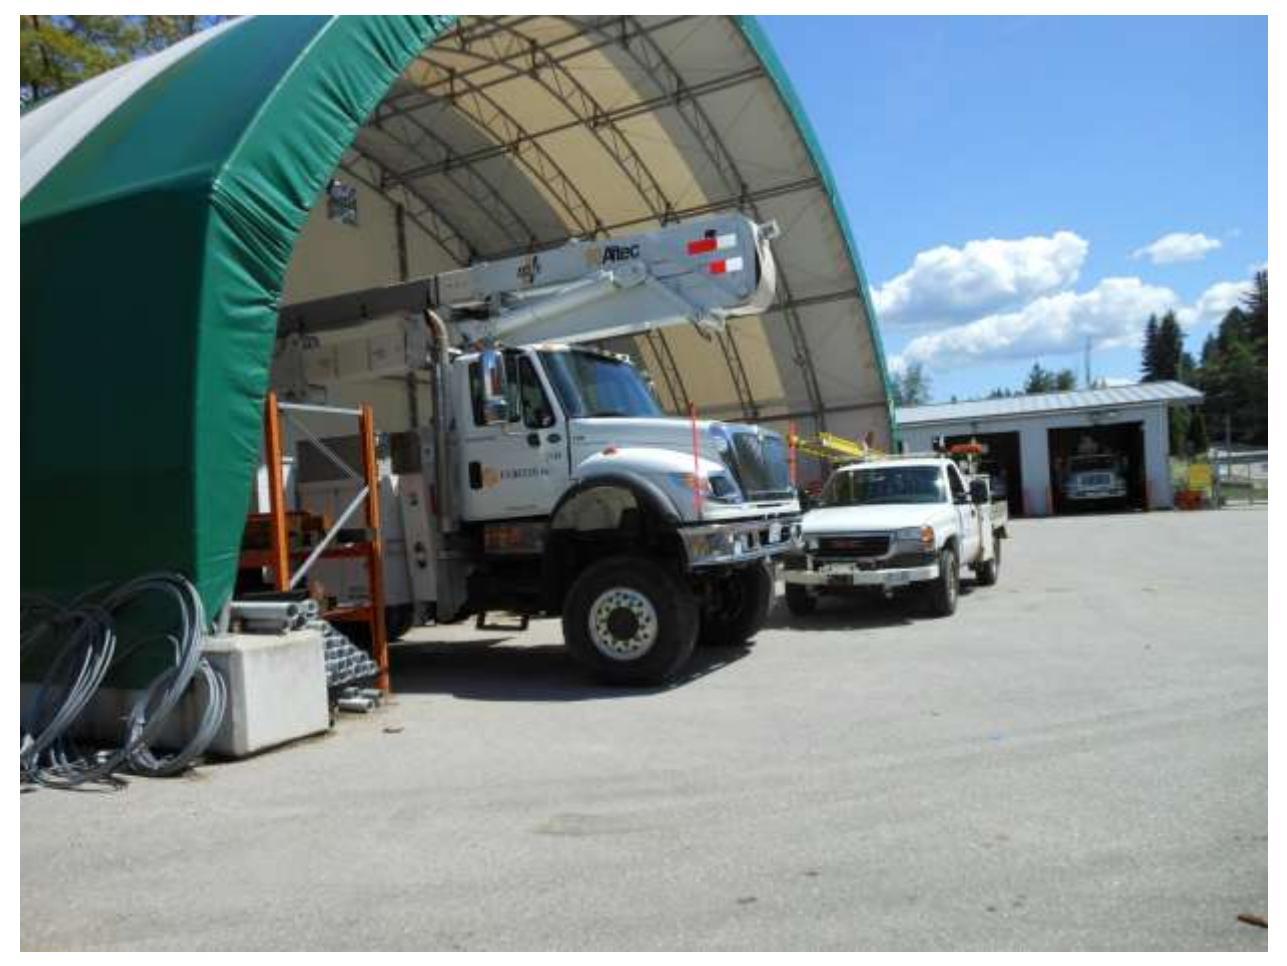
#### Figure 4-4: Castlegar Quonset Hut

13 A Quonset hut is currently being used for parking for the RBD trucks (Figure 4-4). These 14 vehicles require electric plugins for their diesel engines as well as covered dry storage to ensure the safety of FBC staff when working on electrical lines. Although the Quonset hut provides 15 16 some protection from the elements, it does not provide full protection as a secure enclosed 17 garage would. The current RBD model only partially fits in the Quonset hut, and the 18 replacement RBD truck planned for deployment at the Castlegar District Office in 2015 will also 19 extend out of the cover due to its length. These larger RBD trucks have a longer boom which is 20 required to set the longer poles in the ground that are currently being used by FBC. Not all RBD 21 trucks fit in the Quonset hut; large trucks that do not fit under cover in the yard at the Castlegar 22 District Office are covered with tarps every night during cold months so that they are ready for 23 use each day.

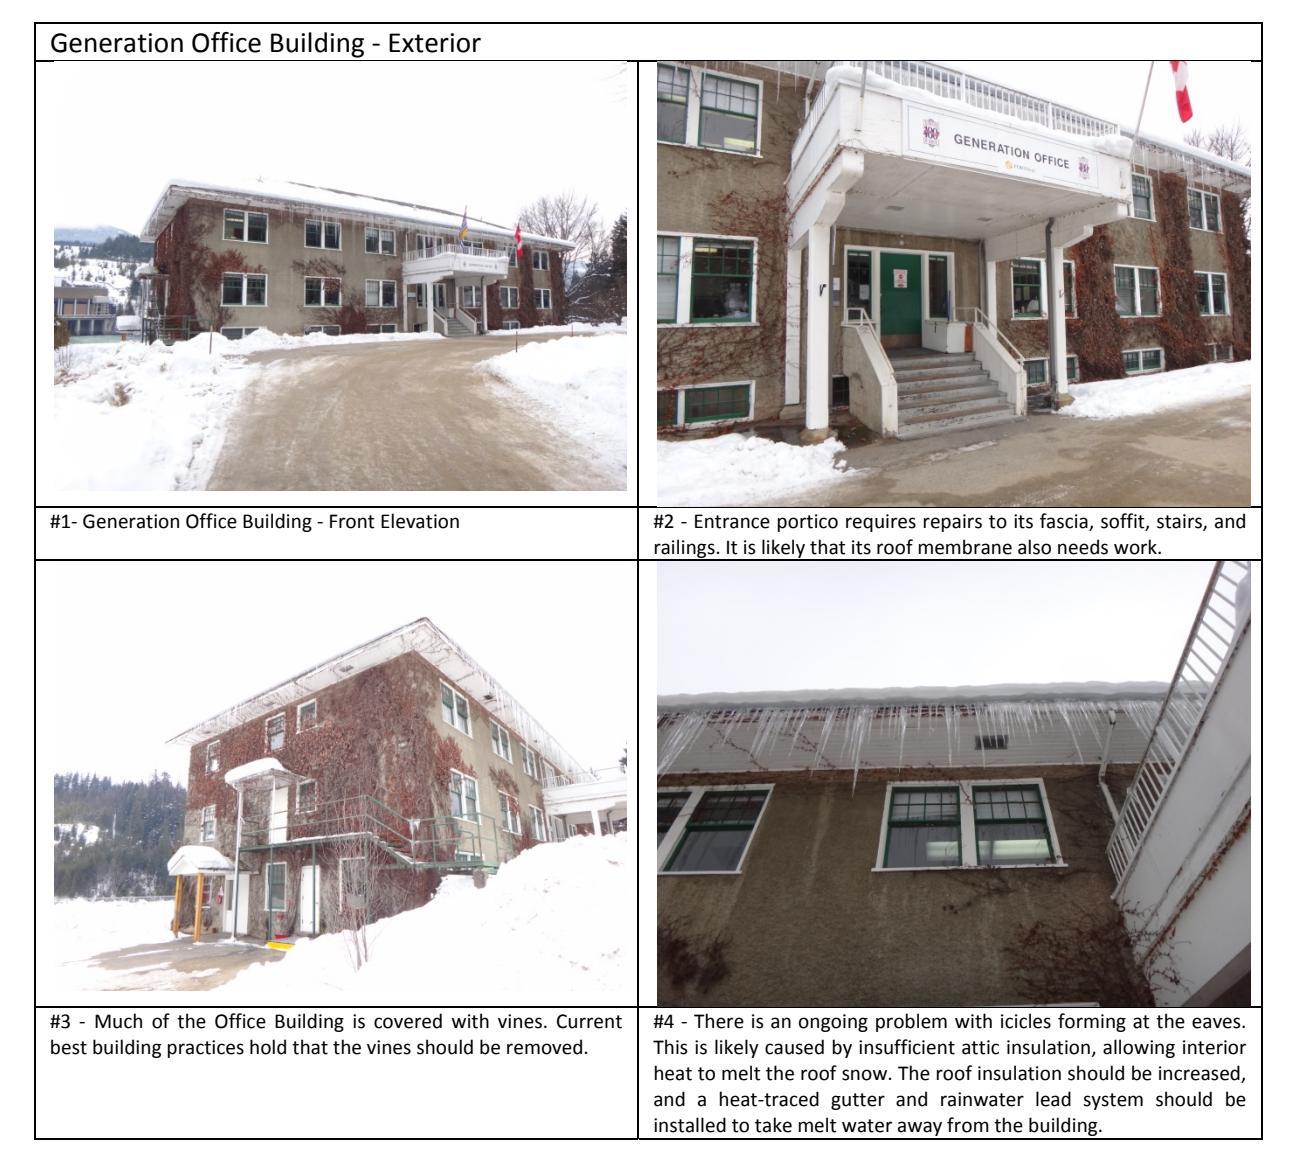
#5 - Main Entrance Stairs are loose, worn, and should be replaced.

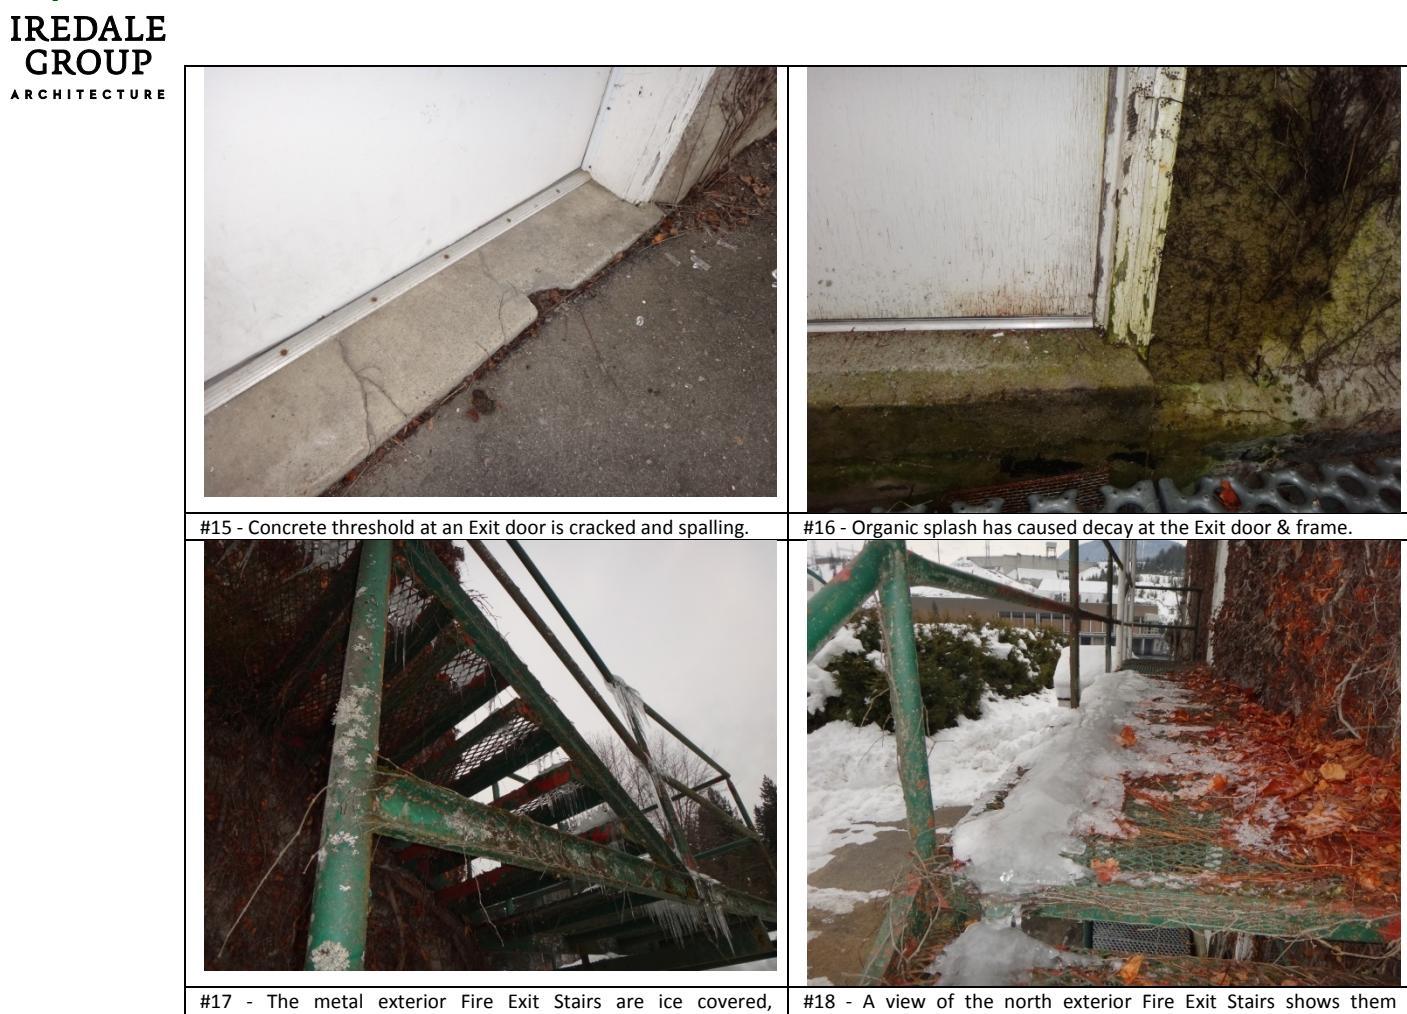
dangerous, and have begun to rust.

#18 - A view of the north exterior Fire Exit Stairs shows them covered with ice, and dangerous to use.

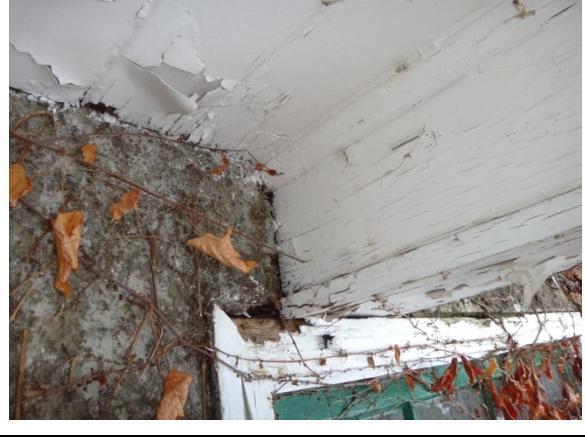
#23 - Note the peel paint at the portico soffit and beam, the organic vine growth on the building, and the decay in the window head trim.

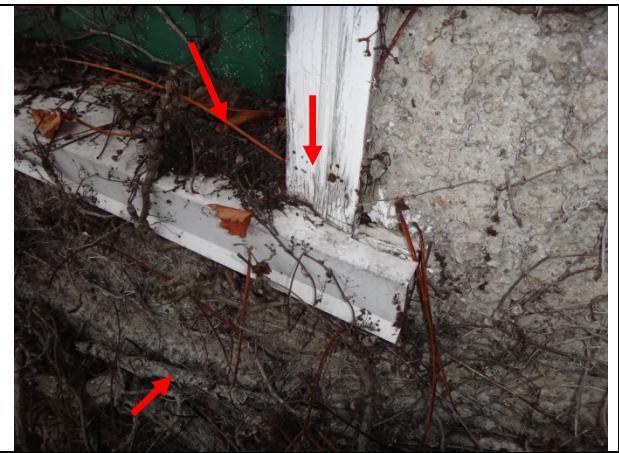
#24 - Note the build-up of organic debris on the window sill, the decayed window jamb, and the cracked stucco.

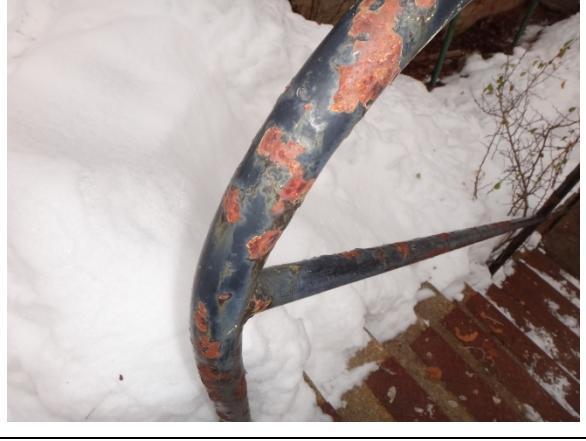
#26 - The south metal Fire Exit Stairs shows similar issues of ice and rust. The stone retainign wall should be replaced with concrete.

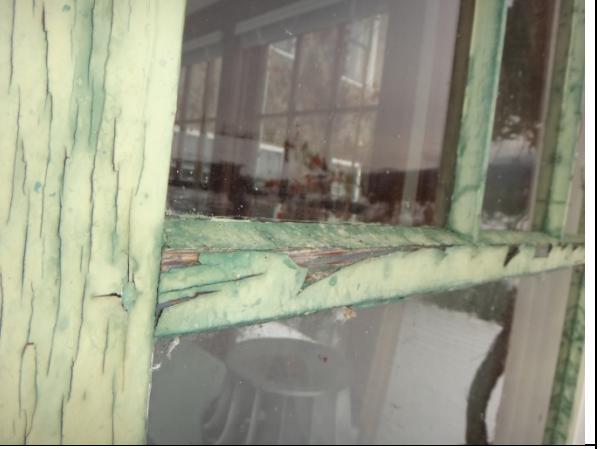
#28 - Close-up of a typical exterior wood window. Note the cracking and peeling paint, and the spalling glazing putty.

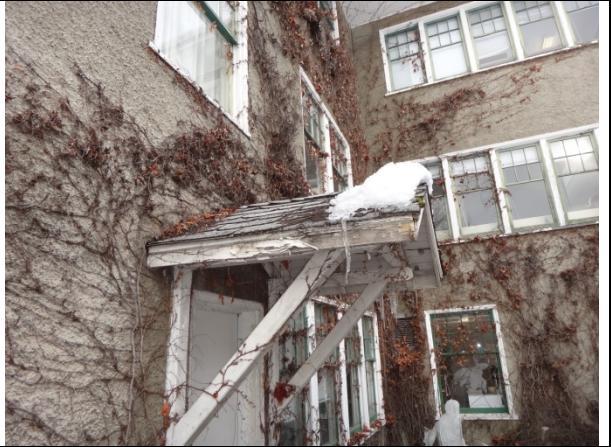
#29 - A section of failed stucco has been repaired with unpainted plywood.

#30 - The rear Fire Exit canopy requires re-roofing, and has decayed wood members that should be replaced.

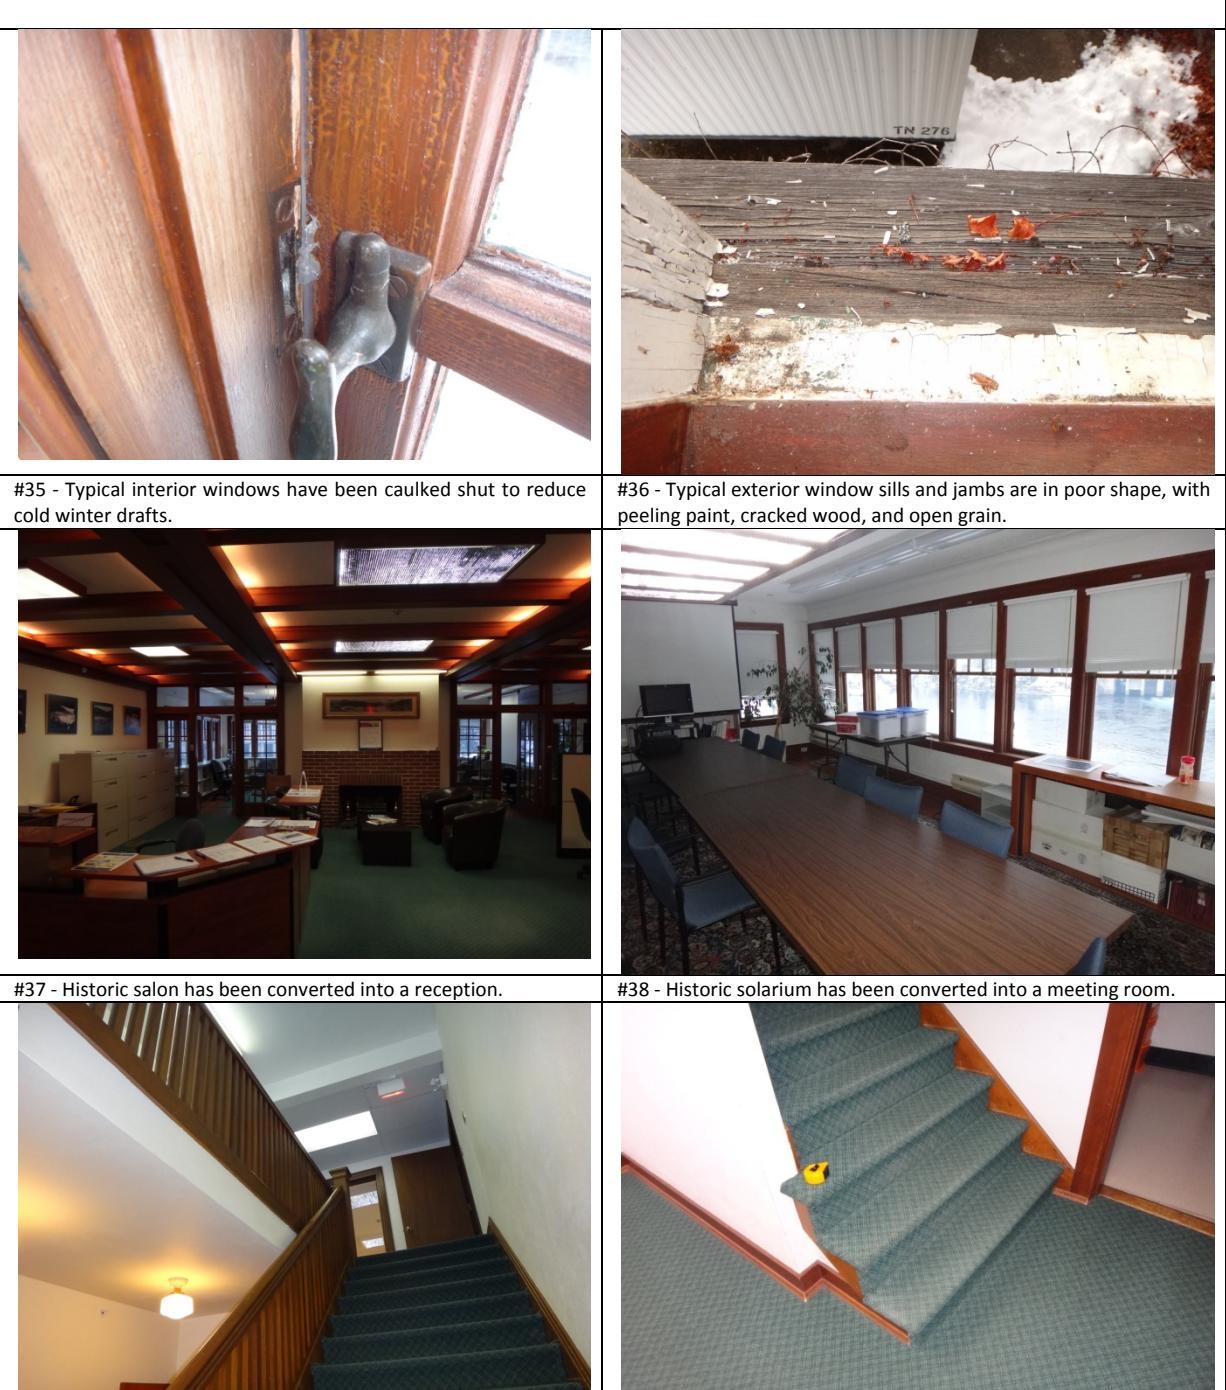
#39 - Open central stairs require railings on both sides, and a fire separation between floors.

#40 - Stairs to the basement require railings on both sides, and are not permitted to have stairs without sidewalls.

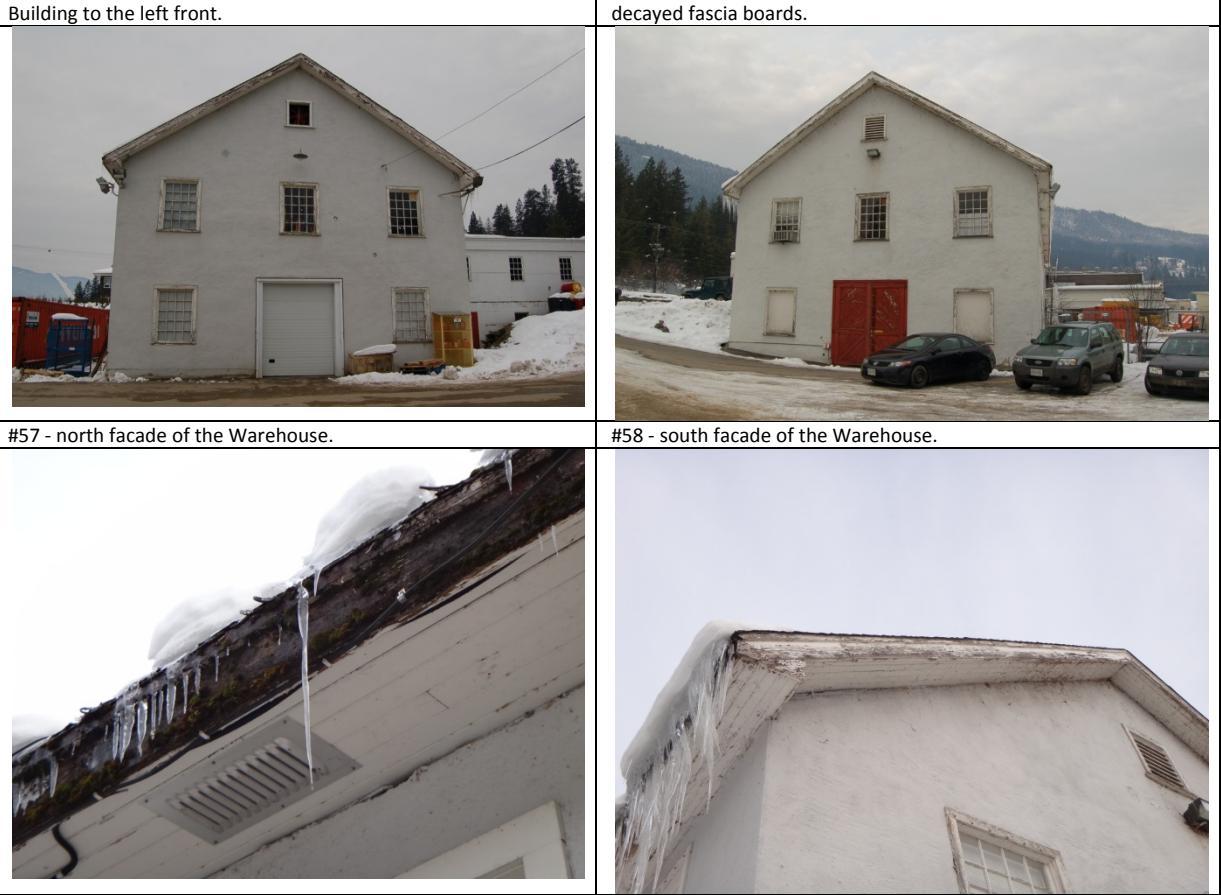
#59 - decayed wood fascia boards.

#60 - icicle build-up is typical through the winter.

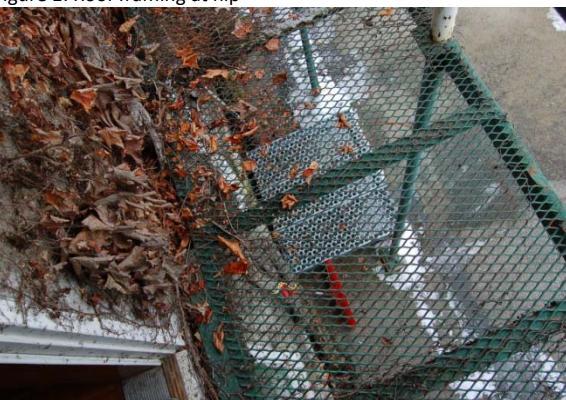
- There are some pressure cracks in the glazing at the main level meeting room on the east side of the building
- Fire escapes have been added on at a later date. The deck mesh grating deflects considerably and is inadequate for the load

Figure 3: Fire escape grating

4. Replace deck grating with properly rated decking - this is a safety issue and should be addressed immediately

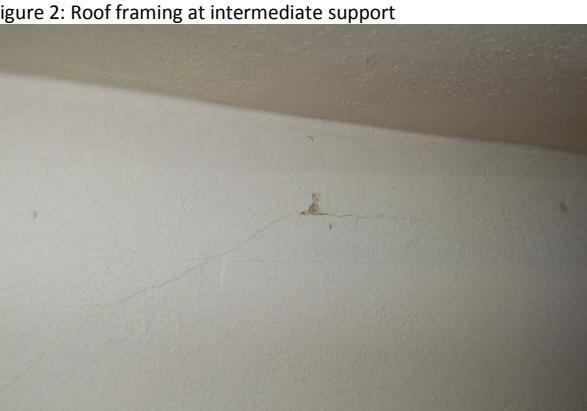
- A number of vines are growing on the south side of the building. Good practice is to remove the vines.
- There are numerous plaster cracks, some of which have been repaired, throughout the interior of the building suggesting that the building experiences constant movement likely due to changing weather conditions and possible ground movements

Figure 4: Cracks in plaster

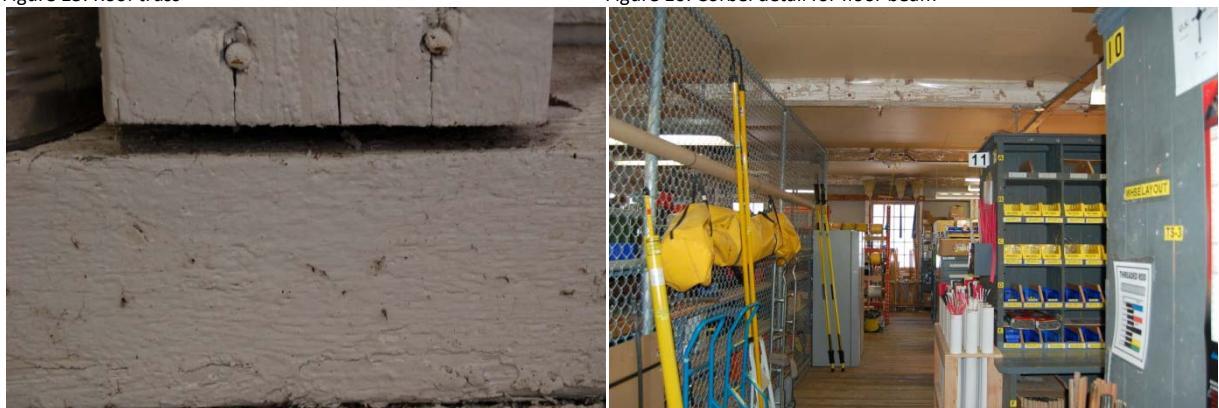
Figure 17: East wall lower floor, gap under post in wall due to Figure 18: typical upper floor storage settlement

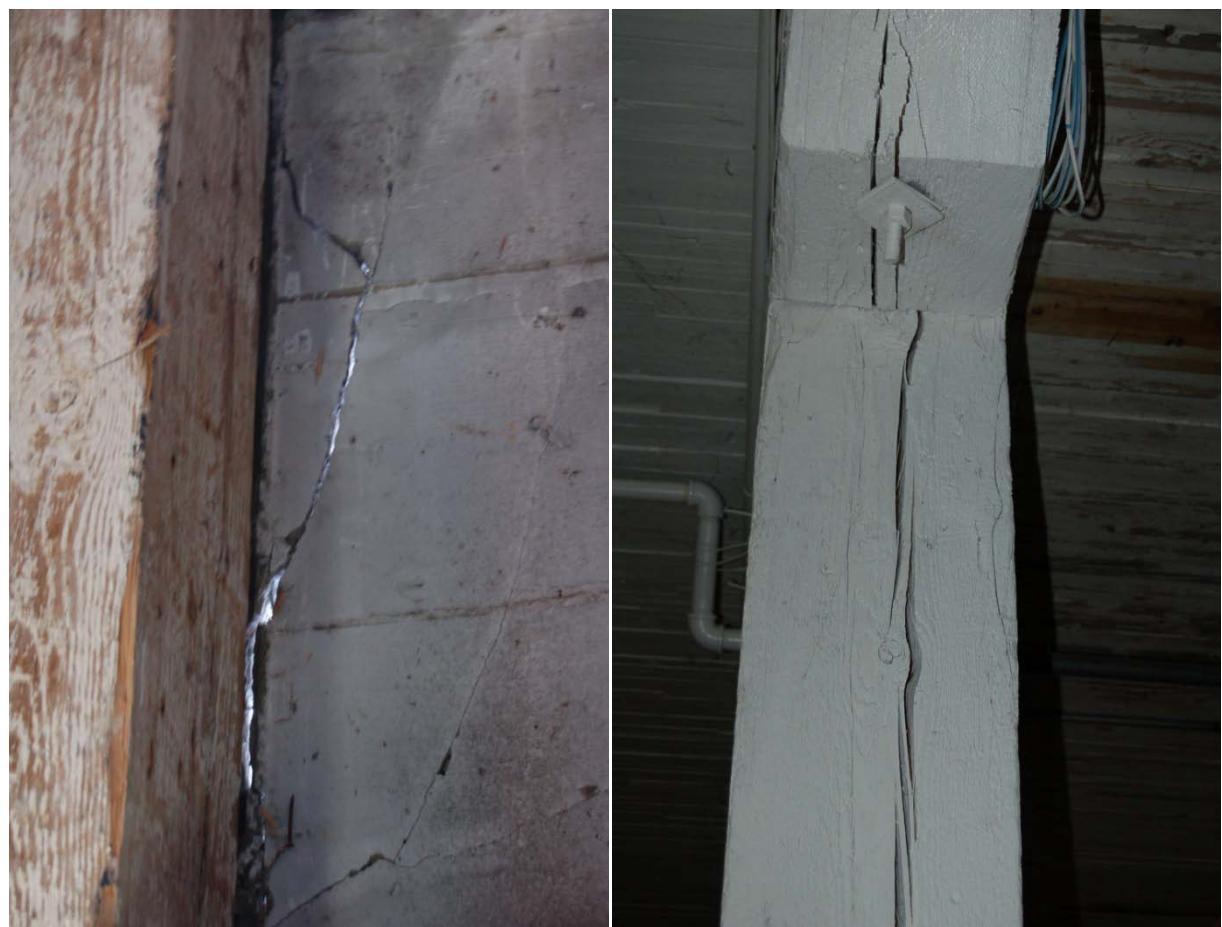
Figure 19: Typical Gunite condition

Figure 20: Typical checking

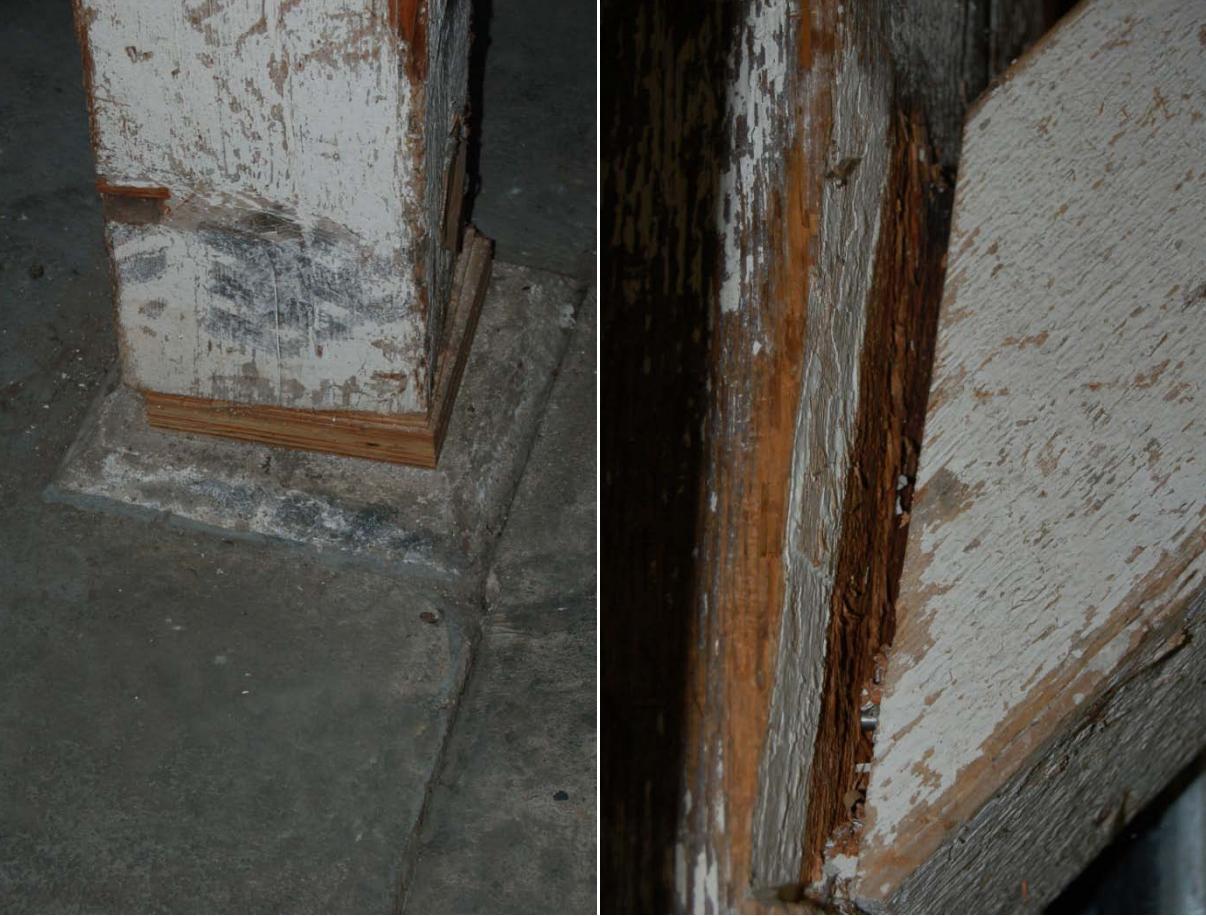
- In the lower floor there are numerous columns that have twisted and are checked
- In the south east section of the lower floor the slab has settled considerably (maximum of about 2 1/2") and shims have been placed under certain central columns. The foundation wall on the east side in that vicinity has also settled and shims and now there are gaps of up to 1 1/2" under the perimeter columns and wall framing in that location. Note that the perimeter concrete foundation wall is not exhibiting any cracking

Figure 21: 2 1/2" Shim under lower floor column - note twist in Figure 22: Truss knee brace pulling away from post on upper level column

- 3. Checking and twisting of truss members no action required other than to monitor the checking if it becomes possible to see through the members then some remedial action may be necessary
- 4. Braces pulling away these should be tightened
- 5. Twisted and checked columns no action required other than to monitor the checking if it becomes possible to see through the column then some remedial action may be necessary
- 6. Settlement a geotechnical review to determine the cause of settlement should be undertaken and then a course of action prepared to restrict further settlement. Shims should be placed under the perimeter wall columns where gaps exist between the bottom of the posts and the foundation wall.
- 7. Slab cracking and settling replace slab
- 8. address water penetration in the spring thaw by providing proper waterproofing and drainage on uphill side of warehouse.

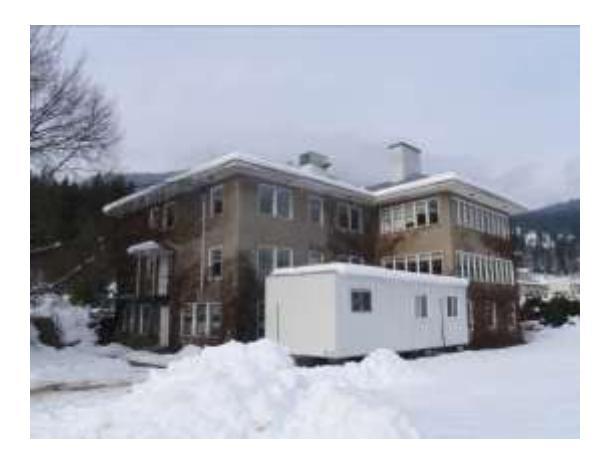
According to WorkSafe BC regulations either fall protection, fall restraint or handrails are required when working on a roof above 4 to 12. To achieve this, at a minimum engineered anchors need to be present. To provide year round access an appropriate roof top hatch and walkway system would need to be installed.

Rooftop unit can be seen perched on the roof

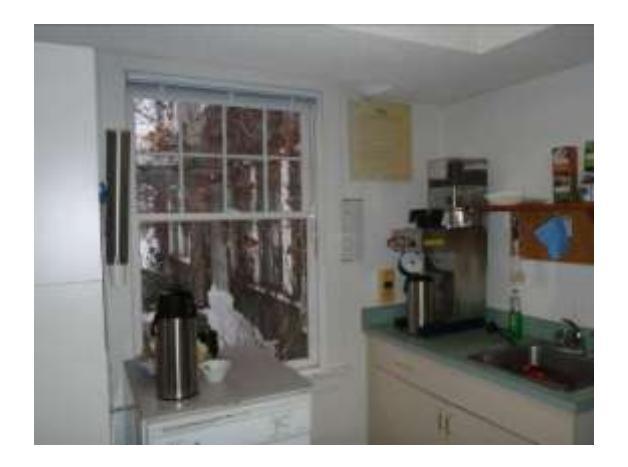
- .5 Staff Room (Basement) Exhaust Fan
- An exhaust fan is present on the South wall of the Staff Room near the coffee machine
  - Expelair model unknown
  - The fan should be cleaned but is in good condition

Staff Room Exhaust Fan

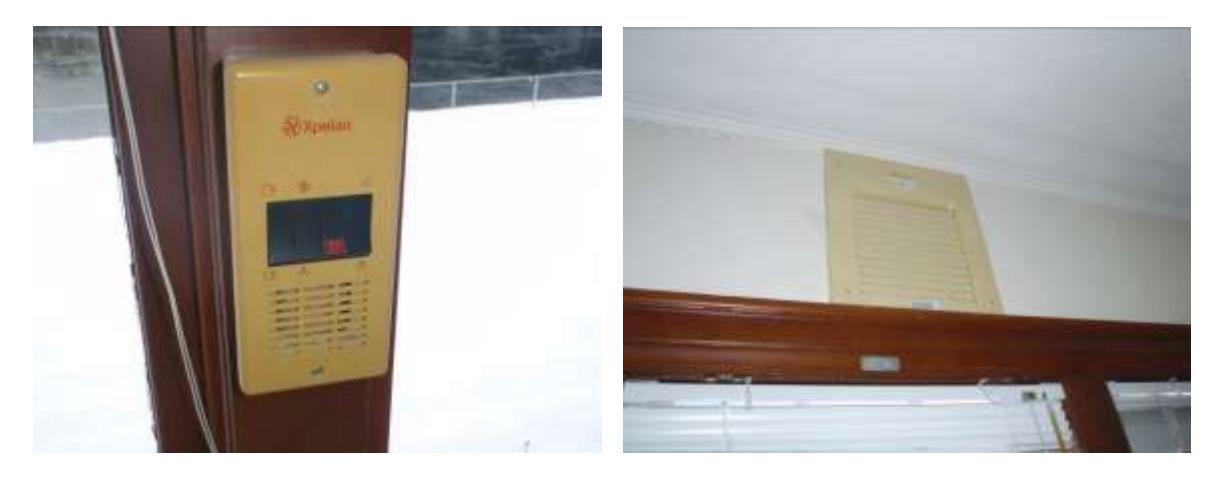
- .6 Main Floor Conference Room Reversible Fan
- A reversible exhaust fan is installed on the East Wall of the Conference Room
  - Xpelair Model WX9
  - The exhaust fan is reversible so it can either provide supply air or exhaust air
  - When the fan was turned on large amounts of dust and debris were expelled however it appears to be in good working order

Reversible Fan Controls Unit

Reversible Fan

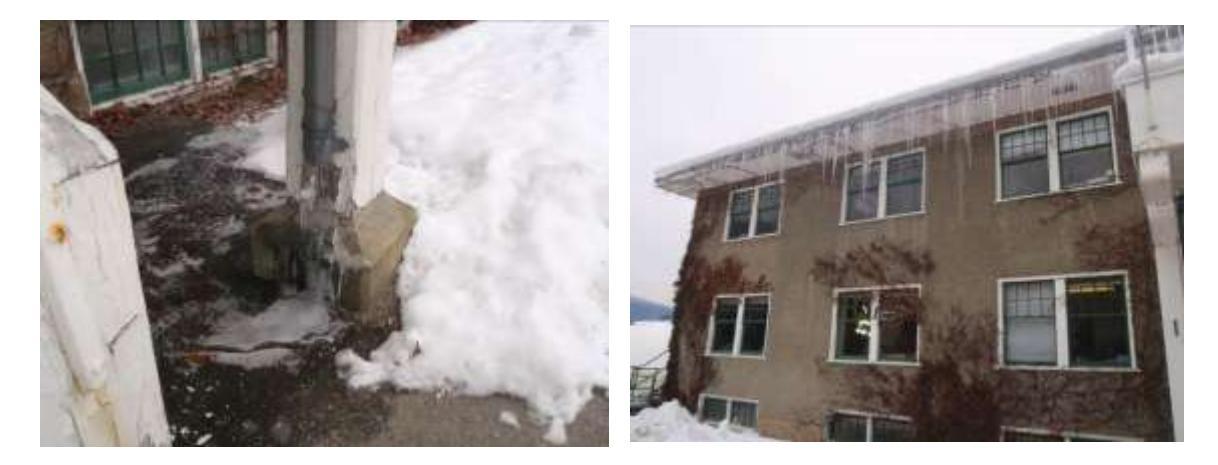
- .1 Storm Drainage:
- There is a gutter around the entrance area roof
  - The down spout diverts storm water away from the entrance way
- There is no gutter around the main building
  - Icicles have built up and are at risk of falling off posing a potential danger to workers

Down Spout from the gutter around the entrance way

Icicle build up

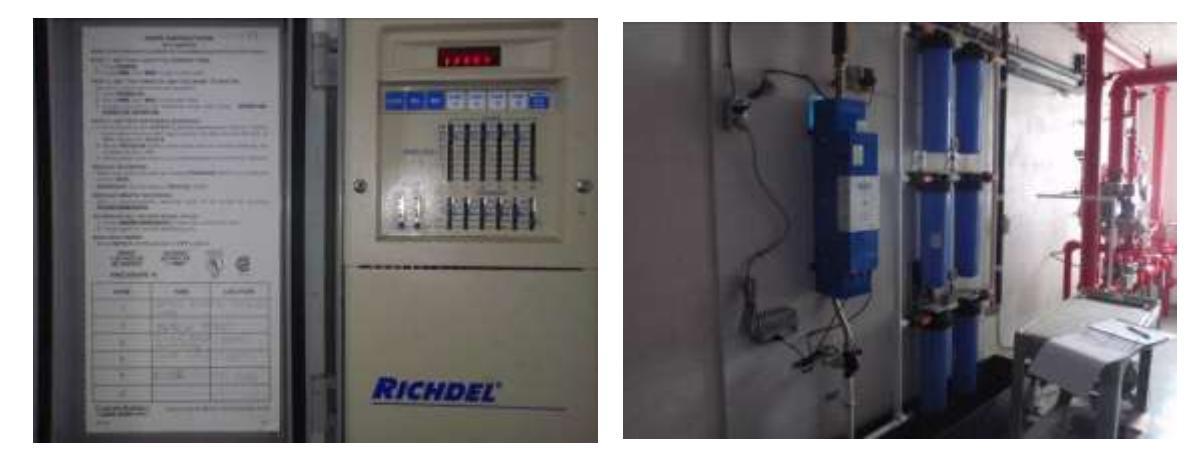
No premise backflow prevention device was observed on site

Irrigation Controls

Hallett Filtration System

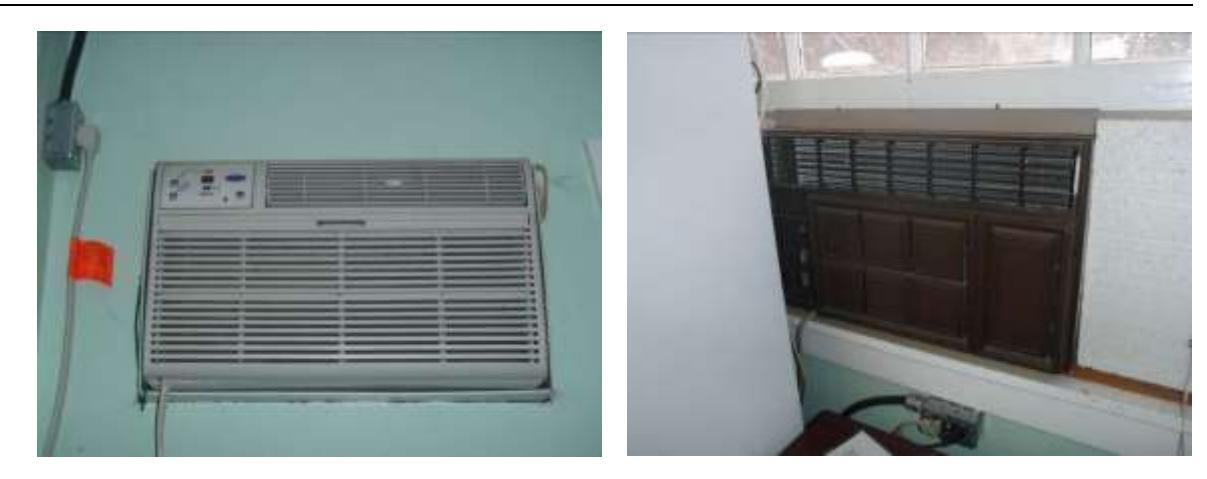
- .2 Window Type A/C Units
- Two window type A/C units are installed in the office area
- The newer one is not functioning
- Older one is working fine
- Window type A/C units are noisy

Non-Functional Window Type AC Unit

Operational Window AC Unit

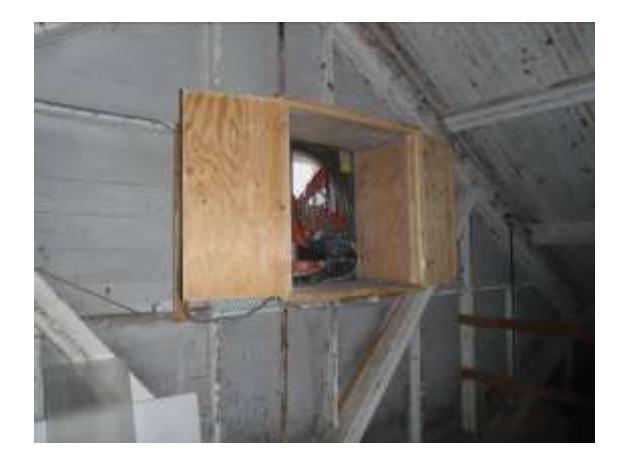
- .3 Exhaust Fan
- There is a 30" dia, ½ hp axial fan located in the attic
  - Dayton Model 3C146A 30"
  - Intake opposite the gable is dirty
  - Attic space is unheated
  - Fan is functioning however it is near end of life

Attic Exhaust Fan

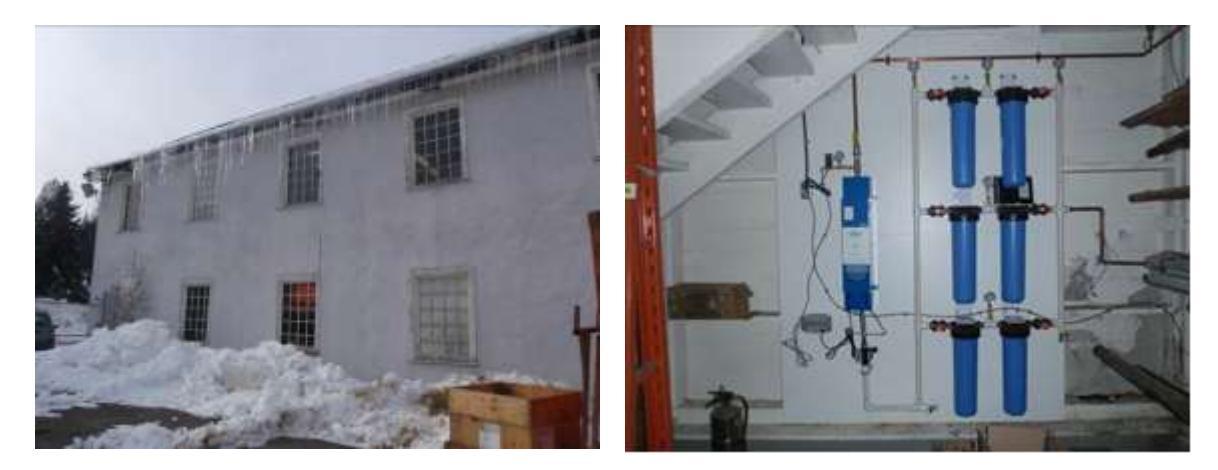
- .1 Storm Drainage:
  - There is no gutter around the building
    - Icicles have built up and are at risk of falling off posing a potential danger to workers

Icicle Build Up

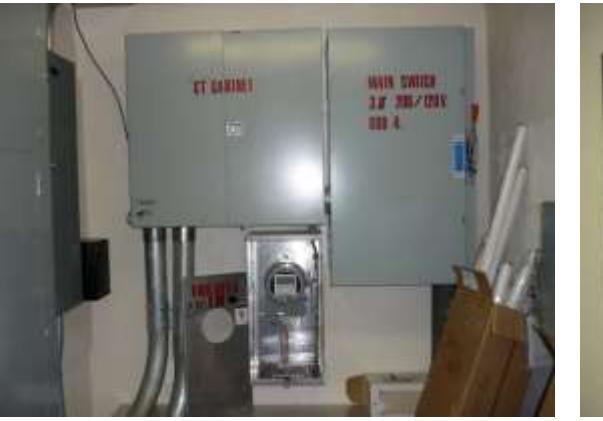
Main power service (600A 120/208V 3ph/4w) and distribution was upgraded in 1987. Feeders are copper. System is in poor condition due to the system age. Main electrical room is clean and dry. Equipment layout is in compliance with CEC (Canadian Electrical Code). Remaining antiquated fuse-style panel on Upper Flr adjacent to Pnl D; use of screw-in fuses in this panel cannot properly ensure that correctly rated fuses are protecting circuit wiring. Branch circuit panels are 95 to 100% filled; little to no capacity for additional circuits. Peak power demand observed to be 85.2kW ie. 49% of Electrical Code allowable for the existing equipment service size.

FortisBC meter, CT cabinet & Main Switch

<u>Recommendation</u>: Equipment should be modernized as the equipment is nearing end-of-life. If modernization is not immediate, all branch circuit panel breakers less than 100A should be tested and replaced if required with new of the same rating due to degradation of performance from age. In the immediate time frame, an infra-red thermographic scan should be conducted on all major electrical distribution equipment to identify any hot spots due to poor electrical connections at cable terminations points. FortisBC staff not aware of any testing done within the last 10 years. Equipment to be scanned should include:

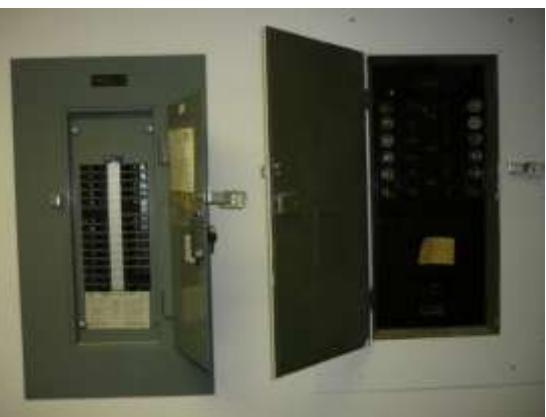
<u>Observations</u>: Main incoming service is a 600A 120/208V 3ph/4w fed from an exterior pad mounted FortisBC 300kVA transformer. Distribution equipment is in poor condition due to present age. Branch circuit panels are relatively full and have limited to no capacity to add circuits. Feeders are copper and noted to be wires in conduit or armoured cables. There is one pre-1940 screw-in fuse style panel observed at one location on Upper Flr in very poor condition.

Upper FIr PnI D & old screw-in fuse style panelboard

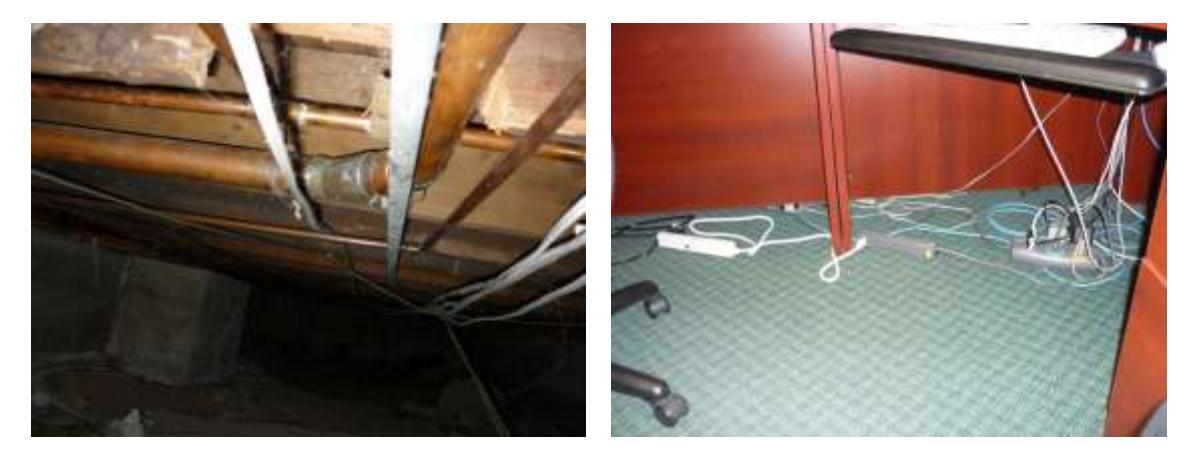
Original wiring is wiring in conduits. Observed existence of old non-metallic cables with cloth sheathing (in crawl space). Combination of NMD (non-metallic dry) cables, BX (armoured cable) or wire in EMT conduit are primarily in use for circuit wiring in the building. Observed newer wiring (NMD) in corridor ceiling space

is inadequately supported per CEC. Branch circuit wiring in aging receptacle outlets observed to be copper. Inadequate quantity of receptacles within offices – observed excessive use of extension cords and power bars.

<u>Recommendations</u>: Replace remaining old non-metallic sheathed cables insulated with cloth or plasticized rubber sheathing (in crawl space) with new NMD or armoured cable - this insulation is susceptible to failure from aging and rodents and could lead to electrical fires. Provide additional receptacles in offices.

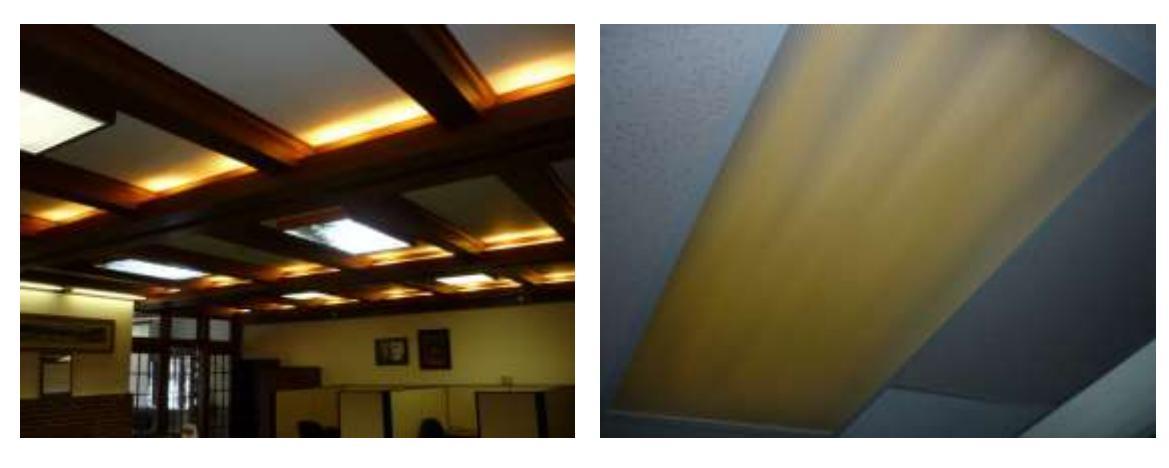
Combination of recessed 2x4 ceiling and surface mounted fluorescent luminaires of varying ages. Lamps consist of a mixture of T12 and T8 linear fluorescent lamps. Observed some use of incandescent lamps in porcelain lamp holder in maintenance and closet spaces. Majority of luminaires utilize inefficient T12 4-foot fluorescent lamps/ballast. T12 lamps are no longer manufactured, banned from manufacturing due to energy inefficiency. T12 lamps on store shelves are last stock available. Lighting levels in general are adequate in offices, storage areas and corridors. Power lighting densities in offices range from apprx 2.5 to 3.9 watts/sf; this exceeds the ASHRAE 90.1 2004 (BCBC 2012) of 1.1 watts/sf. Observed on Upper Flr corridor and offices that 2x4 recessed ceiling fluorescent fixtures are not seismic restrained. No automatic lighting shutoff control in offices (enclosed rooms) as required per ASHRAE 90.1 2004 (BCBC 2012).

Upper FIr Technical Library/Office

Typical recessed 2x4 office/corridor luminaire

<u>Recommendation</u>: Any proposed renovation work affecting lighting is required to comply with ASHRAE 90.1 2004 and will require new luminaires with higher energy efficiencies, utilize less power to produce more lighting and employ lamps that are or in foreseeable future, not on the banned manufacturing list. Upgrade will require automatic lighting control system. Check and ensure all light fixtures are seismic restrained as mandated by BCBC.

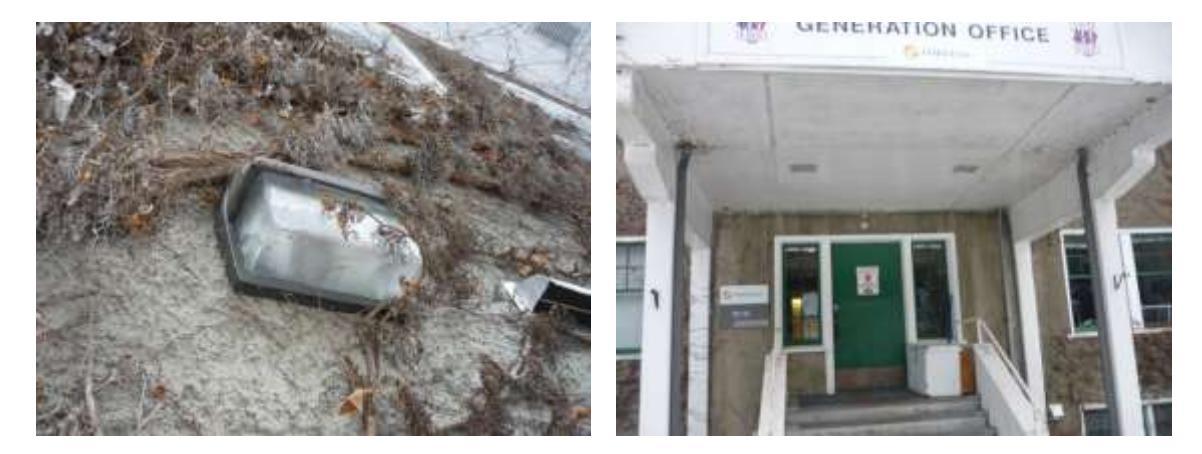
<u>Observations</u>: Surface mounted and recessed soffit HID HPS luminaires. Housings appear in average condition for the environment and the application, slight discoloration of lenses. Observed use of incandescent lamps in unprotected (no wireguard) surface mounted fixtures at two egress locations. Based on suspected age of luminaires, ballasts and lamps may not meet current Energy Code.

Exterior luminaires observed in day light conditions – not illuminated. Consists primarily of surface wall mounted and recessed soffit HID HPS luminaires. Housings appear in average condition, little discoloration of lense. Observed use of incandescent lamps in unprotected (no wireguard) surface mounted fixtures at two egress locations. Timer controlled. Noted vine overgrowth around wall mounted luminaires.

Exterior wall-mounted HID luminaire

Main entrance with recessed HID luminaire

<u>Recommendation</u>: Monitor operation of exterior lights for lamp and/or ballast failure. When replacement required, luminaires to meet ASHRAE 90.1. Remove vines from surrounding luminaire.

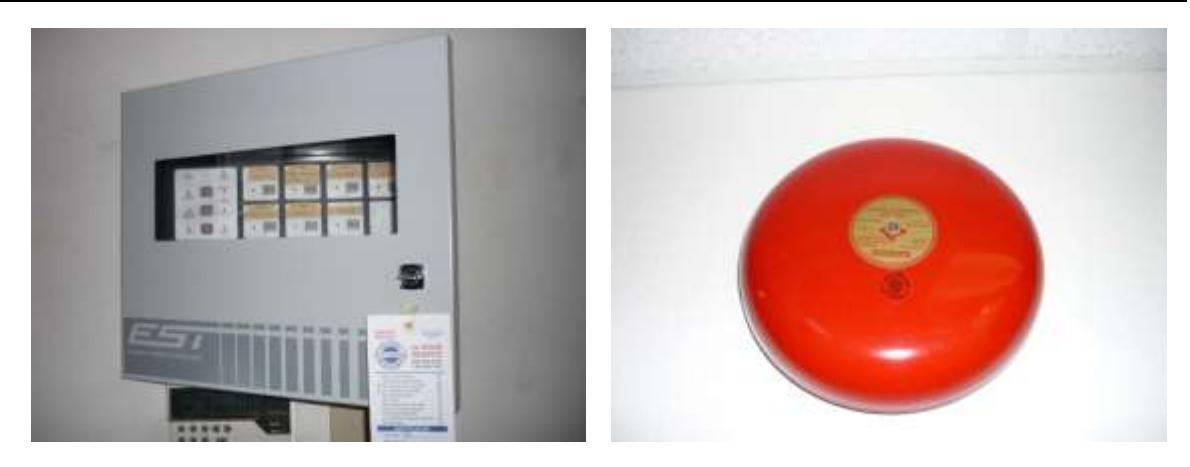
<u>Observations</u>: Outdated fire alarm system subject to difficult maintenance issues. Fire alarm zone annunciation requirements are in non-compliance with BCBC sentence 3.2.4.8 2)b)i. Missing code-required manual stations at two Lower FIr corridor egress locations and at top of Upper FIr stair locations. Central vacuum system not tied to fire alarm system as required. FA system was last verified in August 2012.

Fire alarm system is an analogue Edwards EST1 – 2Z3, with 6 active zones (Lower FIr, Main FIr North, Main FIr South and Upper FIr, Sprinkler Wet, Sprinkler Dry, AC Shutdown); there are two spare zones. Components include single-stage manual stations, 10" dia fire alarm bells, heat and smoke detectors, sprinkler flow and tamper switches; there is no tamper-switch on the double check main water supply valves – chain locked only. The annunciation of the zones do not comply with BCBC 3.2.4.8 2)b)i – specifically, separate zone annunciation is required for the Upper FIr and cannot be combined with the Main FIr South. Sprinkler zones should annunciate by floor level; current installation does not provide this specific floor identification. There are no manual stations at the doors exiting the building via Lower FIr Hallway 25 or Conf/Staff lunchrm, and no manual stations at top of Upper FIr stairs leading to Main FIr as required per BCBC. System is out of production and adequate for current use but parts will be more difficult to acquire. Maintenance issues may escalate as components fail at this stage in equipment near end-of-life. System last verified in Aug 2012. Central vacuum system is required (per BCBC 3.2.4.13) to be interconnected to the fire alarm system to shut-down upon fire alarm. No indication that this is done.

Fire Alarm Control Panel at Main Lobby

Typical 10" fire alarm bell

<u>Recommendation</u>: The fire alarm code deficiencies (proper zone annunciations and additional manual stations at exits) should be rectified to be Code compliant. The existing fire alarm panel is recommended to be replaced due to the age of the system as commented above.

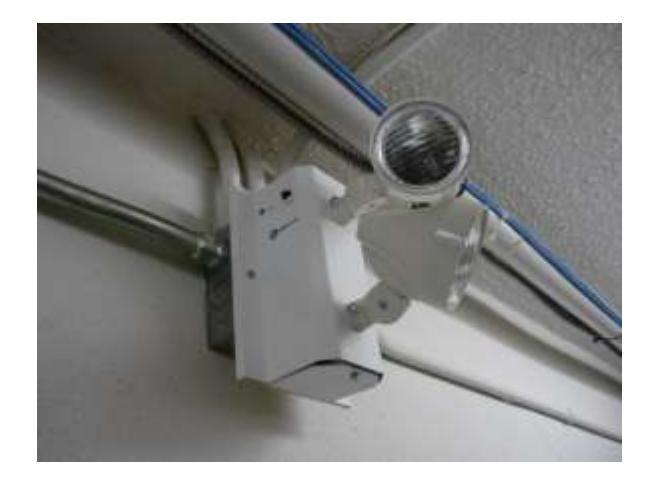
Emergency battery heads not wired to illuminate with failure of local lighting circuits as is good engineering practice. Not all areas of the Lower FIr (Document Storage, Drafting, Fireline/Records, Hallway to First Aid,
Lunch Rm) provided with emergency heads. Upper and Main Floors provided with EM heads at top entrances onto stairs but central floor areas (Reception area, Technical Library) lacking. No tags on EM battery units to indicate date of last testing. Spot test of a few battery units indicate fully charged and operational battery/head combinations.

Typical DC battery emergency double-head

<u>Recommendation</u>: Provide additional EM battery lighting in select areas on the Upper, Main and especially Lower floors. Retain services of a qualified testing agency to certify proper operation of the existing emergency battery and heads; tag with verification tag.
