July 9, 2015

#### Re: FortisBC Inc. (FBC or the Company)

## Application for a Certificate of Public Convenience and Necessity (CPCN) for the Kootenay Operations Centre (the Application)

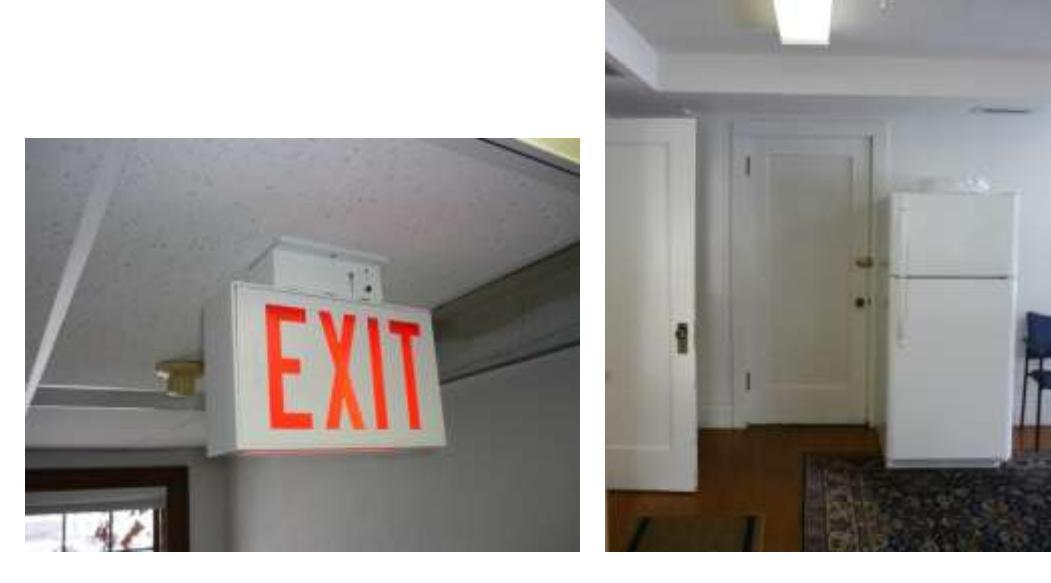
<u>Observations</u>: The exit signs are near their expected life expectancy. The exit signs are in proper locations to provide guidance of occupants to exits. Two locations in Lower Flr (Staff Lunch Rm and Document Storage) are noted to be without exit signs above doors to exterior.

Exit signage are early generation LED and in general, provided at required locations at above stairs and above Exit doors to exterior. Two locations in Lower Flr (Staff Lunch Rm and Document Storage) should have Exit signs above doors to exterior. General placement of exit signs for guidance to exit door locations within floor areas appears adequate. Unable to verify connection to DC circuits.

Exit sign Upper Flr South Corridor

Staff Lunch Room with no Exit signage

<u>Recommendation</u>: Replace all existing with new higher efficiency LED-lamped exit signs. Provide Exit signage at two door locations to exterior on Lower Flr as required by Code.

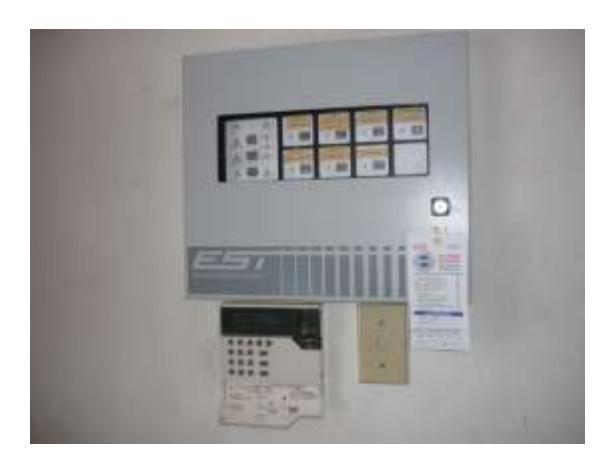
Existing security panel is a DSC Maxsys multizone system with motion detectors providing coverage on the Lower Flr areas. There are no door contact zones. Coverage is limited and does not appear that the system is heavily relied upon.

Security panel below FACP in Main Lobby

<u>Recommendation</u>: Assess requirement of the system and augment to provide better coverage of windows and doors with the addition of magnetic contacts in addition to the current coverage via the installed motion detectors. Recommend replacement of existing system with new due to excessive age.

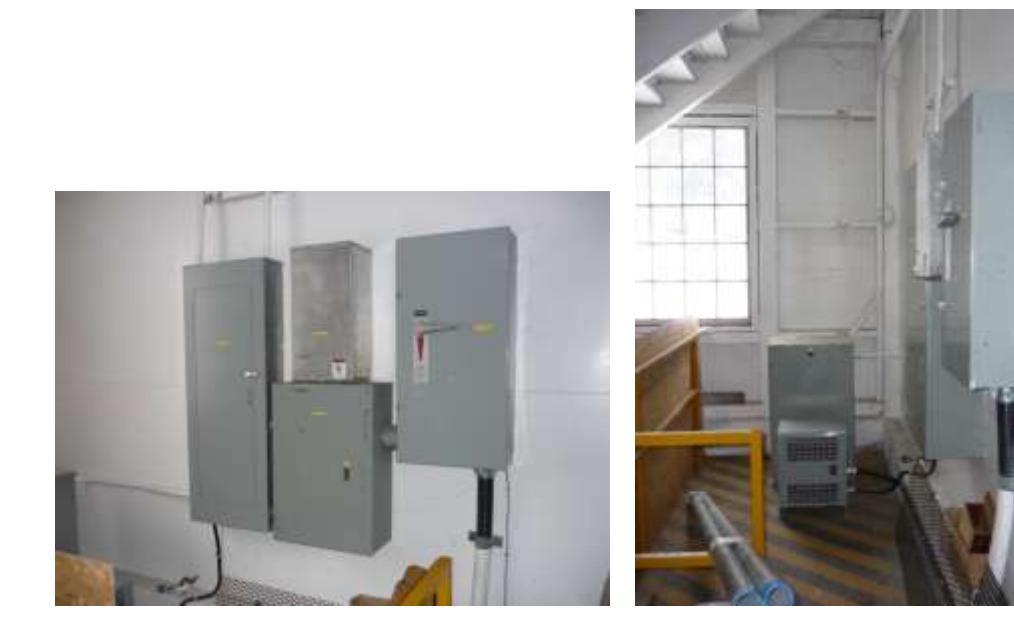
<u>Observations</u>: Main power service (400A 347/600V 3ph/3W) and distribution upgraded within apprx 20-30 years in poor condition based on its estimated age. Main feeders are copper. The service feeds power to the Warehouse building as well as the adjacent Paint and Oil Storage building. There is another subfeed (10kVA transformer) to another building identified as "Storage Can".

Main power service (400A 347/600V 3ph/3W) and distribution upgraded within apprx 20-30 years. Feeders are copper. System is in poor condition due to the equipment age. The distribution consists of a 600V 400A main fused disconnect switch, a 50kVA transformer, a 10kVA transformer, CT cabinet, FortisBC revenue meter . Equipment situated in a clean, dry location with Code required adequate maintenance space. Power distribution from the warehouse feeds the Paint and Oil Storage Bldg (70A-2P 120/208V 1-ph 3-wire service) to the west and a Storage facility (50kVA service) to the east. Equipment layout is in compliance with CEC (Canadian Electrical Code). Three branch circuit panels in the building with approx. 12ccts available in total. Peak demand at 100.96kW; 30.4% of Electrical Code allowable value for the existing equipment service size.

Main switch, meter, CT cabinet & distribution panel Transformers in background

<u>Recommendation</u>: Equipment should be modernized as the equipment is nearing end-of-life. If modernization is not immediate, all branch circuit panel breakers less than 100A should be tested and replaced if required with new of the same rating due to degradation of performance from age. For the immediate time frame, an infra-red thermographic scan should be conducted on all major electrical distribution equipment to identify any hot spots due to poor electrical connections at cable terminals breaker connection terminals and cable junction points. Equipment to be scanned should include:

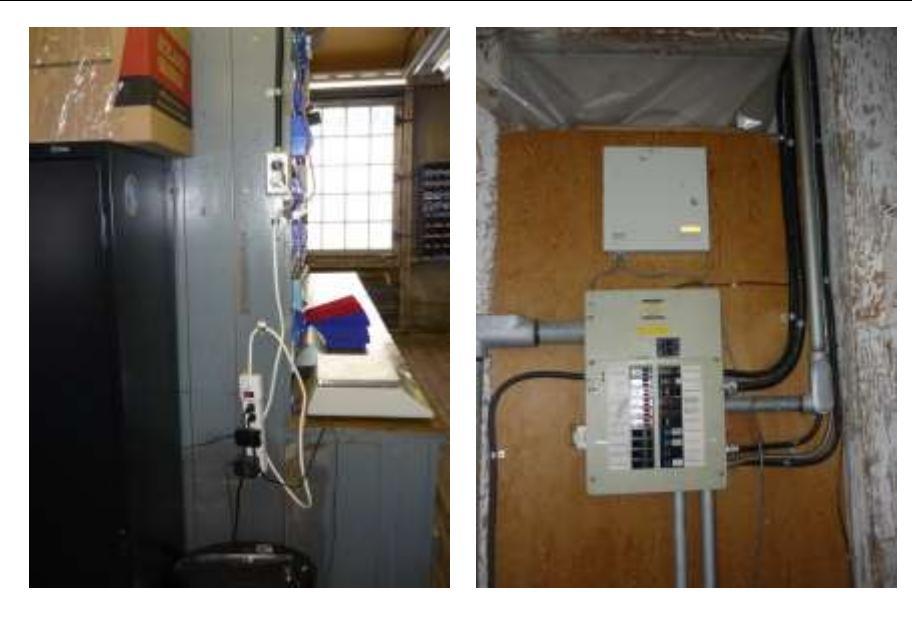
Warehouse area in general has had original wiring updated with wire-in-conduit (some conduits aptly reused for new wiring installation) or armoured cable. Interior space wiring appears to be copper wiring. Dated installed electrical cables (apprx 40yrs old) still in use in minimal quantities. All wiring are exposed and surface-mounted directly to wood structure. Observed very small quantity of old (50+ yrs) non-metallic cloth sheathed (knob-and-tube) or metallic sheathed power wiring in loft; unable to determine if these are energized and currently in use.

Typical installation of receptacles

Branch panel with security panel above

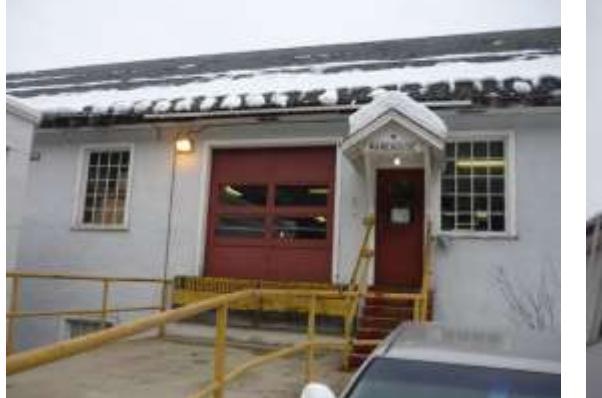
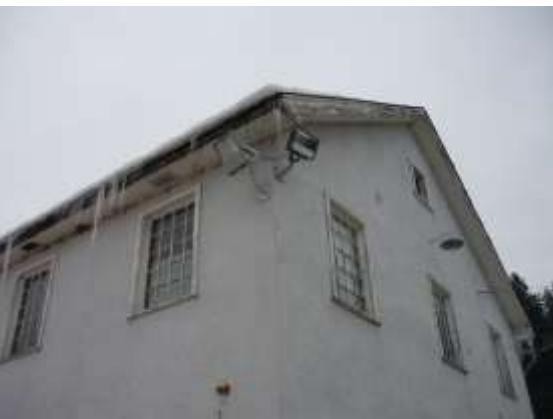
Majority of exterior luminaires observed in day light conditions – not illuminated. Consists primarily of surface mounted HPS wall-cubes and bracket-mounted flood lights at underside of building gutter line. A compact fluorescent lamp in a porcelain lamp holder provides illumination at the underside of the main entrance. A surface mounted HPS wall-cube near the entrance, together with the soffit light was illuminated at 11:00AM suggesting a control schedule issue. Luminaire housings appear in average condition, little discoloration of lenses. All exterior lights appear to be timeclock controlled as exterior lighting turned on upon our departure from site at 4:00PM.

Warehouse main entrance

Bracket mounted flood light at building perimeter

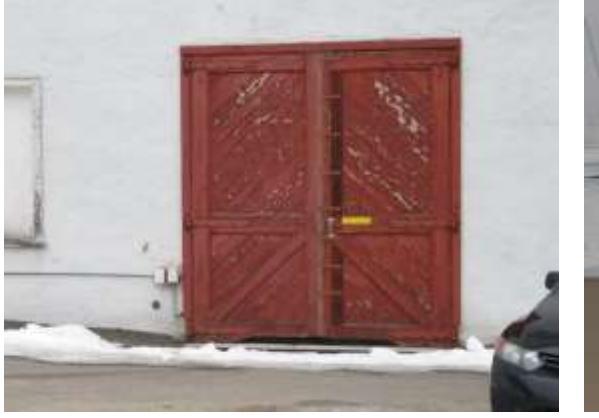
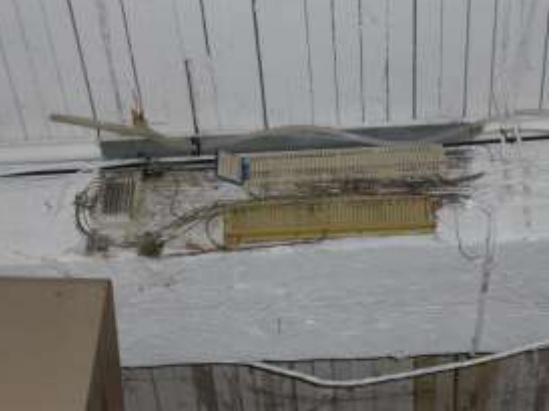
Very limited amounts of data/comm cabling. Incoming underground telephone service appears to enter from south end of building exterior. Only area of data/comm connectivity required is the office on the Main level.

Incoming tel/comm service adjacent to door

Termination/distribution of tel/comm at BIX block

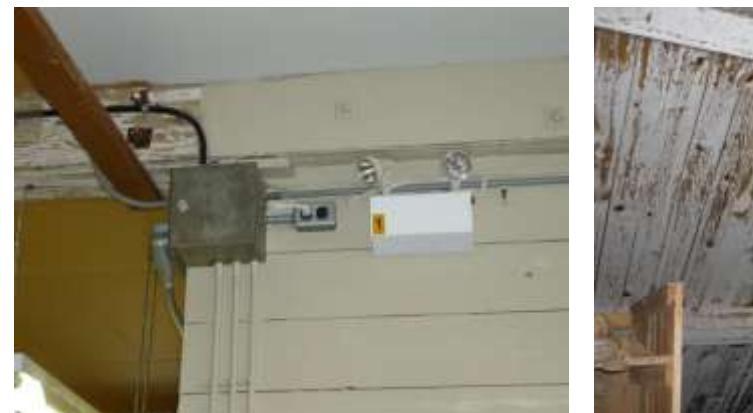
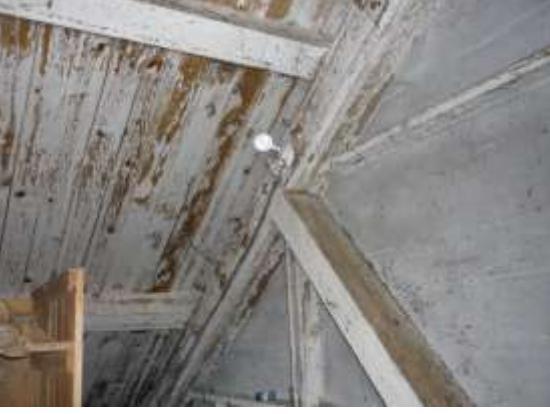
Current installation of emergency DC battery heads for emergency egress illumination is not adequate on each of the three levels. Observed only one set of double-heads in the Loft and Lower floor level and two double-heads on the Main floor. BCBC 3.2.7.3. mandates minimum requirement of 10lux/1FC at tread level along principal routes to exits; existing DC head provisions do not meet this requirement.

Emergency DC battery heads on Lower Floor

Double-heads in Loft by stairs

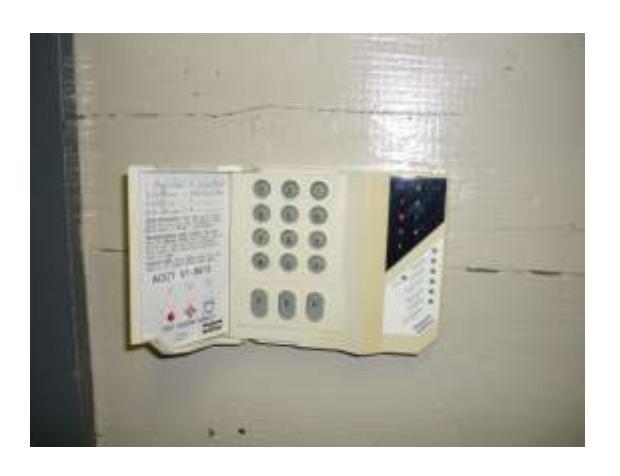
Existing security panel is a DSC PC2550 multizone system with motion detectors providing coverage with the following zones: Main, Lower FIr, Office, Line Shop, Entrance, Front Door . There are no door or window contact zones.

Security panel adjacent to office entranceway

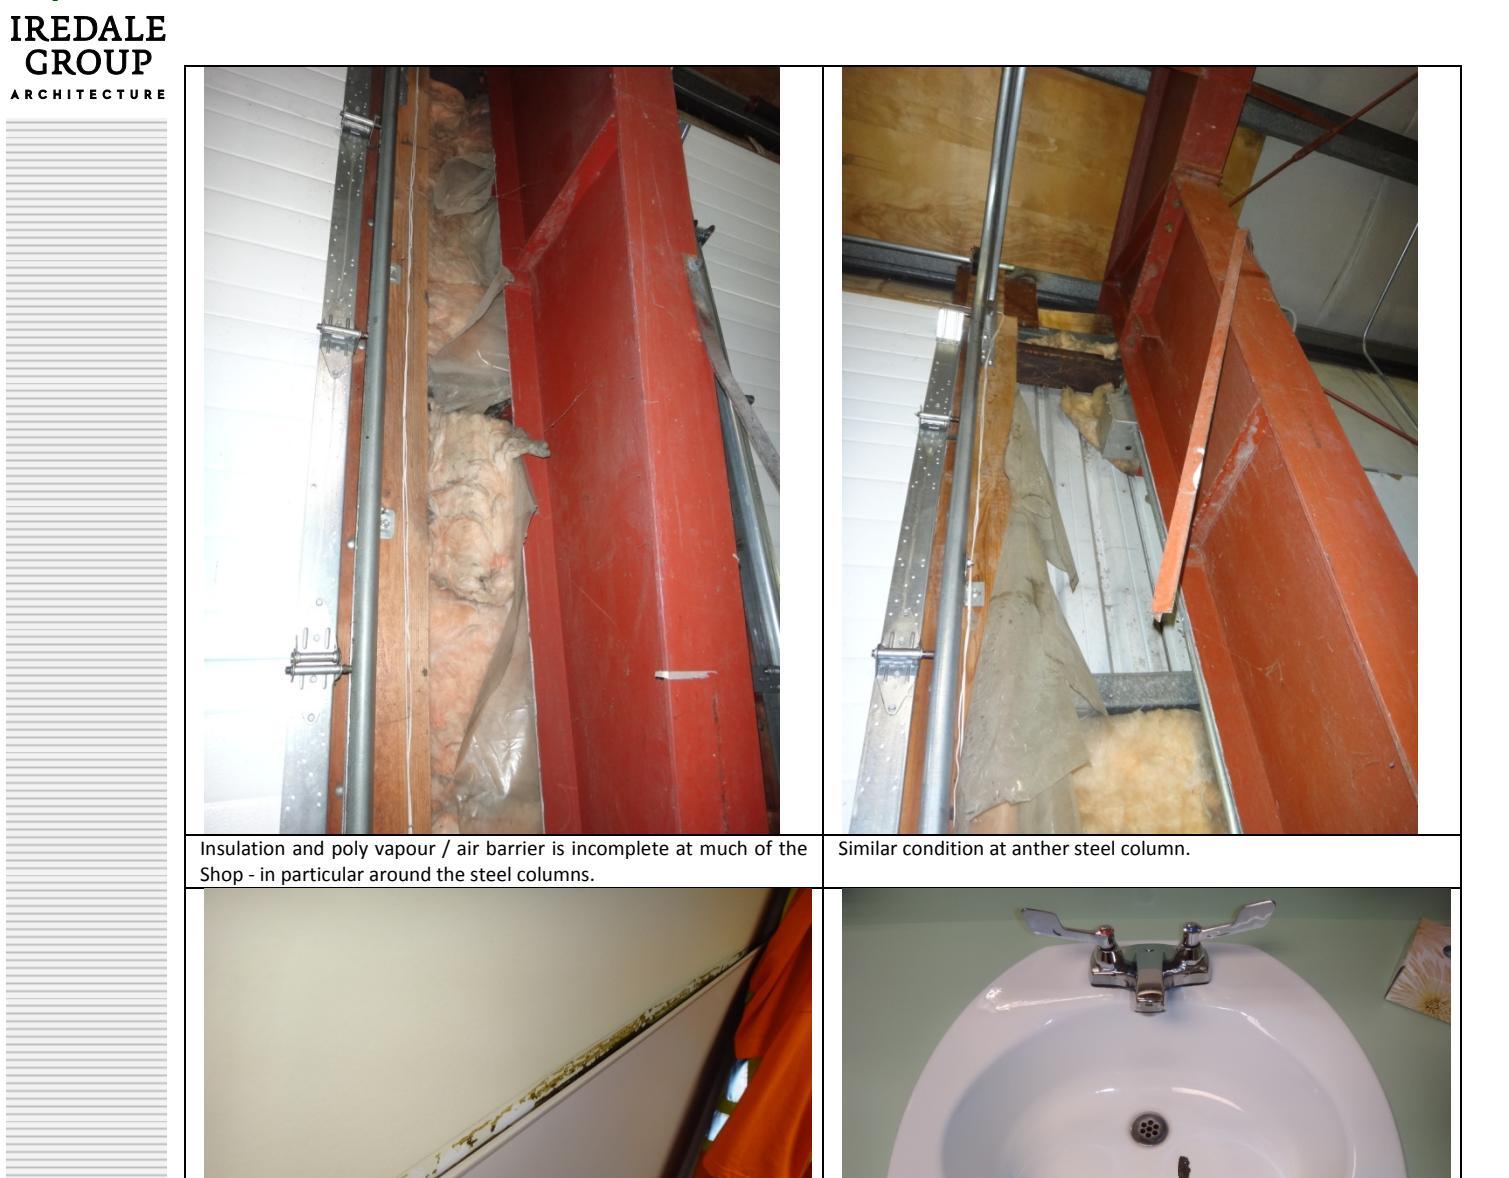
Some interior finishes require repair.
