**AN APPLICATION FOR A  
CERTIFICATE OF PUBLIC CONVENIENCE and NECESSITY**

**COPPER CONDUCTOR REPLACEMENT (CCR) PROJECT**

**June 27, 2008**

**Appendix A: FAILURE INVESTIGATION OF COPPER CONDUCTOR AND MATERIAL PROPERTIES ASSESSMENT**

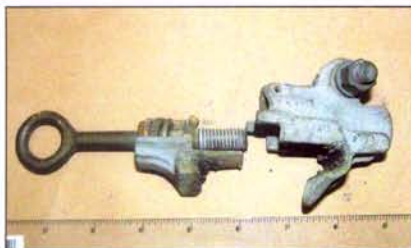
- The hot tap in which the failure occurred consists of a cast aluminum body which is tin coated to prevent galvanic corrosion between aluminum and copper (Figure 1). The conductor failed in the approximate center of the clamp portion of the hot tap (Figure 2).

- The fracture surface and outer surface of the conductor were coated in a sooty black dust likely from arcing in the vicinity of the failure (Figures 2 and 5). The conductor was subsequently cleaned with a corrosion inhibited acid solution to facilitate examination.

Figure 2: View of fractured conductor in hot tap saddle
