Re: An Application for a CPCN for the 2009-2010 Capital Expenditure Plan Project No. 3698519

Please find enclosed FortisBC Inc.'s responses to Information Request No.1 from the BC Utilities Commission. Twenty copies will be couriered to the Commission.

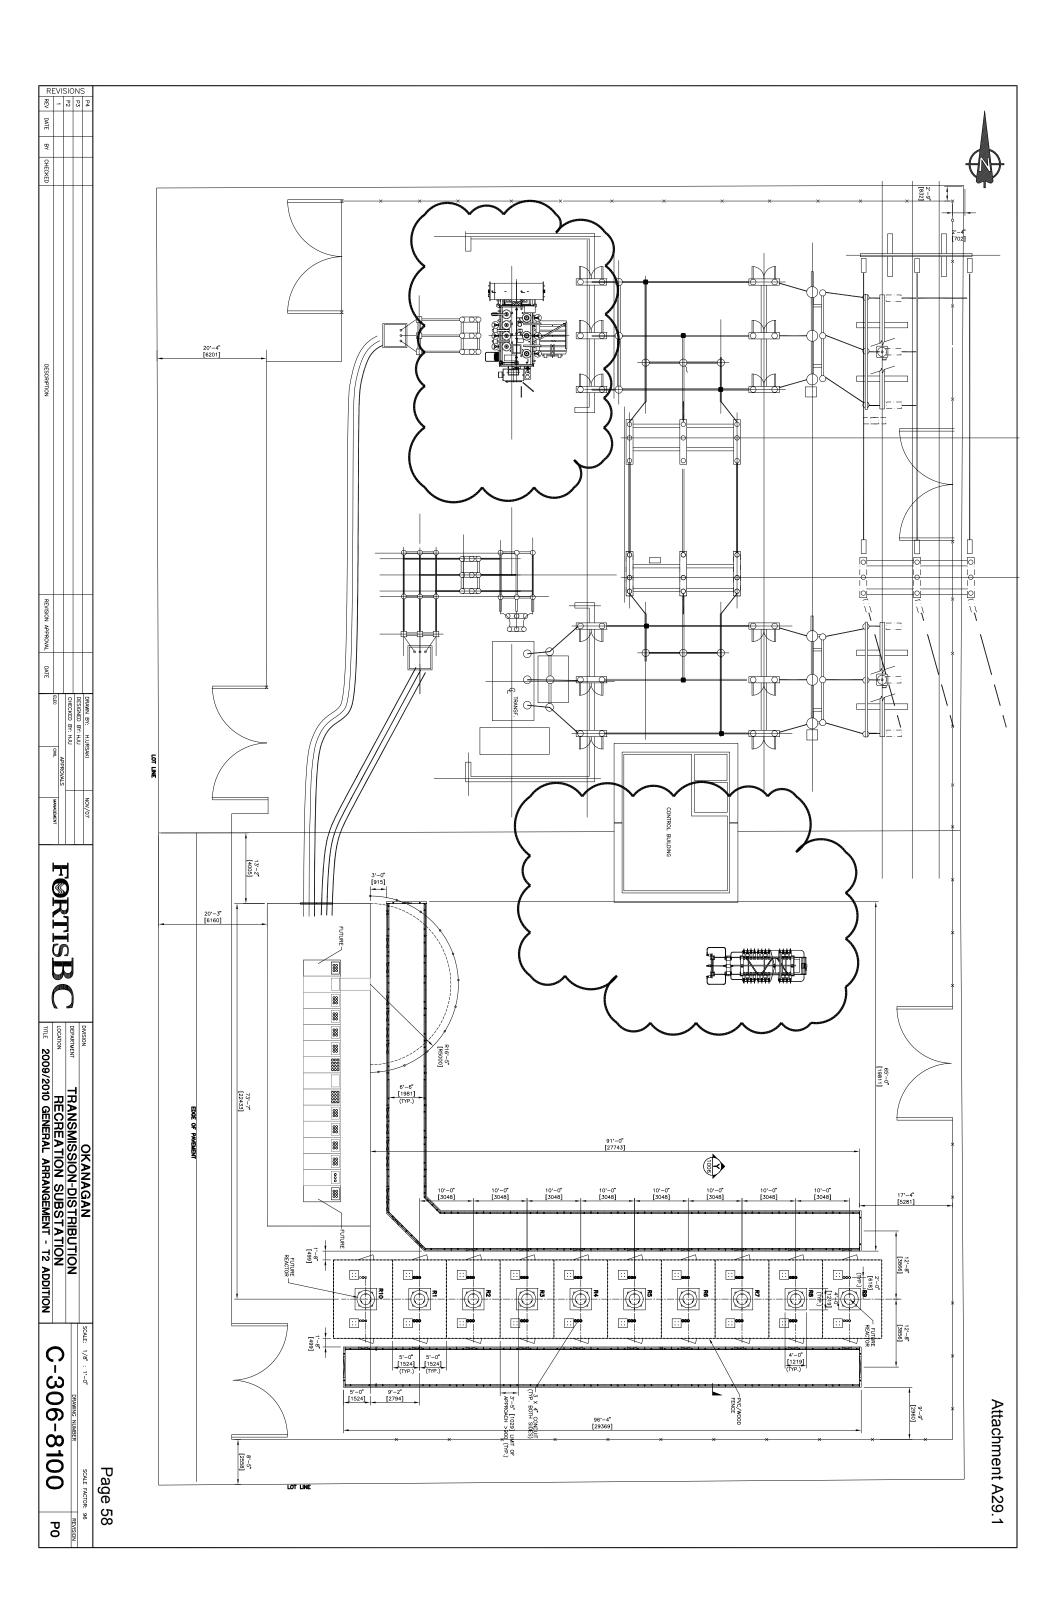
1	29.0	Reference: 3. Transmission and Stations, Transmission and Station
2		Growth Projects
3		Exhibit No. B-1, Recreation Substation, p. 49
4		Siting
5	Q29.1	Would FortisBC please supply conceptual substation and transmission
6		line siting diagrams including footprints and existing as well as new
7		statutory rights-of-way?

8 A29.1 Please see Attachment A29.1.

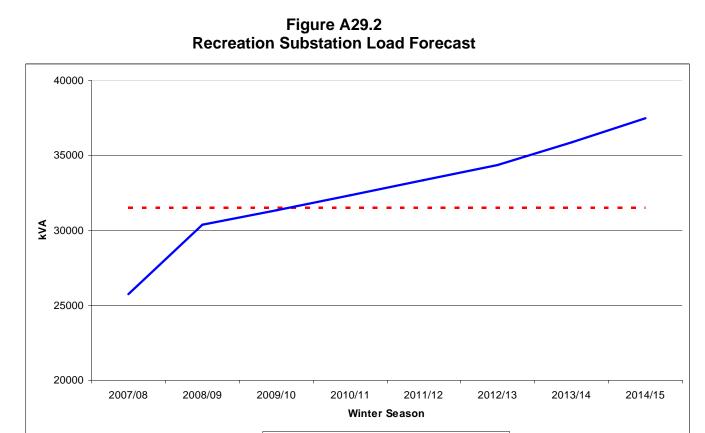
- 3 A29.2 Please see Figure A29.2 below.
- 4 5

1 Q29.2 Would FortisBC please supply the load demand curve justifying the need

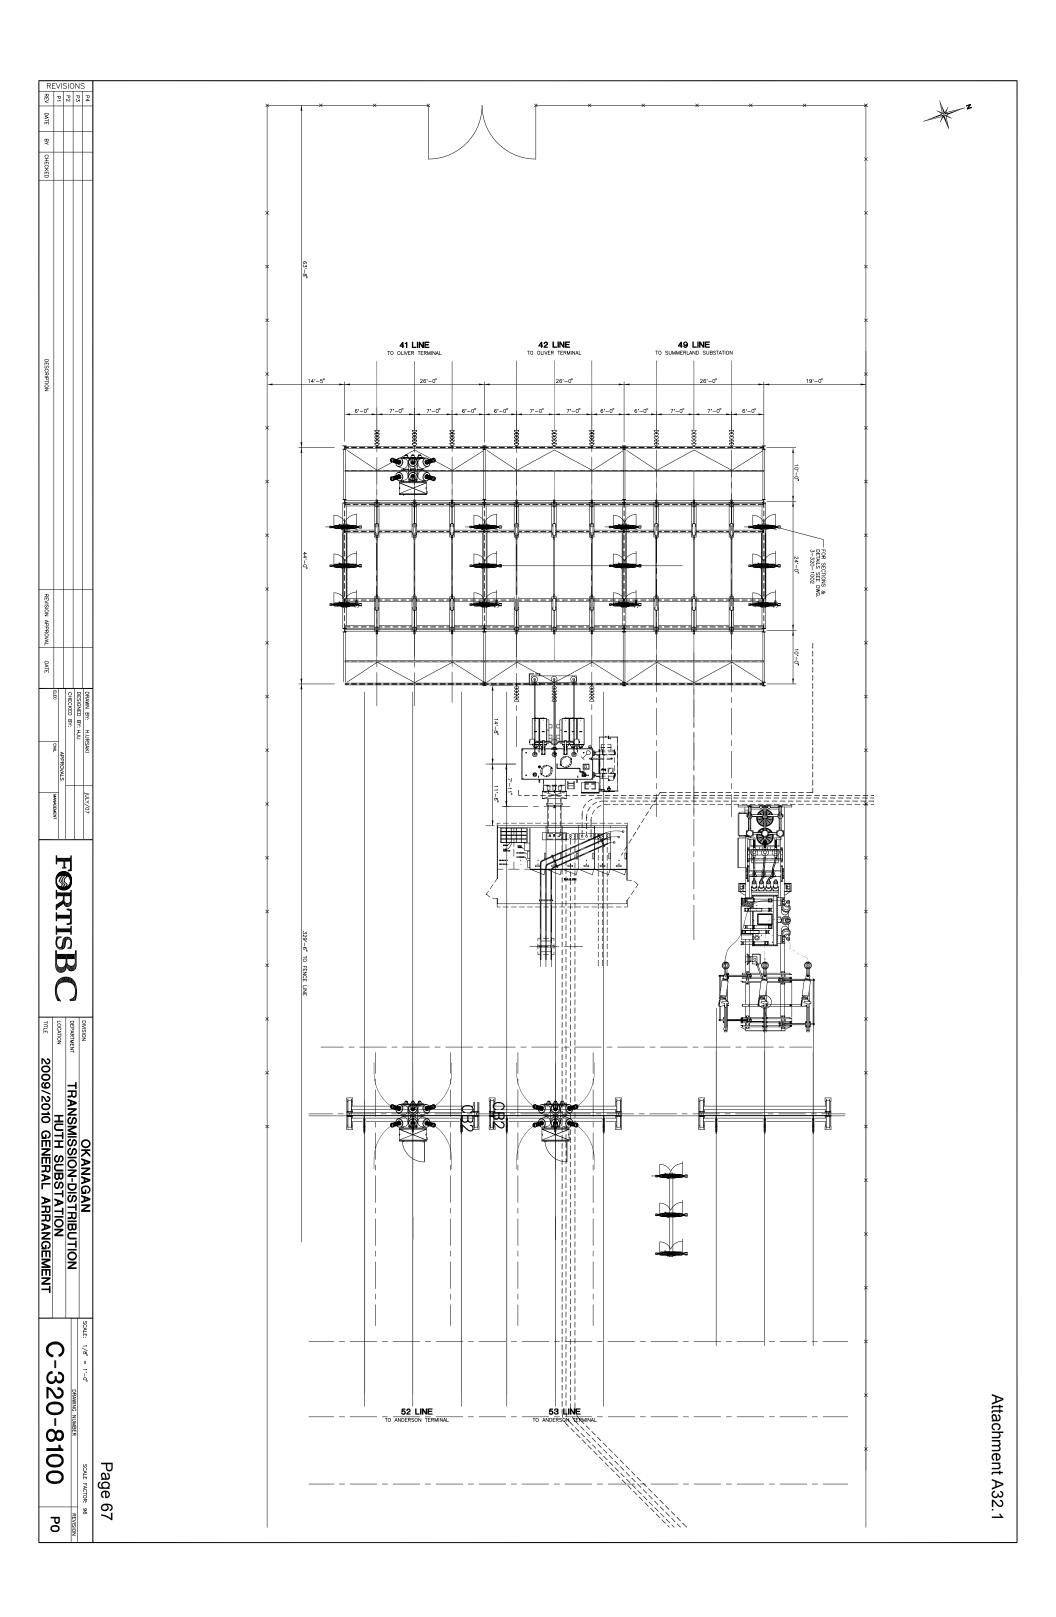
1	32.0	Reference: 3. Transmission and Stations, Transmission and Station
2		Growth Projects
3		Exhibit No. B-1, Huth Substation Upgrade, pp. 51-52
4		Bus Arrangement Modification
5	Q32.1	Would FortisBC please supply conceptual substation and transmission
6		line siting diagrams including footprints and existing as well as new
7		statutory rights-of-way?
8	A32.1	A conceptual general arrangement of the substation work is attached as
9		Attachment A32.1 below. No new rights-of-way are required for either the
10		substation or transmission line work.

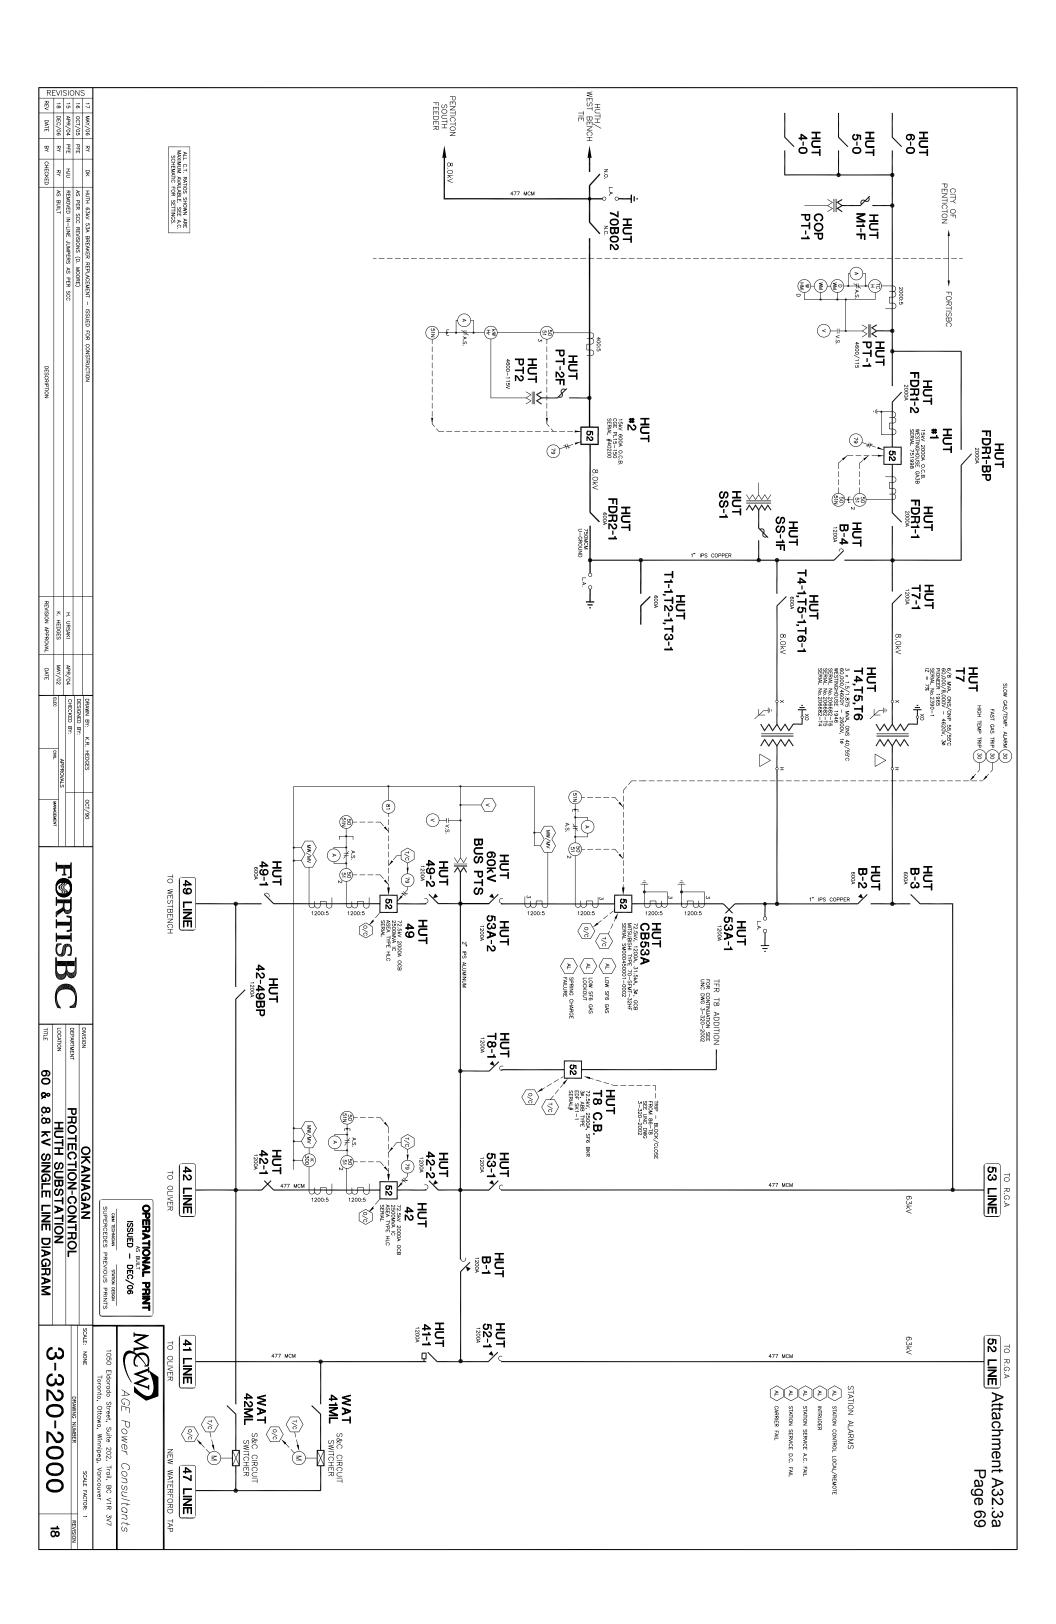
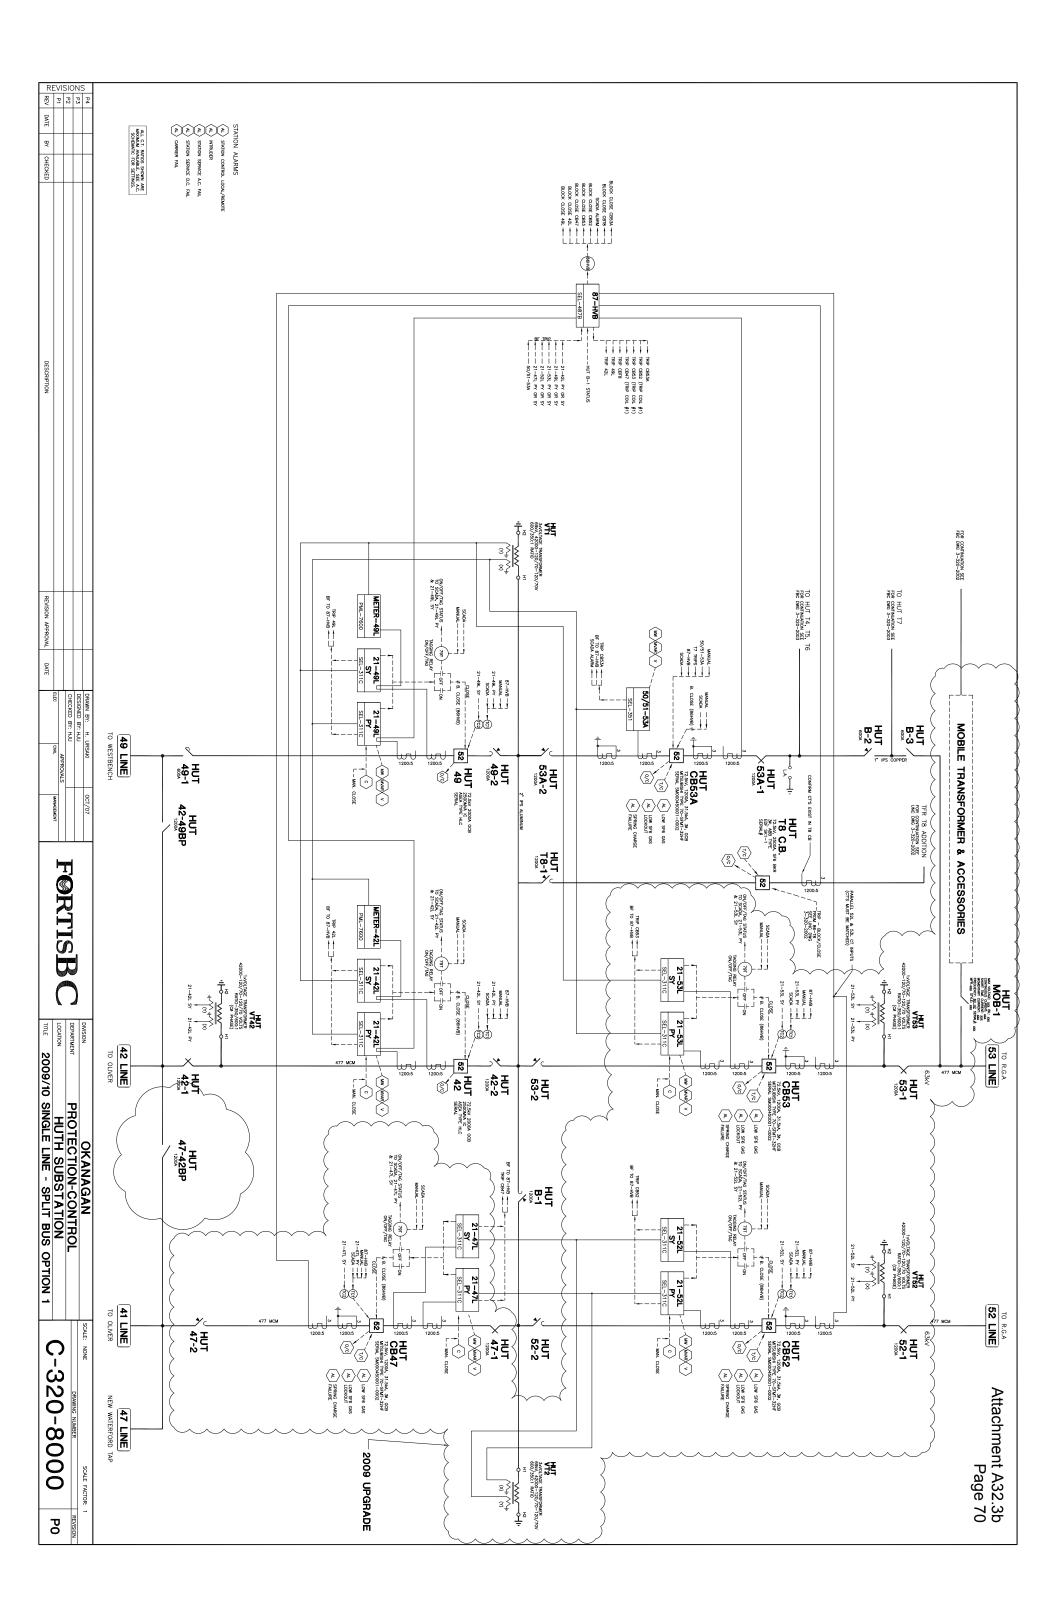
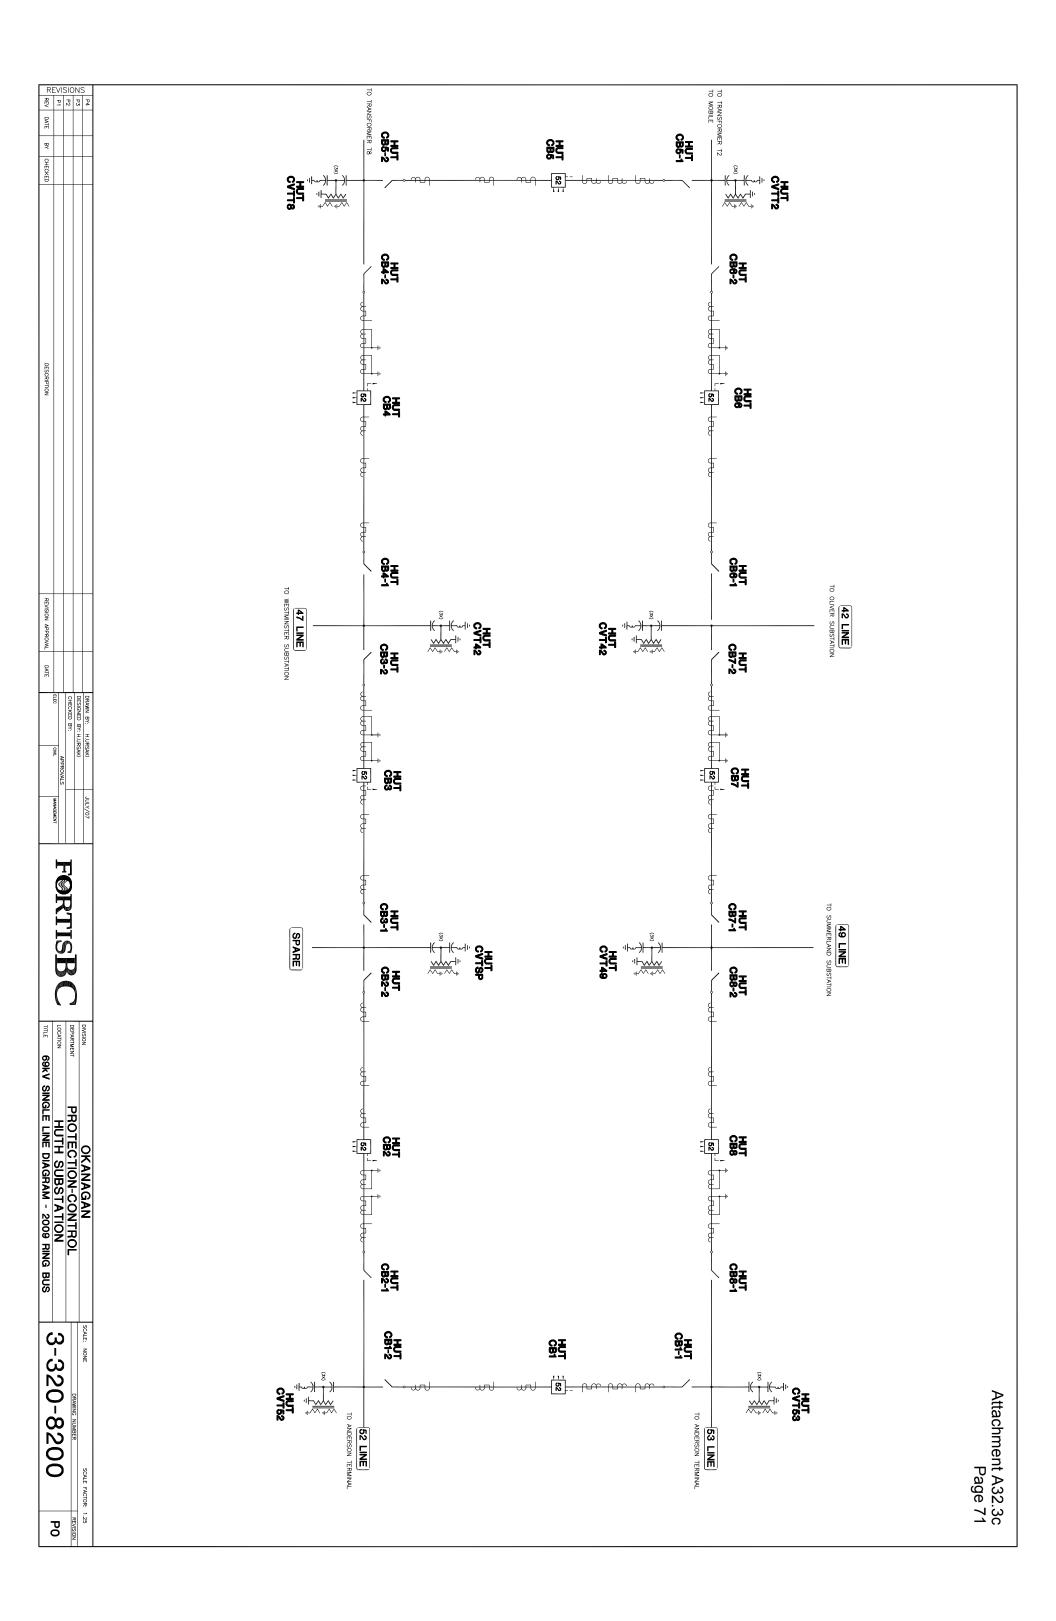
1 2	Q32.2	Would FortisBC please identify if there have been any reported safety issues with this substation since 1950?
3 4	A32.2	Although the station is a legacy substation and does not necessarily meet current construction standards, no specific safety issues have been identified.
5 6	Q32.3	Would FortisBC please provide single line diagrams for the existing, single-us configuration and the ring bus alternative?
7 8	A32.3	Please see Attachment A32.3a below depicting the existing configuration, Attachment A32.3b depicting a split bus configuration, and Attachment A32.3c

9 depicting a ring bus configuration.

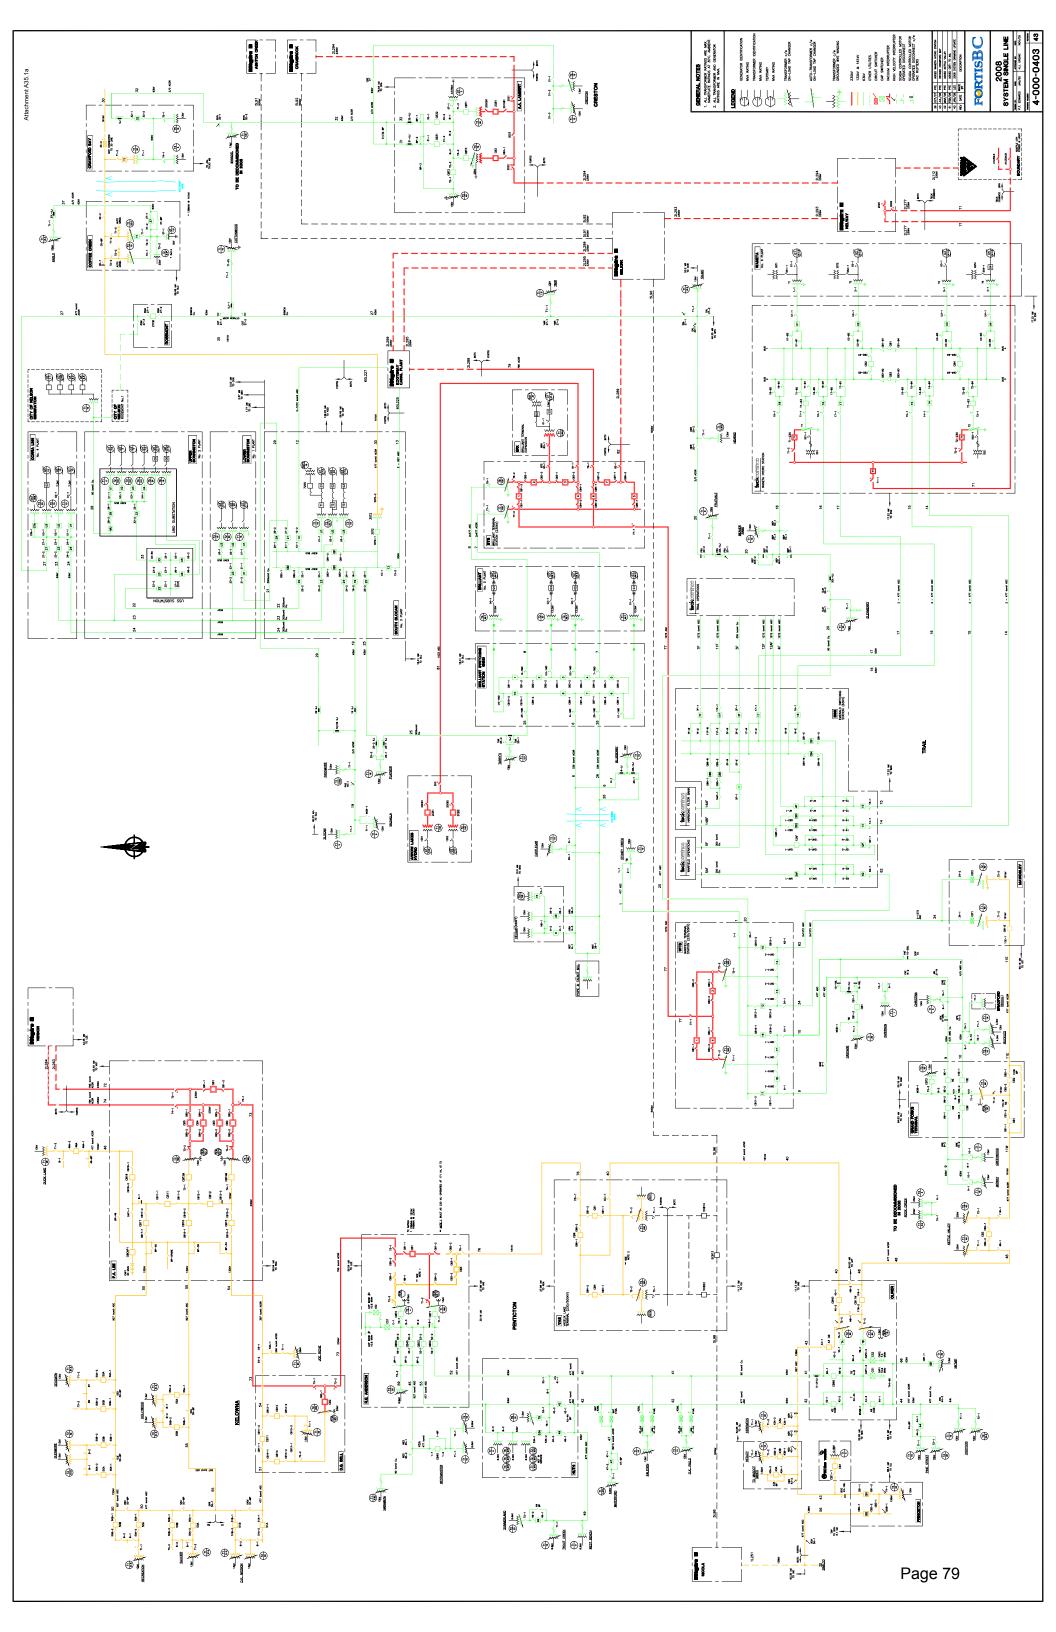
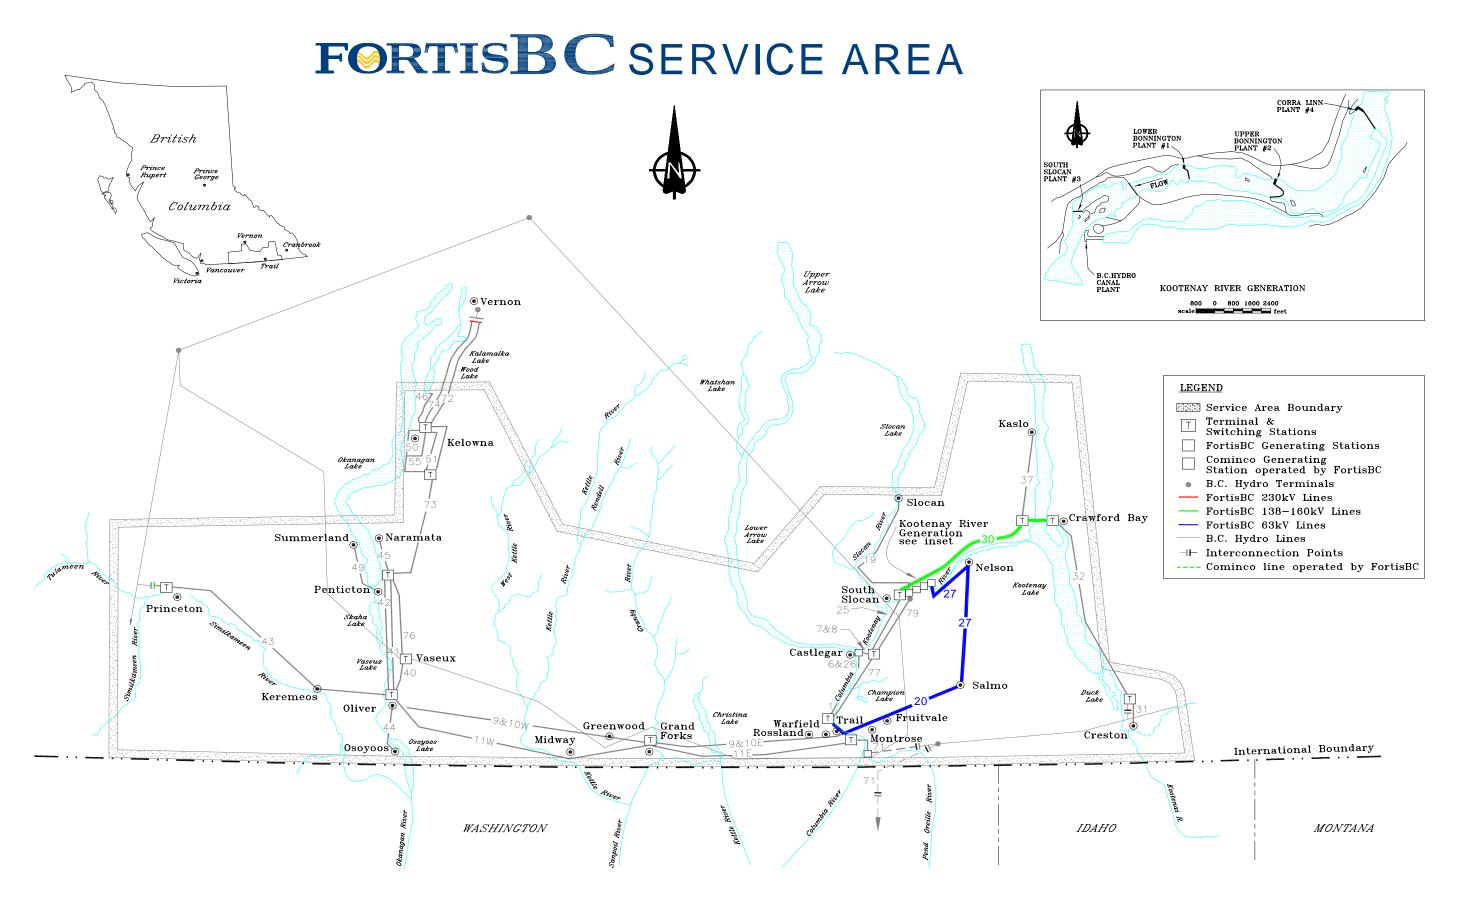
1	35.0	Reference: 3. Transmission and Stations, Sustaining Projects
2		Exhibit No. B-1, Transmission Line Sustaining Projects, p. 55
3		Table 3.2
4	Q35.1	Please provide a one-line diagram of the FortisBC transmission system
5		and a FortisBC service area diagram showing the transmission lines in
6		the table.
7	A35.1	Please see Attachment A35.1a and A35.1b below. For convenience, an
8		electronic copy of the requested single line diagram of the FortisBC
9		transmission system has also been included.

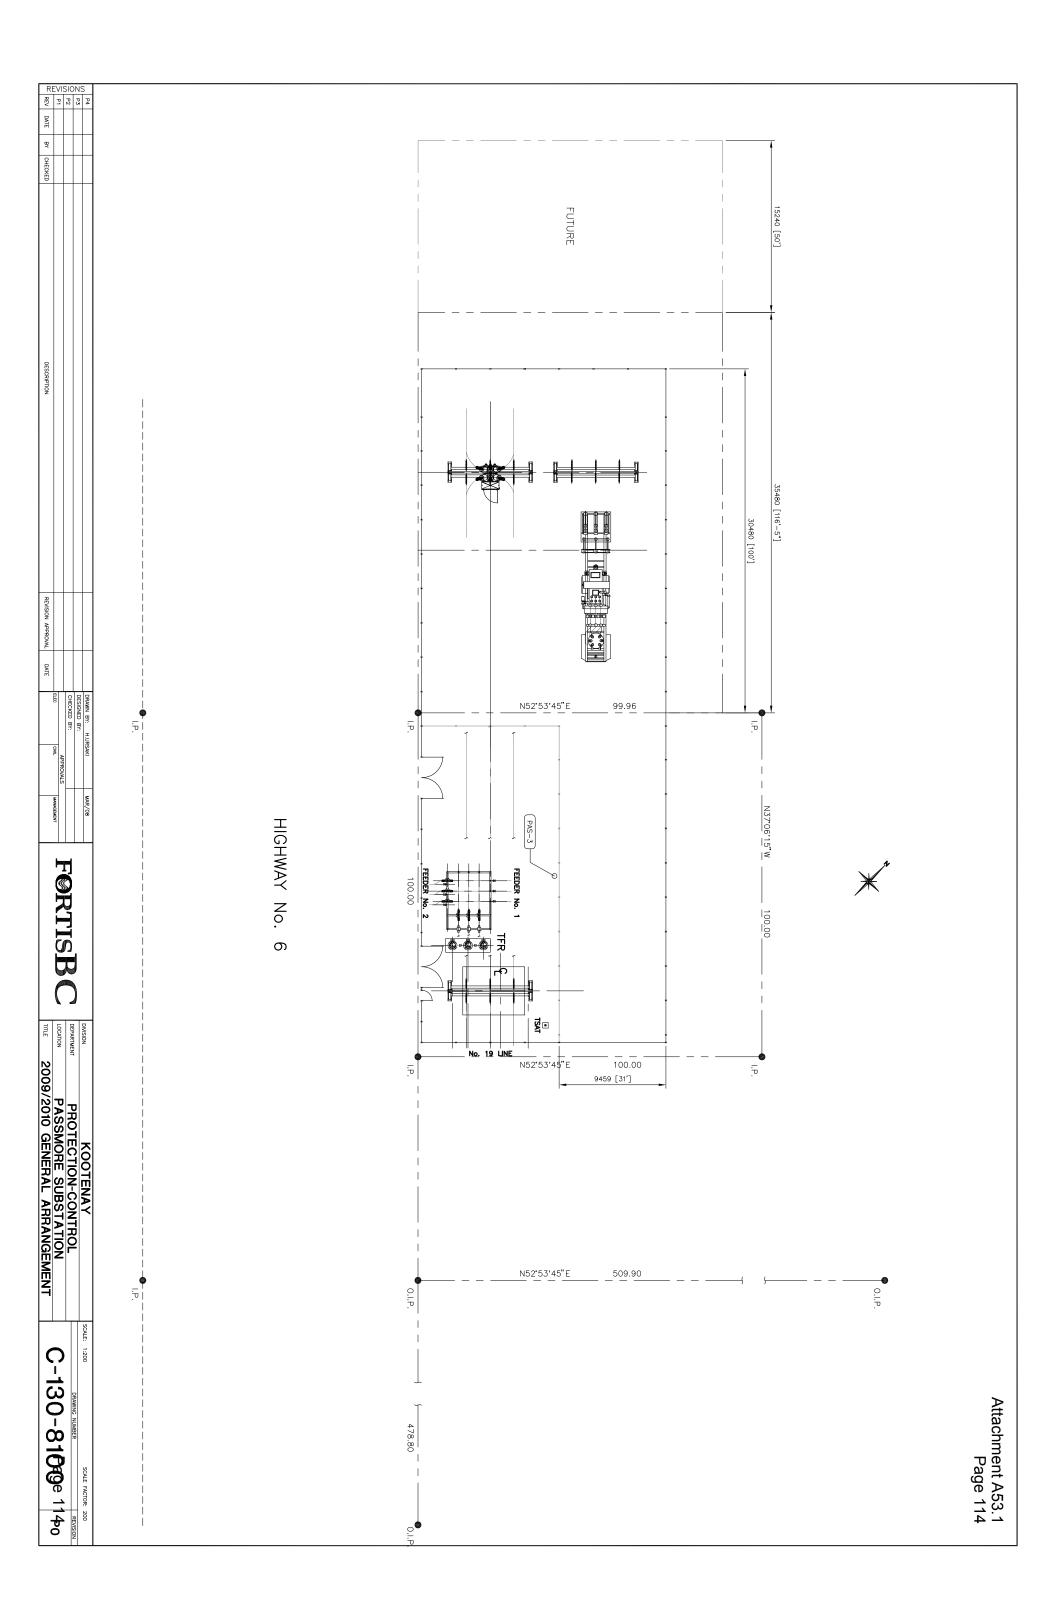
1	53.0	Reference: 3. Transmission and Stations, Station Sustaining Programs
2		and Projects
3		Exhibit No. B-1, Passmore Substation Upgrade, p. 71
4		Substation Expansion
5	Q53.1	Would FortisBC please supply conceptual substation and transmission
6		line siting diagrams including footprints and existing as well as new
7		statutory rights-of-way that may be required?

8 A53.1 Please see attachment A53.1 below.

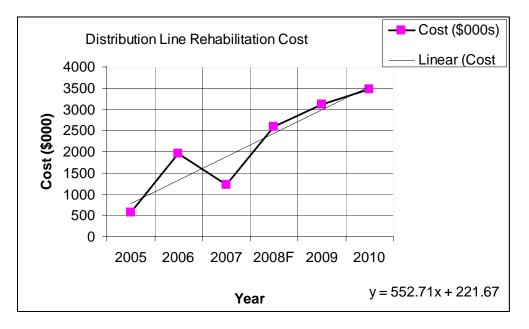
10Q67.4As these estimates are based on historical information, please explain the11additional annual growth in the annual estimated funds required of12\$500,000/year. See Chart.

A67.4 As noted in the 2009-2010 Capital Plan (Exhibit B-1), page 89, line 28 and 29,
 the historical average has been increased by \$750,000 per year for 2009 and
 2010 to accommodate Hot Tap Connector replacements.

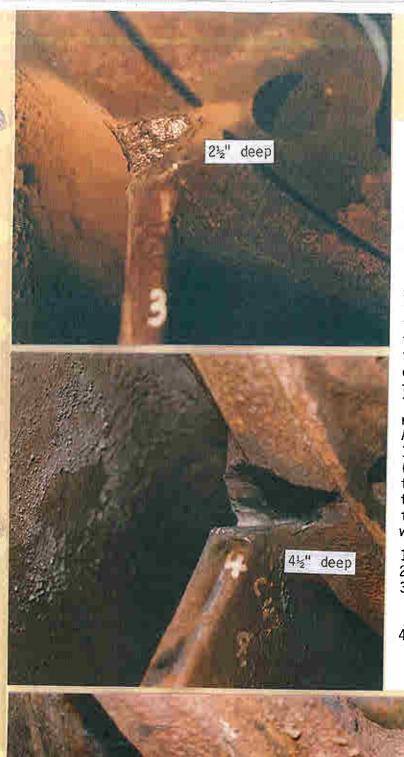
PLANT #3 UNIT #1 1985 OVERHAUL <u>RUNNER REPAIRS</u>

The cracks at the juncture of the trailing edge of the turbine buckets and the runner cone mounting flange initially appeared to be our most serious problem. We could not see the full extent of the cracking till the runner cone was removed. Close inspection after the cone was lowered showed that thirteen of the fifteen buckets had near identical cracks in this area. Due to time constraints, we were able to repair only ten of these defects. Of the three cracks left unrepaired, one (Vane 13) had been noted in 1973 and had not propagated. Another (Vane 12) had been repaired in 1973 and had re-cracked. While the third (Vane 7) had not been noted before. These three cracks provide a good base for monitoring the runner crown cracking in the future. The welding procedure for the work was as follows:

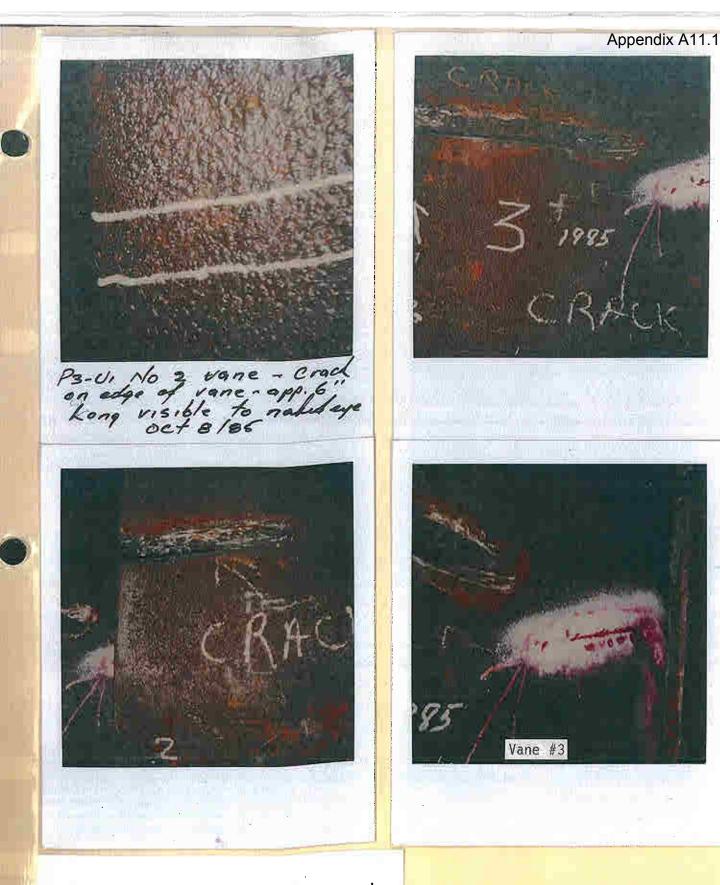
The No.2 vane crack was the initial crack found after the runner had dried out. It and the crack found in No.3 vane were near old repairs but not near enough to indicate a procedure problem in those repairs. Additional stay vanes were installed between the cracked vanes and the adjacent sound buckets. The outline of the old repair can be clearly seen in the picture immediately above.

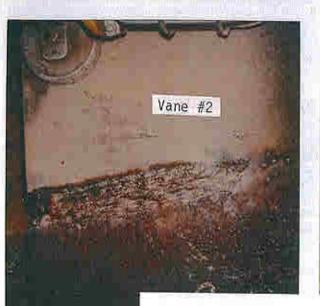
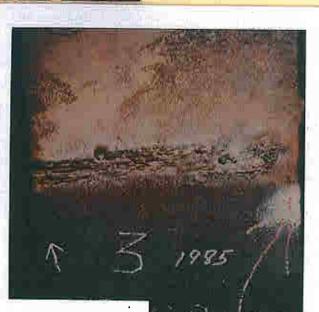
Repairs at Vanes #2 and #3 before final pass. The repair weld consisted of a S.S. 309 "butter" pass and S.S. 308 filler metal. All passes except the root were peened. The new weld was back gauged to the root and backwelded using the same procedure. Preheat and interpass heat was maintained at 200 F+. The weld was finished high and ground

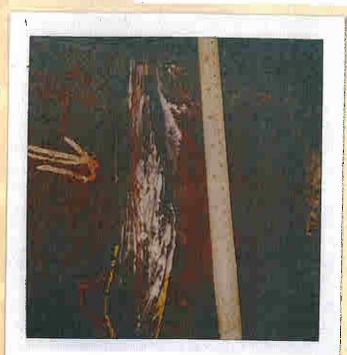
Crack at Bucket #9 inside view after gouging

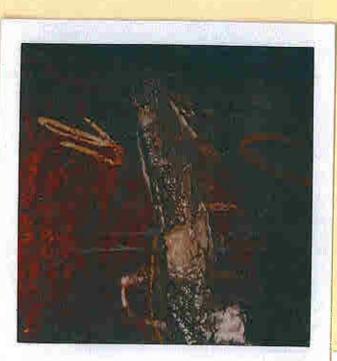
Block welding on inside

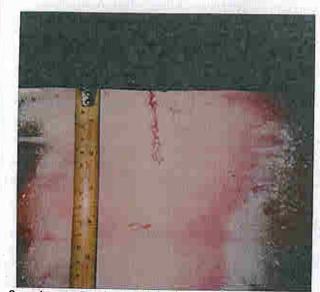
Crack at Bucket #9 outside view before gouging

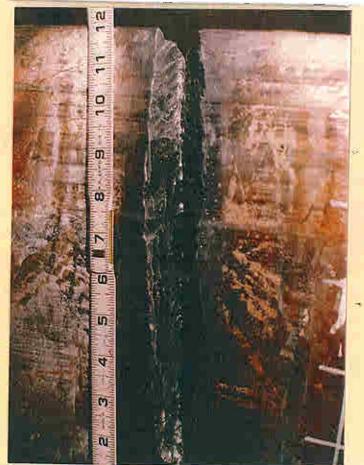
Outside view after backgauging - we had to go right through the new weld to eliminate the crack. At this stage, a magnetic particle check for cracks in the base of the opening revealed a crack adjacent to our weld. We decided to complete the repair on the initial crack and to treat the new crack as a separate problem.
